SERVICE BULLETIN

APPLICABILITY: **2020-2022MY** Legacy and Outback
2022MY WRX
2022MY BRZ

NUMBER: 15-259-20R

SUBJECT: Denso Gen 4 Cockpit One (CP1)
 Infotainment System Operating TIPS

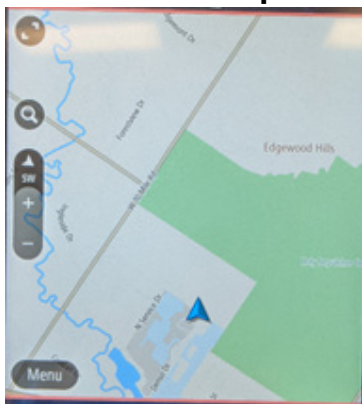
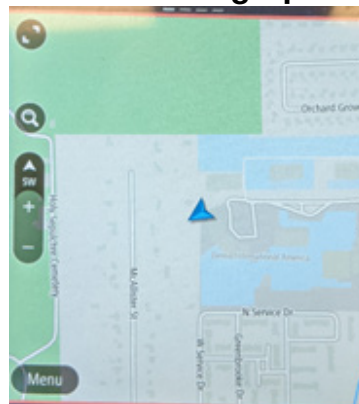
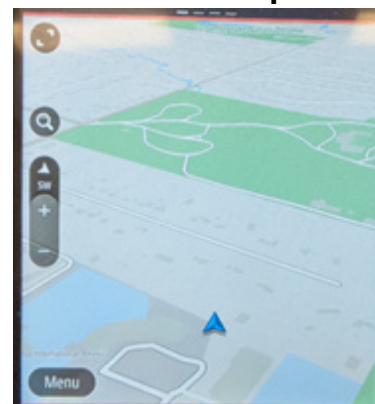
CONDITION #1b: Navigation issues due to street names not shown.

Please note street names only appear in 2D north-up and 2D heading-up. **Street names are not shown in 3D heading-up map orientation mode.** This is TomTom User Interface constraint for CP1.0 system. So this operation is characteristic.

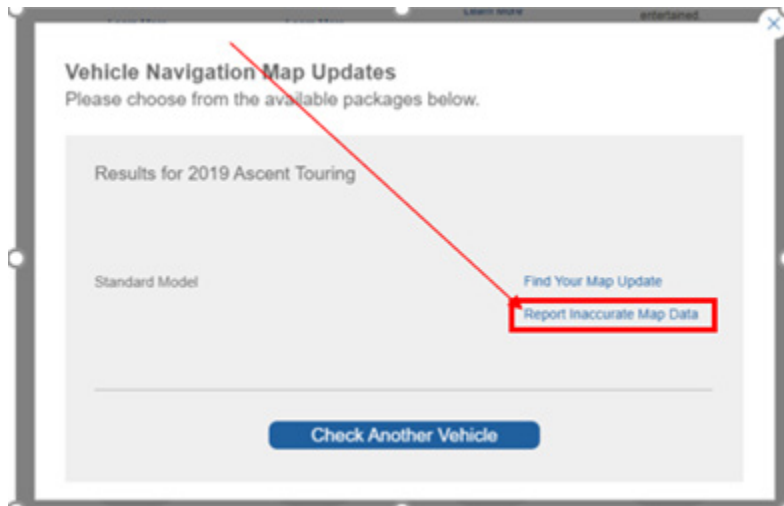
If even after the map is updated , there is still a concern about inaccurate map data (no match for street name, no match for town/city name, address not found etc.) we appreciate the feedback reported using the link from SOA website <https://www.subaru.com/owners/index.html>.

Select “Navigation” and the vehicle of interest using pulldown menus, click command button “Search for Updates” button and use the link “Report Inaccurate Map Data”.

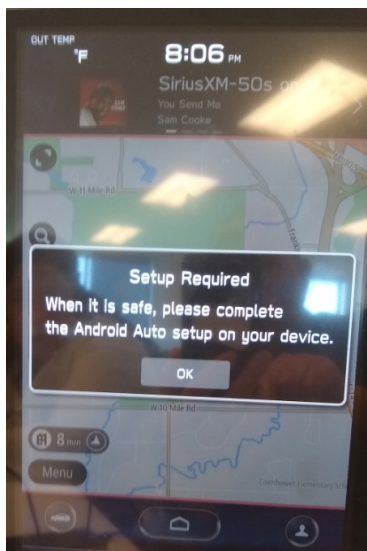
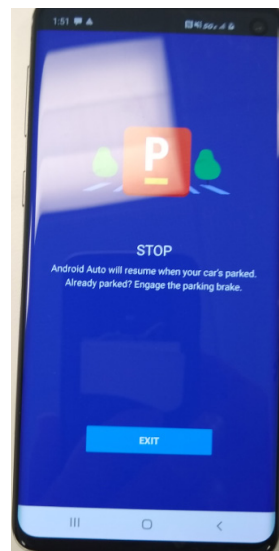
CONDITION #8: Android Auto does not launch.

CAUSE / NOTE: The vehicle must be stopped and the electric parking brake (EPB) must be ON to complete the initial pairing process between the CP1 / Gen 4 Infotainment system and the phone using the Android Auto application. When connecting a phone to the USB port, follow the messages on both the CP1 display and the phone screen. See below an example.

This is a normal operating characteristic. It is a good practice to confirm an undamaged, genuine cable is used to connect the phone as well as the making sure the phone is set to accept connection with a new vehicle.

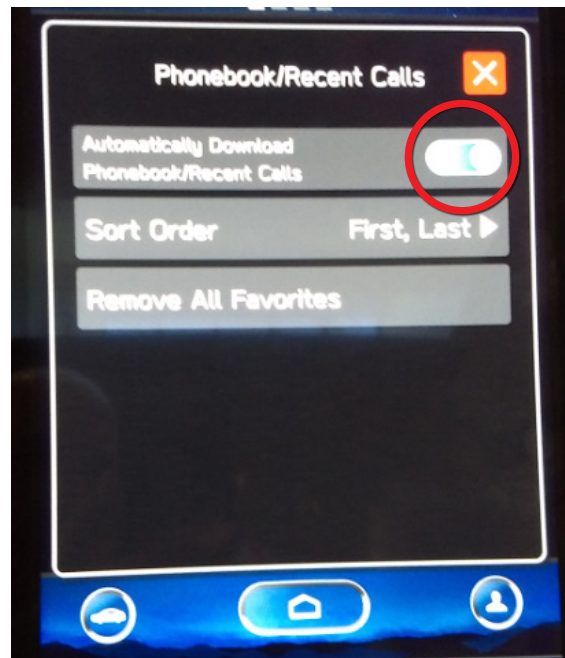
Home > Settings > Phone > Phonebook/Recent Calls

CONDITION #10: User is unable to download Phonebook Contacts.

When assisting with questions about the phonebook download process, start by verifying the option is enabled in the CP1 / Gen 4 Infotainment system using the following screen shot as a guide.

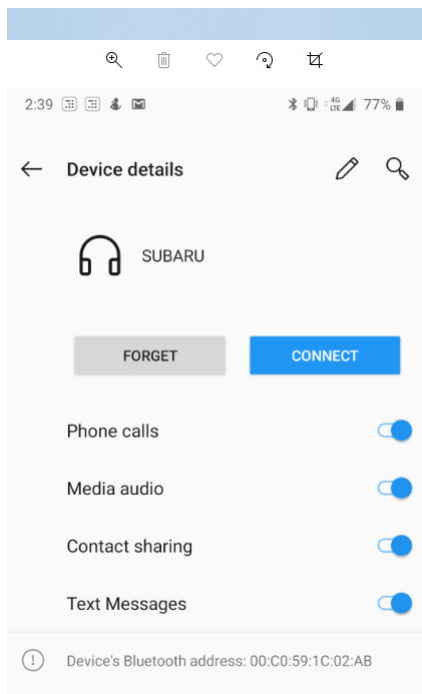
- **Android Device**

If the customer still cannot access the phonebook or messages, check the phone’s Bluetooth settings to ensure all related sharing settings are enabled.

Select the gear icon next to your vehicle device name. Ensure all settings are enabled.

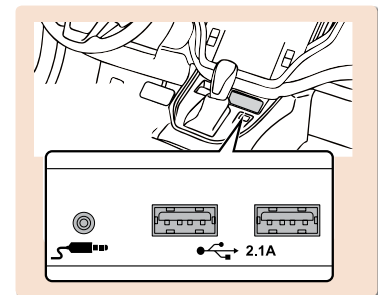
**CONNECTING A USB MEMORY DEVICE/
PORTABLE DEVICE**

CONDITION #12: Playback of audio files using a USB memory device does not work.

Always confirm the customer is using a correct port as well as following the guide lines for the media requirements. If the customer still can't play back their audio files using a USB memory device, confirm the device has not been damaged. Once the USB device is confirmed to be OK, follow the applicable Service Manual procedure to perform further diagnostics.

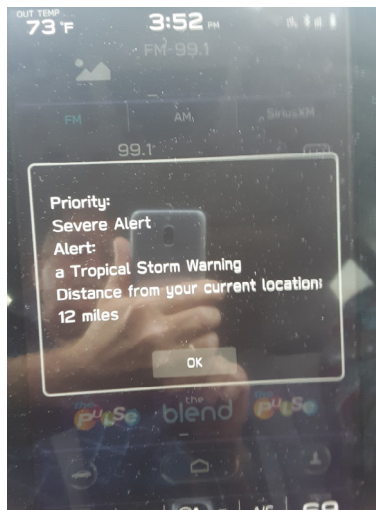
Weather alert

CONDITION #16: Weather Alert message

The Denso CP1 system is designed to receive severe weather alert information from Sirius XM (SXM) and display a pop-up window with the alert message as shown below.

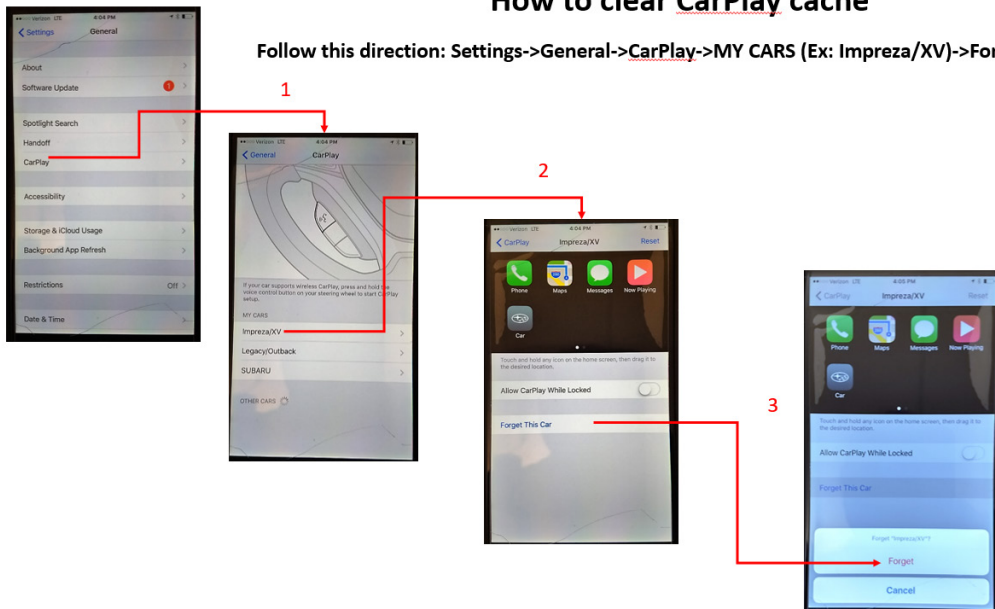
How to clear CarPlay cache

CONDITION #18: No Audio during CarPlay

Follow this direction: Settings->General->CarPlay->MY CARS (Ex: Impreza/XV)->Forget This Car

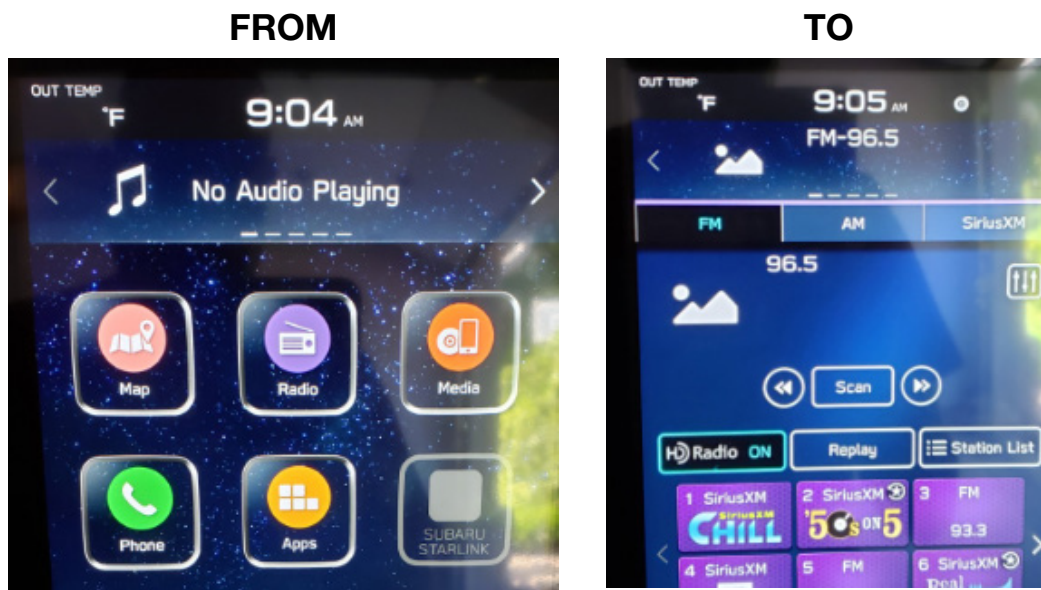
CONDITION #25: Volume adjustment isn't available and Audio isn't playing

CAUSE: There have been many reports for audio playback and volume adjustment issue following CP1 reboot. Please keep in mind it might be a normal operation, if you see a message “No Audio

The message “No Audio Playing” in the status bar area indicates no audio source was selected for CP1 following reboot. Likely resulted from CP1 running projection application or streaming audio prior its shutdown. This is not a failure and the customer should not be alarmed.

RECOMMENDATIONS: please select the audio source (SXM, AM, FM, Media etc.) to enable playback (audio output)
