Service Bulletin

Bulletin No.: 21-NA-286

Subject: Rear Hands-free Liftgate Feature Intermittently Inoperable or Difficult to Operate

Brand:	Model:	Model Year:		Breakpoint:		Engine:	Transmission:
		from	to	from	to		
Buick	Envision	2021	2022	SOP	November 20, 2021

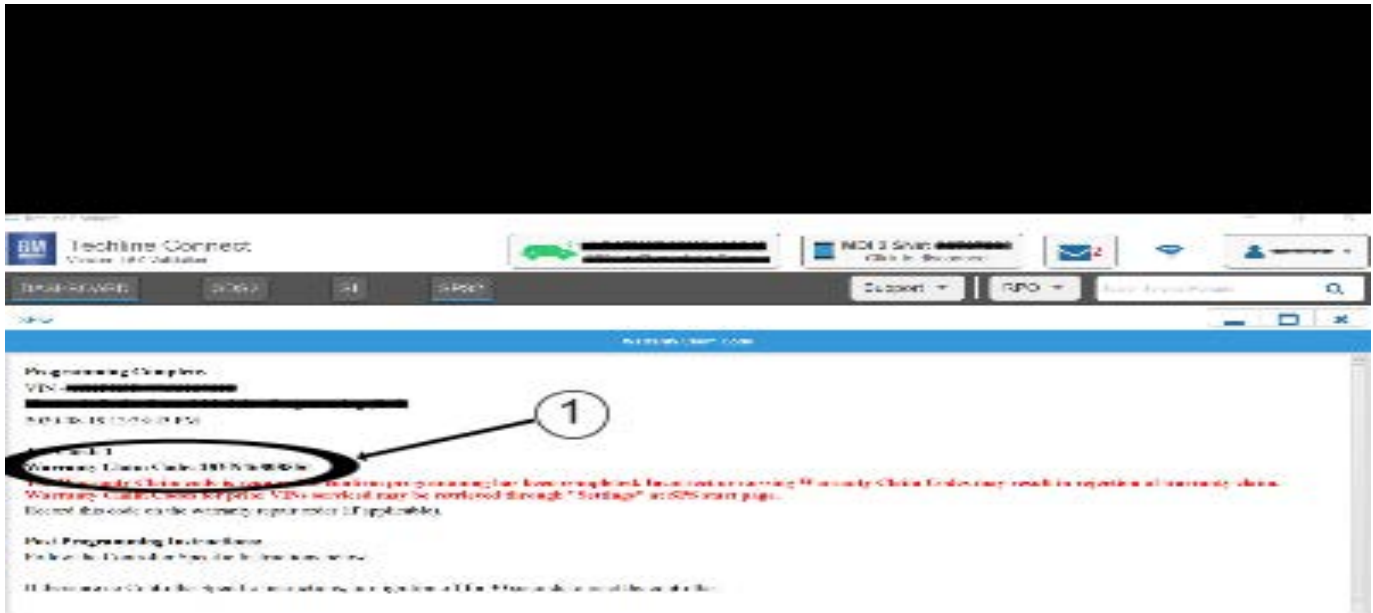
5431209

Important: If the same calibration/software warning is noted on the TLC or SPS Summary screen, select OK and follow screen instructions. After a successful programming event, the WCC is located in the Service Programming System dialogue box of the SPS Summary screen. No further action is required. Refer to the Warranty section of the bulletin.

1. Reprogram the Body Control Module. Refer to *K9 Body Control Module: Programming and Setup* in SI.
