Technical product information

Topic	Rotating screen alignment
Market area	Russische Föderation (5RU),Australia E04 Bentley rest Asia and Australia (6E04),China 796 VW Import Comp. Ltd (Vico), Beijing (6796),Germany E02 Bentley rest Europe (6E02),Japan E03 Bentley Japan (6E03),Korea, (South) E08 Bentley South Korea (6E08),United Arab Emirates E06 Bentley Middle East and Africa (6E06),United Kingdom E01 Bentley UK (6E01),United States E05 Bentley USA and rest America (6E05)
Brand	Bentley
Transaction No.	2065896/1
Level	EH
Status	Approval
Release date

New Continental GT - New Continental GTC and New Flying Spur

The gap and fit between the "veneer face" fascia panel of the Bentley rotating display (BRD) and the passenger and drivers side fascia panels may differ from one side to the other

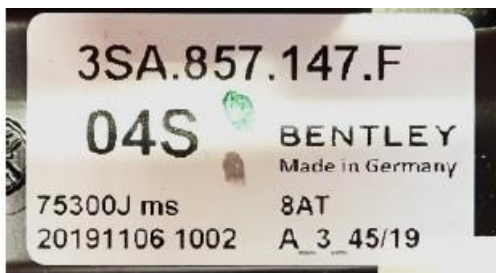
Figure 21

- Take a photo of the BRD prior to packaging (Noting any damage)
- Take a photo of the BRD identification number (Figure 21 as an example)

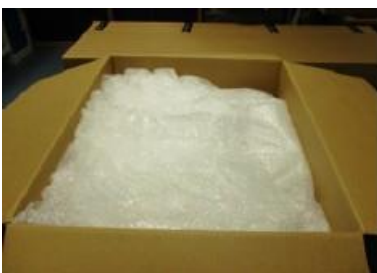
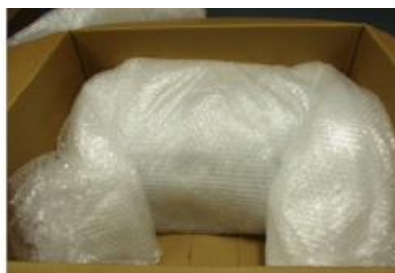
Figure 22

- All returned BRD's must be packaged in the replacements original packaging (Figure 22) to avoid any damage during return transit
