SERVICE BULLETIN

Classification: TF16-001C	Reference: NTB17-003C	Date: February 16, 2022
------------------------------	--------------------------	----------------------------

FLUID LEAK CAUSED BY TRANSFER ASSEMBLY RIGHT SIDE DRIVE SHAFT OIL SEAL

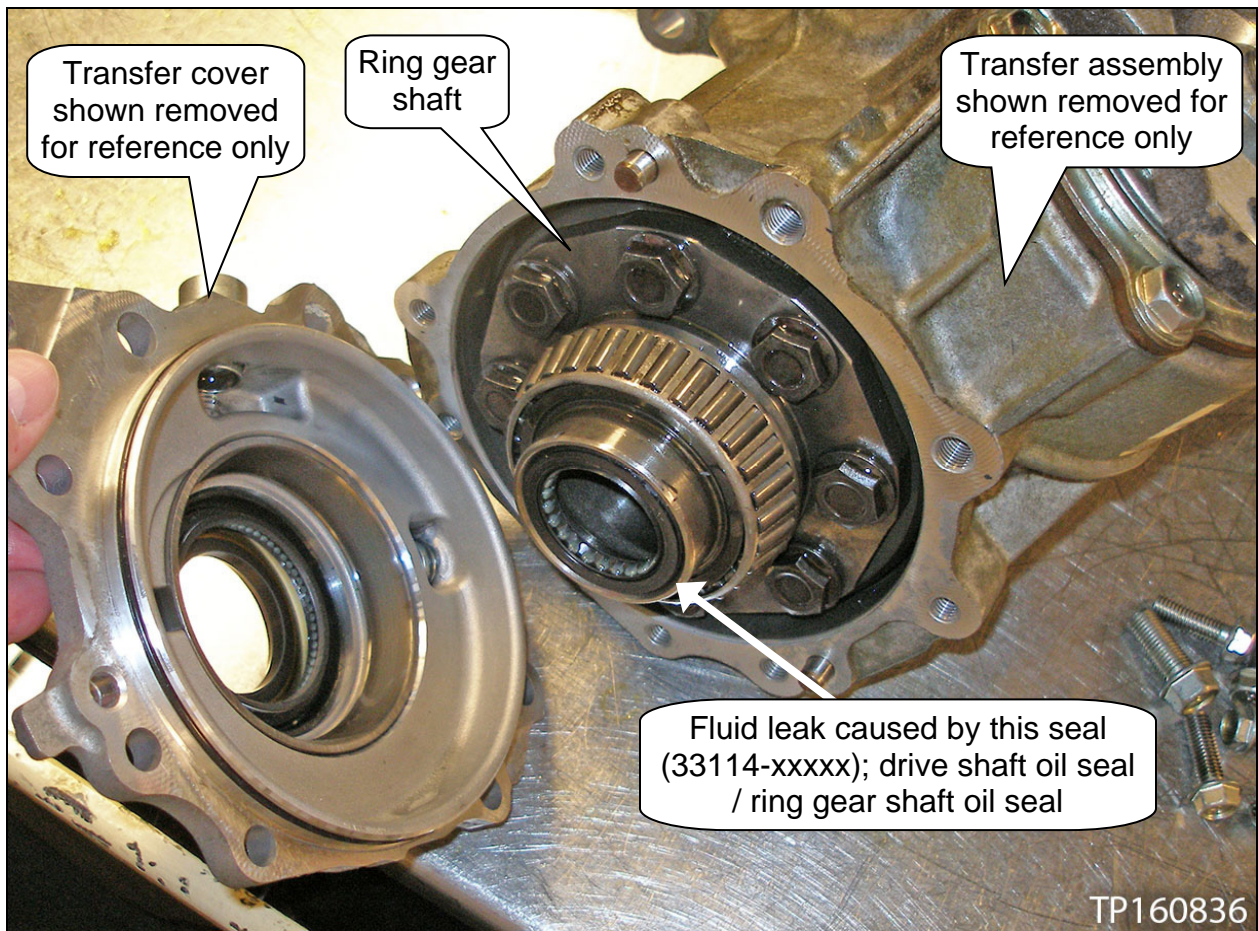
Figure 7

* The seal causing the leak is called "Drive shaft oil seal" in the ESM for all applied models except Rogue, Rogue Hybrid, Rogue Sport, and Altima. For these vehicles, it is called "Ring gear shaft oil seal".

To avoid damage to the transfer assembly and new seals, use an appropriate seal installer and seal protector during the repair.

- This repair does NOT require transfer assembly removal from the vehicle.
- This repair does NOT require transfer cover removal from the transfer assembly.
