## Index of models

**NEW TOPICS** 3

### NEW TOPICS

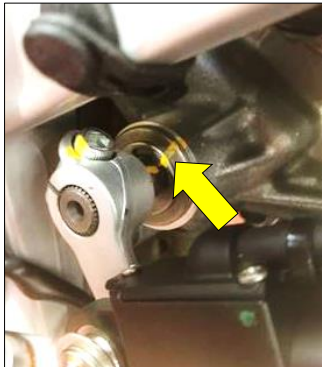
2	<p><u>ONLY</u> <u>Panigale V4</u> <u>(all versions)</u> <u>Streetfighter V4</u> <u>(all versions)</u></p> <p>Introduction of gear selector shaft certification</p>	Gear selector

<p>We have received some isolated reports of a possible loss/absence of the <b>snap ring (A)</b> of the gear selector shaft. We would like to inform you that an additional certification on all Desmosedicci Stradale engines between snap ring, washer, and crankcase at the outlet of the gear selector shaft has been added along the production line. The first engine serial number with this new certification is ZDM1100WC #001513#.</p> <p>Upon the first workshop service, you are thus invited to check for the presence of the <b>snap ring (A)</b> on all engine serial numbers preceding the one specified above.</p> <div data-bbox="1771 1066 2197 1433">

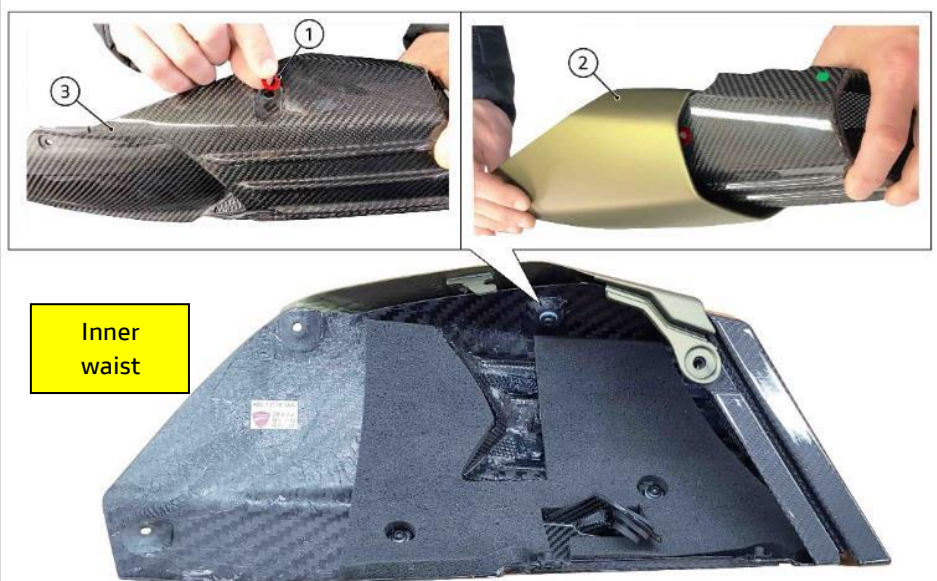
<p>We have received some isolated reports about a possible indentation of the RH and/or LH outer cover of the air conveyor.</p> <p>To avoid this phenomenon, it is necessary to position <b>washer (1)</b> 4x14x1 Part no. 85240171A between <b>outer cover (2)</b> and carbon air <b>conveyor (3)</b> in the upper fixing point, as shown in the figure.</p>

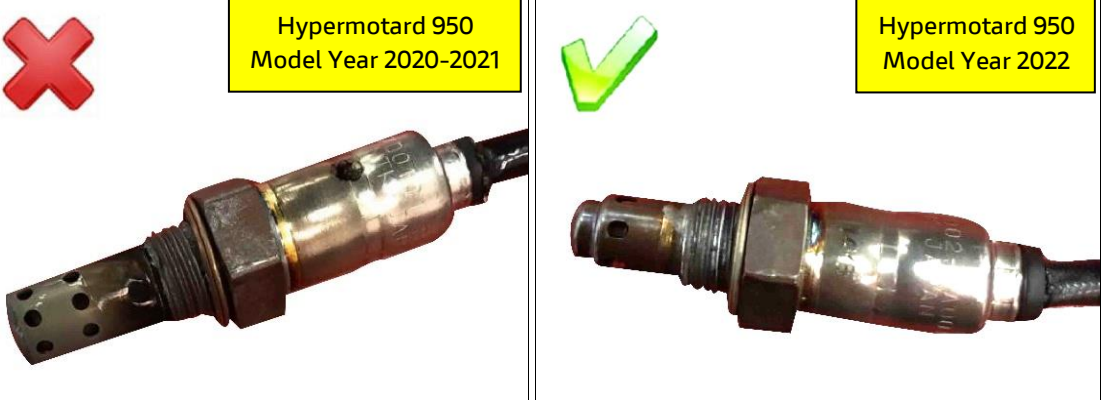
no.	Symptom	Subject	Photo	Notes and Indications - Corrective action
3	<p><u>ONLY</u> <b>Hypermotard 950 MY22</b></p> <p>Possible validation of errors P2A03 Horizontal cylinder lambda sensor (oxygen sensor) [Value out of range] and/or P2A00 Vertical cylinder lambda sensor (oxygen sensor) [Value out of range]</p>	Lambda sensors	-	<p>We have received some isolated reports of the possible validation of the following errors:</p> <ul style="list-style-type: none"><li>• P2A03 Horizontal cylinder lambda sensor (oxygen sensor) [Value out of range]</li><li>• P2A00 Vertical cylinder lambda sensor (oxygen sensor) [Value out of range]</li></ul> <p>after riding only 1000km/600mi.</p> <p>Our analysis has shown that this phenomenon is linked to the possible installation of lambda sensors relating to the previous Model Year (Model Year 2020-2021 EURO4 version) despite having the same connector on the wiring side.</p> <p>We would like to inform you that the production line has made the process more robust in order to avoid this issue.</p> <p>Should you find the above mentioned errors, we ask you to ensure that the dedicated lambda sensors part no. 55215021A for the Hypermotard 950 Model Year 2022 are actually installed</p> <div data-bbox="1048 647 2168 1056">

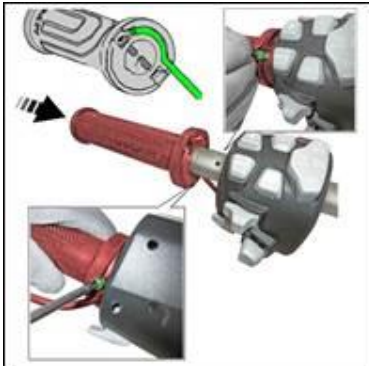
<p>We have received some reports about heated handgrips that have not been installed correctly and so the cable between the handgrip and the switch may be pinched.</p> <p>We kindly ask you to always follow the instructions provided on the DCS under the "accessories catalogue" section or in the model presentation bulletin (SRV-SRB-20-049) and to <u>comply with the correct orientation of the cable and handgrip</u> as shown in the figure.</p>

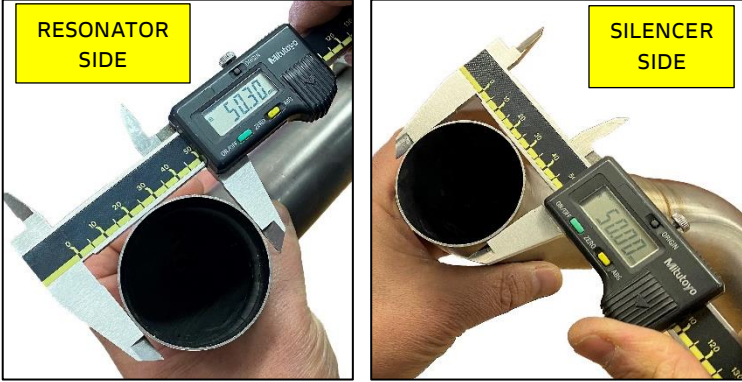
<p>For this reason, we ask you to check the kits in your possession and verify their Serial Number. If the serial number is the same as the one shown above, we ask you to measure the diameter of the holes in the silencer manifolds with a gauge and check that they have a diameter of:</p> <ul style="list-style-type: none"> <li>- <b>50.0 mm</b> for silencer-side hole</li> <li>- <b>50.3 mm</b> for resonator-side hole</li> </ul>

<p>If the measured values are not correct, it will be necessary to order the conforming manifold using the following part numbers:</p> <ul style="list-style-type: none"> <li>- Silencer front manifold <b>Part no. 96413531A</b></li> <li>- Silencer rear manifold <b>Part no. 96413541A</b></li> </ul> <p>For warranty claims on components, we ask you to fill out a <b>Yutech</b> report and ask your Service Area Manager for guidance.</p>

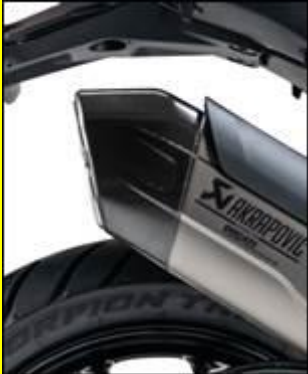
no.	Symptom	Subject	Photo	Notes and Indications - Corrective action
44	<p><b>NEW</b></p> <p><u>ONLY</u> <u>MULTISTRADA V4</u> <u>(all versions)</u></p> <p>Possible color change of the Akrapovič silencer carbon endcap</p>	Akrapovič Silencer carbon endcap Type-approved and Racing

<p>We have received some reports of a possible color change of the Akrapovič racing Exhaust Silencer carbon endcap.</p> <ul style="list-style-type: none"><li>• Should the customer experience this phenomenon, please remove the carbon endcap and check for possible traces left by the passage of gas.</li><li>• Should the exhaust show traces of vents, please fill out a <b>Youtech</b> service request attaching photos highlighting the gas passages.</li></ul> <p>If the exhaust does NOT show any traces of gas passages, please fill out a <b>Youtech</b> service request and replace only the carbon endcap <b>Part no. 57315281A</b> and, at the same time, also the 4 aramid washers <b>Part no. 97610991A</b>.</p>

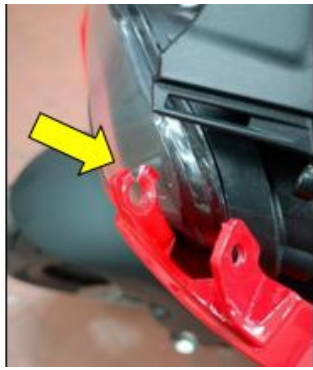
no.	Symptom	Subject	Photo	Notes and Indications - Corrective action
1	<p><u>ONLY</u> <u>Panigale V2</u></p> <p>Precautions during PDI: installation of the side half-fairings</p>	Side half-fairings

<p>We received some isolated claims about the possible breakage of the top fastener retaining the LH side half-fairing to the headlight fairing.</p> <p>During PDI and whenever removing the side half-fairings, we remind you to pay utmost attention to the tightening of the <b>2 screws M5x0.8 (1)</b> retaining the upper LH and RH half-fairings to the headlight fairing; always comply with the specified tightening torque of <b>2 Nm ± 10%</b>.</p>

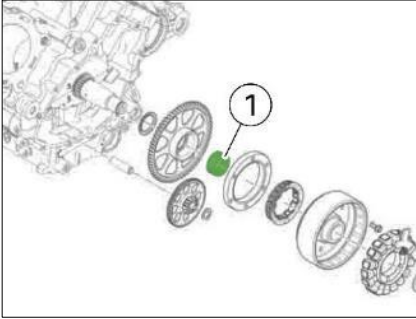
no.	Symptom	Subject	Photo	Notes and Indications - Corrective action
4	<p><u>ONLY Panigale V4</u></p> <p>Starting system update</p>	Starting system	-	<p>To ensure a better starting operation of the engine, we inform you that from engine serial number:</p> <ul style="list-style-type: none"> <li>- ZDM1100W4#007612# for EUR version</li> <li>- AGNK007652 for CAL version</li> </ul> <p>the <b>roller bearing (1)</b> has been introduced instead of the bushing.</p> <p>Please, note that the spare part catalogue has been updated.</p>

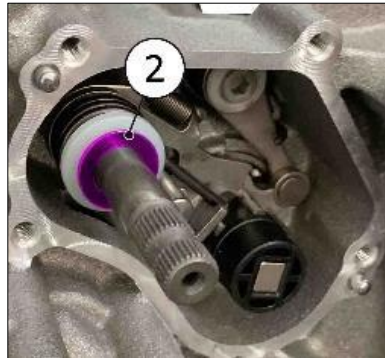
no.	Symptom	Subject	Photo	Notes and Indications - Corrective action									
12	<p style="text-align: center;"><u>ONLY</u> <b>959 Panigale</b> <b>(all versions)</b></p> <p>Possible hardening of gear shift control with difficulty in shifting gears when hot</p>	Gear selector	-	<p>We have received some isolated reports about a possible hardening of the gear shift when hot with consequent difficult selection of gear ratios. Based on the analyses carried out, this phenomenon could be due to a hardening between the gearbox sensor magnet plastic support and the relevant seat inside the cover.</p> <p>You are kindly asked to carry out the following operations:</p> <ol style="list-style-type: none"> <li>1) Remove the <b>gear shift cover (1)</b> on motorcycle LH side</li> <li>2) Check for the presence of <b>shim (2)</b></li> <li>3) Mill the end face of the plastic cage for the selector magnet (3) shorter by 0.1 mm maximum and the outer curved edge where it enters the bore of the cover by 0.1 mm maximum, <u>or</u> mill the internal <b>surface (4)</b> of the cover highlighted in the figure and remove 0.1 mm maximum of material from the end and bore of the recess. Ensure the orientation of the magnet is not changed on the shift selector or the gear position will not be able to be determined by the sensor.</li> </ol> <div style="display: flex; justify-content: space-around;">

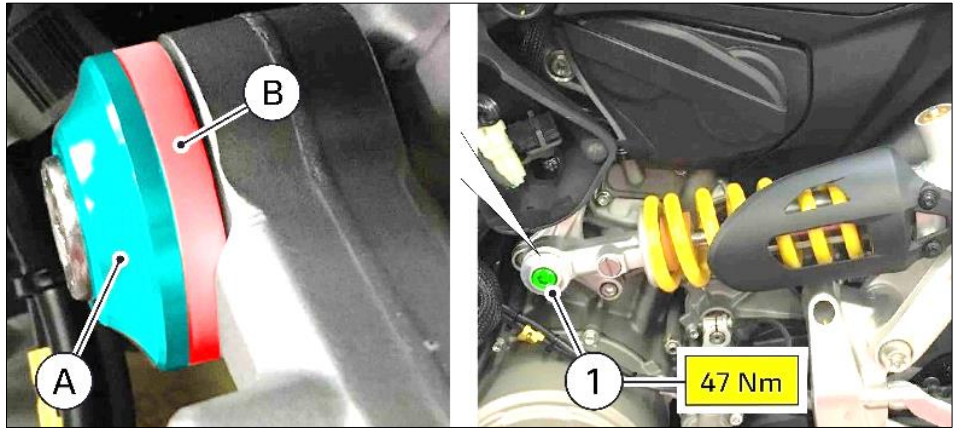
no.	Symptom	Subject	Photo	Notes and Indications - Corrective action
17	<p><u>ONLY</u> <u>Panigale V2</u></p> <p>Possible contact of Sachs rear shock absorber reservoir with vertical head manifold heat guard</p>	Sachs rear shock absorber reservoir

<p>We would like to inform you that starting from the frame number <b>ZDMHAATW2MB003762</b>, a spacer and a Teflon anti-rotation washer have been introduced at the front fixing screw of the shock absorber to prevent possible contact between the rear shock absorber reservoir and the vertical head manifold head guard. The contact results in a cosmetic defect only.</p> <p>In case of complaints from the Customer, it is possible to proceed with the installation of spacer <b>part no. 7111D981AA (A)</b> and washer <b>part no. 7131E352A (B)</b>, as shown in the figure.</p> <p>We remind you to always apply the <b>screw M10x45 (1)</b> with Shell GADUS S2 V220 AD 2 grease and to tighten the screw to the new torque of <b>47 Nm</b> (the previous tightening torque was 45 Nm).</p>

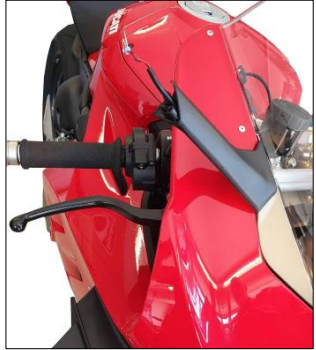
<p>We received some isolated claims about the possible breakage of the rear-view mirror arm due to minor impacts.</p> <p>We would like to inform you that to avoid the phenomenon described above, new, stronger rear-view mirrors have been introduced and can be ordered using the following part numbers:</p> <ul style="list-style-type: none"><li>• LH rear-view mirror: <b>Part no. 523S0645A</b></li><li>• RH rear-view mirror: <b>Part no. 523S0655A</b></li></ul> <p>In the event of rear-view mirror arm breakage due to minor impacts, we ask you to send a Youtech service request and then proceed with replacement of the component under warranty unless otherwise advised by your reference Service Area Manager.</p>

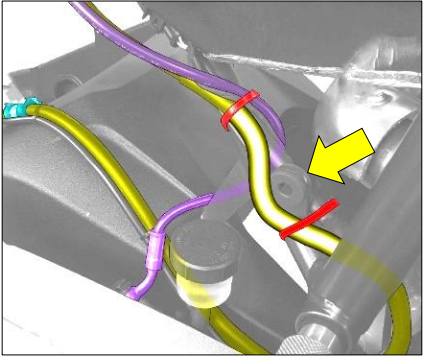
no.	Symptom	Subject	Photo	Notes and Indications - Corrective action				
1	<p><u>ONLY Scrambler 800 (all model versions and MY, excluding Desert Sled model version)</u></p> <p>Precautions when routing the rear brake caliper hose</p>	Rear brake hose	-	<p>We have found that sometimes, during maintenance operations, the rear brake caliper hose is not correctly positioned along the frame due to incorrect installation by the technician during service.</p> <p>Make sure that the rear brake caliper hose (yellow), passes outside the left side cover mounting bracket with respect to the motorcycle centerline and is fixed with the two self-locking ties (red) as shown in the figure.</p> <p>The operation of inspection and possible repositioning is very simple and involves the disassembly of the left side cover only.</p>

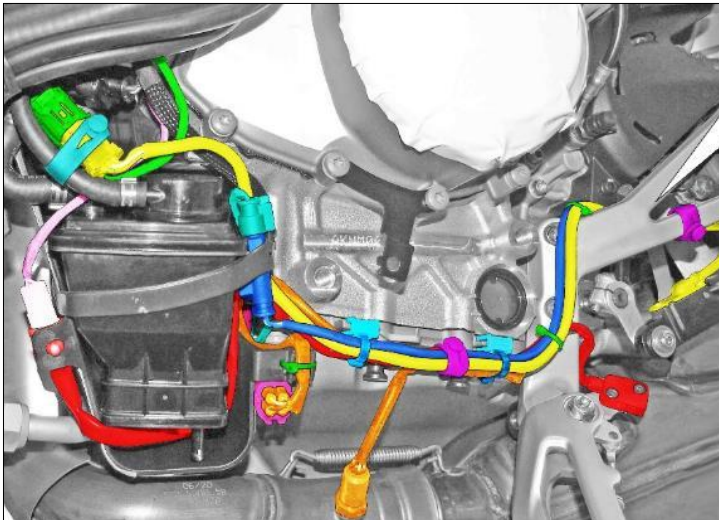
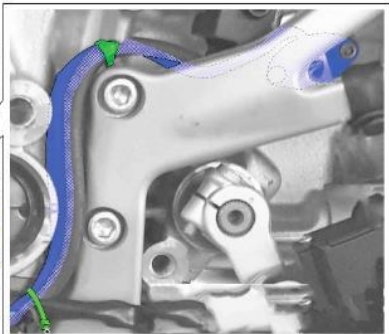
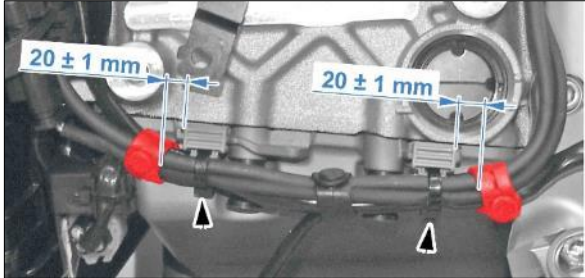
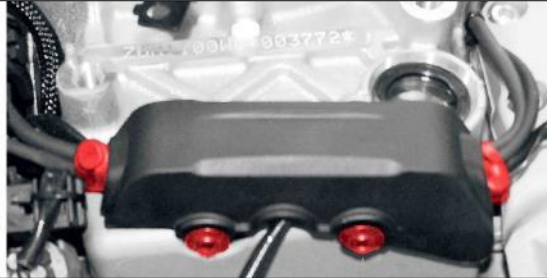
no.	Symptom	Subject	Photo	Notes and Indications - Corrective action
1	Updated layout of motorcycle wiring	Wiring	-	<p>We would like to inform you that the layout of the side stand cable - gear sensor cable - Ducati Quick Shift cable - lambda sensor cable and of the gear sensor connector and cable at the lower crankcase, on the left side of the motorcycle (as shown in the figure) has been updated starting from frame number ZDMFA00AALB003932.</p>

<p>Before installing the wiring cover, apply two L=39 mm button ties respecting the dimensions shown in the figure:</p>

<p>We ask you to respect the new layout of the cables and the gear sensor connector in case of servicing of the mentioned parts.</p>

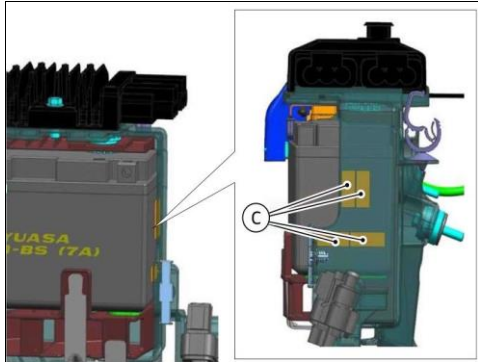
<p>The ongoing tests on the product have revealed the possibility of contact between the battery and its support, which causes marks on both surfaces due to vibration. These marks do NOT affect the correct operation of the electric system and therefore of the vehicle.</p> <p>In order to prevent such marks, <b>4 adhesive pads (C)</b> in rubber 9X23X1.4 part no. 86612791A have been introduced in the production line to be applied inside the battery support.</p>
