Volvo Chassis - Diagnostic Trouble Codes (DTC's) - MID130 PID160 FMI1 Or FMI2 - For The I-Shift **Transmission**

I-Shift Transmission With Mixed Components

V-431-001A

(November 2010)

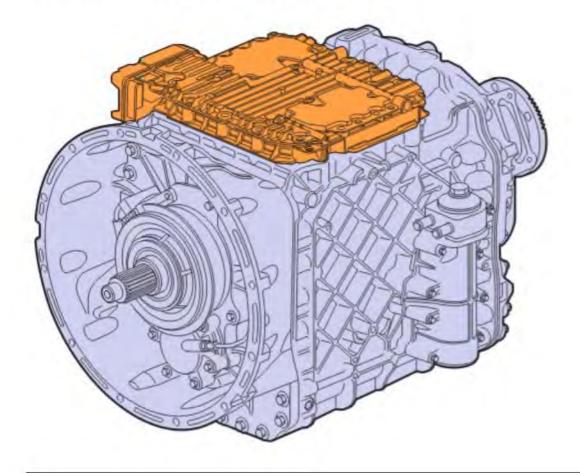
The installation of replacement parts in an I-Shift transmission (Version-C) may result in diagnostic trouble codes (DTC's) MID130 PID160 FMI1 or FMI2. The DTCs are due to a hardware mismatch of transmission control module-D (TECU-D) or TECU-C, cable harness with speed sensor and sensor wheel in the generation D (New) or C (Old) versions of the I-Shift transmissions. To determine the combination of mixed components, a conversion kit is available and used to eliminate the DTCs MID130 PID160 FMI1 or FMI2.

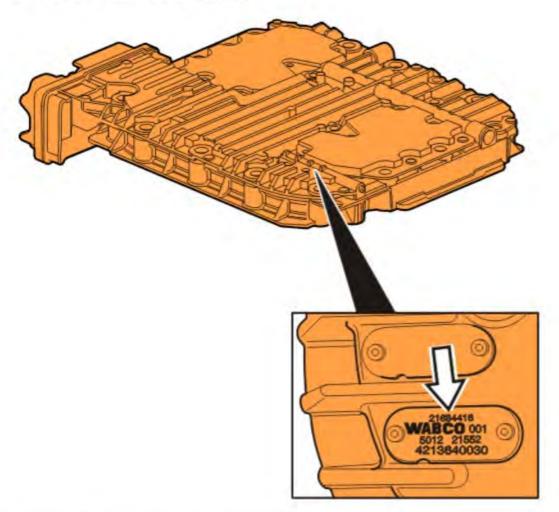
have been released. Both are connected to the related part numbers in Impact. The conversion kit will add parameters KBQ and KBR to the TECU-D. By setting these in different combinations the software will identify if either a TECU-D or complete GCU-D is installed in an I-Shift generation C transmission. If the correct conversion kit is not run, a DTC MID130 PID160 FMI1 or FMI2 will result.

When installing a replacement part TECU-D or complete GCU-D assembly in an I-Shift generation C transmission, a conversion kit must be run. Follow with download of software to MID130, enabling the TECU-D to identify if it is installed in an I-Shift generation C transmission. To select the correct conversion kit, TPI 432-014 and TPI 432-015 Copyright to this documentation belongs to the Volvo Group. No reproduction, copying, change, amendment or other similar disposal is entitled without prior written consent by the Volvo Group
