SERVICE BULLETIN

APPLICABILITY: 2020-22MY Legacy and Outback Models **NUMBER:** 15-261-20R
SUBJECT: Reprogramming File Availability for Optimization of Gen 4 Denso CP1 Infotainment Systems **DATE:** 03/10/20
REVISED: 04/22/22

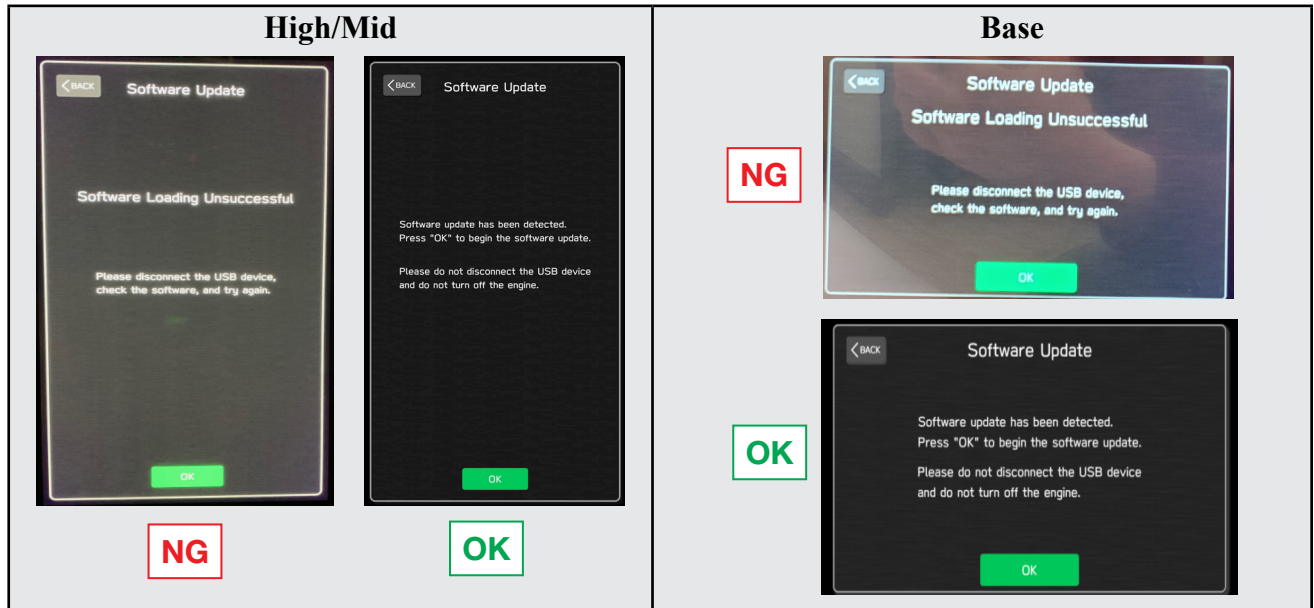
- 4e) Insert reprogramming USB into the USB port and press **OK**.
NOTE: If after plugging in the USB, the screen displays a **Software Loading Unsuccessful** message, confirm the USB device has been properly formatted and the the software on the device matches the system being reprogrammed (example: Base software is being used to update a Base system) and retry.

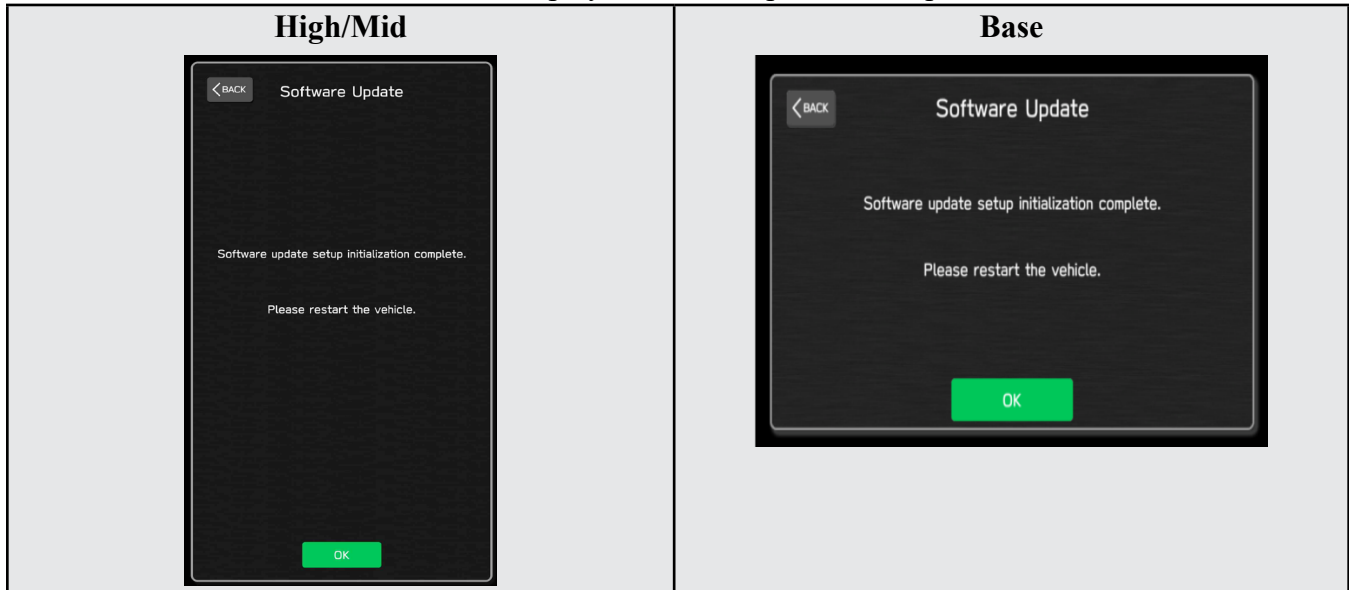
- The screens shown below will be displayed when the process completes.

1. Turn the ignition OFF, open the driver’s door, close the driver’s door and **WAIT** for 3 or more minutes before proceeding further.
2. Open the driver’s door again and either turn the ignition ON (if a charger is connected) or start the engine.
3. Go to Dealership Mode menu again (PRESS and HOLD the RIGHT-side temperature control buttons (both up and down) and press the Tune / Scroll knob 6 times then release all to display the Dealership Mode) and select Software Update as in **STEP 4c** beginning on pg. 11.

IMPORTANT NOTE: If this procedure is required, contact Techline as additional action may be necessary.

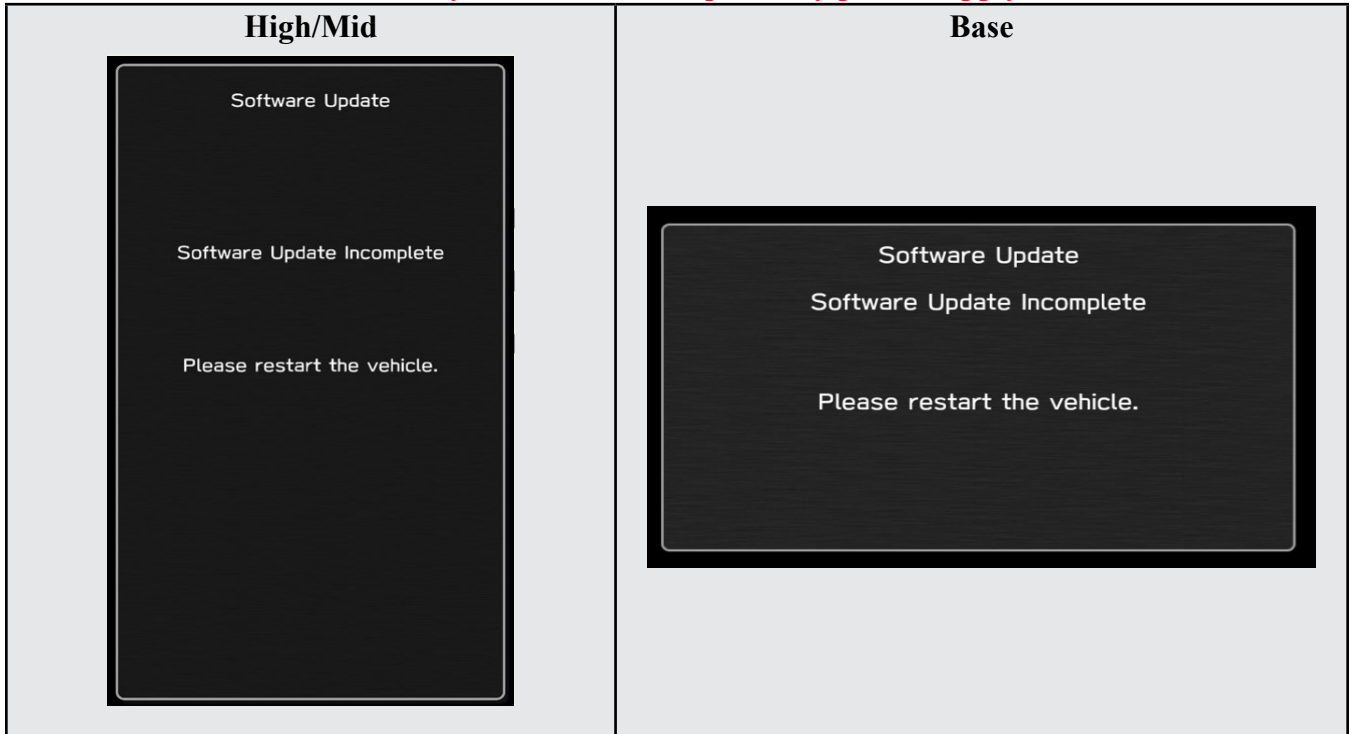
- If the first attempt of update fails with the message below, follow the steps described below 1-2 to 1-8 before retrying the software update.

1-2. Turn the ignition switch or the engine OFF, and turn it ON again.

Caution: Do not remove battery terminal and keep battery power supply.

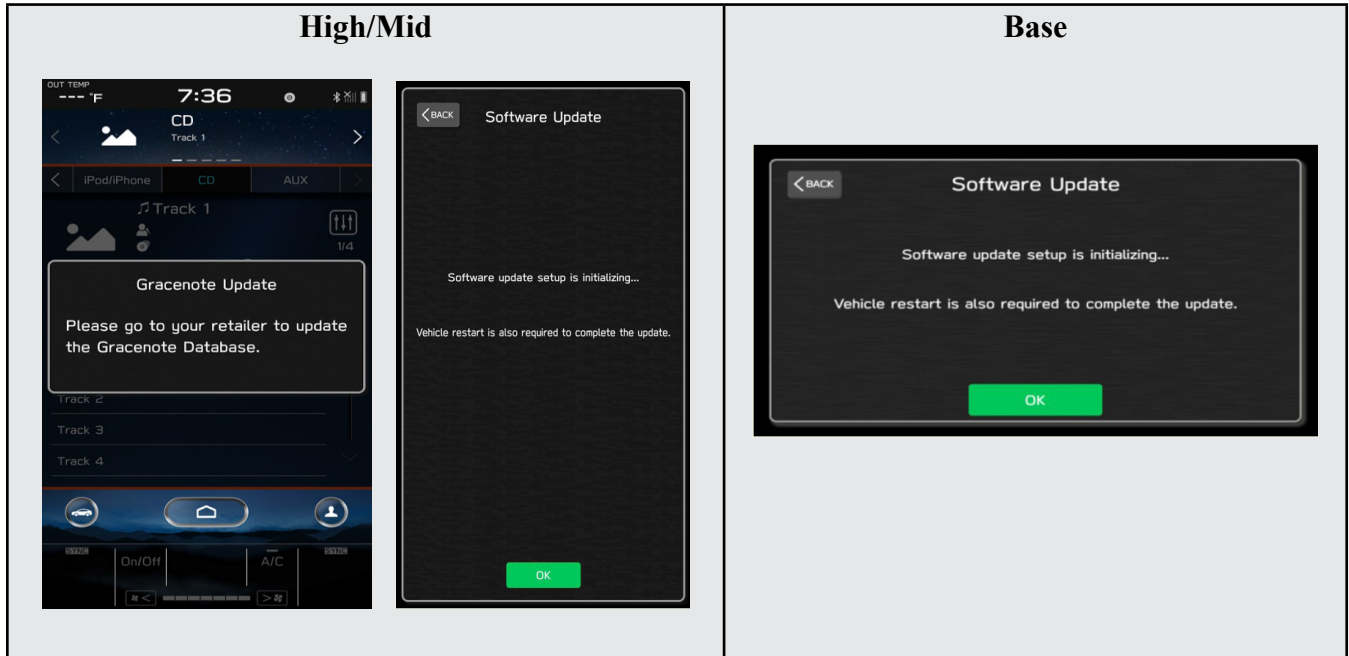
In case the Gracenote update popup screen appears or software initializing screen does not go away for more than 20 minutes, please perform steps 2-1 to 2-11.

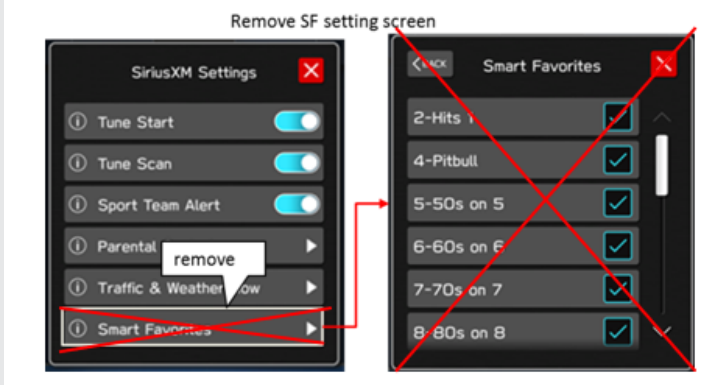
Number	New Functions and Improvements:
16	<p>1. Sirius XM Smart Favorites menu has been removed from SiriusXM Settings</p>

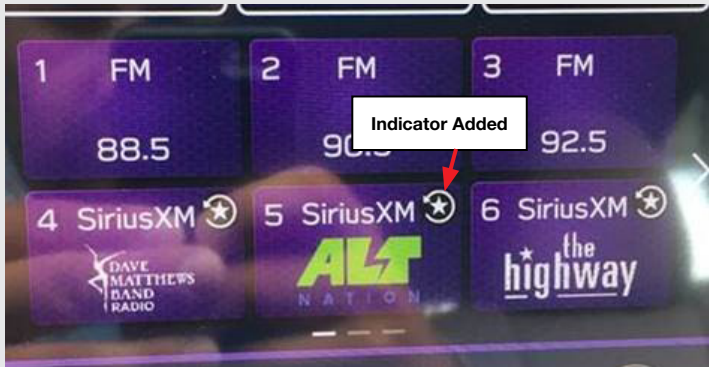
<p>2. Going forward first 10 set Sirius XM presets are now smart favorites by default</p> <p>3. Smart favorite channel has “star” added to the preset button</p>
