<b>Subject:</b>  <b>CONNECTED VEHICLE SYMPTOM TROUBLESHOOTING</b>	<b>Service Alert No.: SA-017/22</b>
	<b>Last Issued : 04/04/2022</b>

## APPLICABLE MODEL(S)/VINS

2019-2022 Mazda3	2021-2022 CX-5	2022 MX-30
2020-2022 CX-30	2021-2022 CX-9	2023 CX-50

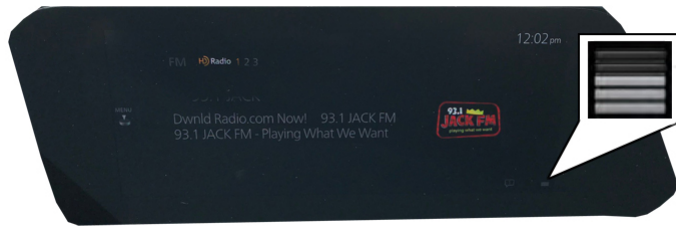
Radio waves are not being received. Move to a location with good reception.

Weak reception.

Good Reception

Strong reception.

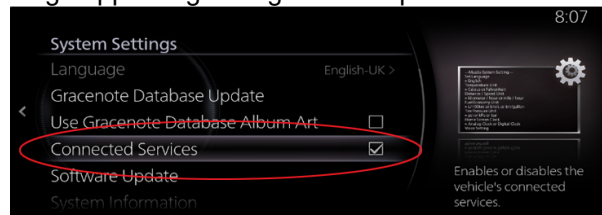
Connected Services disabled (box unchecked)

Enable Connected Services (box checked) to prevent  
message appearing at engine start up.

**Note:** If customer Opted-Out ( CSP04), advise customer  
to keep Connected Services box checked. The vehicle will  
not transmit data.

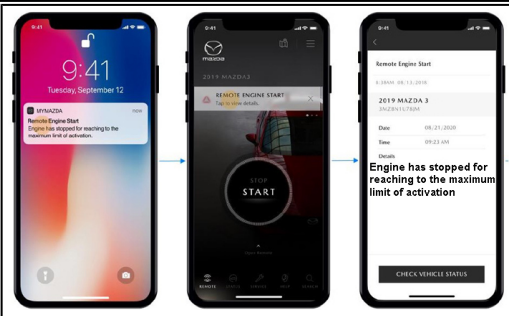
Connected Vehicle Troubleshooting			
Symptom	Cause	Action	
1 Remote function(s) inoperative. <ul style="list-style-type: none"> <li>• Engine Start / Stop</li> <li>• Door Lock / Unlock</li> <li>• Lights ON / OFF</li> </ul>	Go to the MyMazda App to view the reason for remote function failure.	<b>Push Notification</b>

<b>OS Lock Screen</b> Tap the push notification
		<b>Activity History</b>	Go to the MyMazda App INBOX -> ACTIVITY HISTORY -> to view reason for remote function failure.
