Subject: APPLE CARPLAY™ / ANDROID AUTO™ FREQUENTLY ASKED QUESTIONS (FAQ)	Service Alert No.: SA-026/22
	Last Issued : 04/27/2022

Frequently Asked Questions (FAQ)

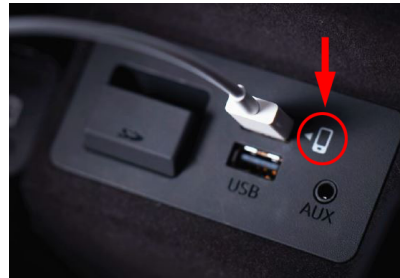
smartphone icon. Both USB ports will accept the Apple CarPlay™ or Android Auto™ cable.

2. Confirm that a high-quality certified smart phone cable is used.
3. Disconnect the battery and wait 2-3 minutes.
4. Reconnect the battery
5. Perform infotainment factory reset and confirm proper operation.

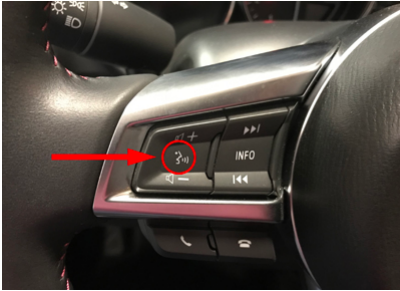
Apple CarPlay™: The Waze app or the Google Maps app does not open when using the steering wheel Voice Command

When using the steering wheel Voice Command button, the navigation system defaults to the Apple Maps app.

button to set a navigation destination.
