David J. Johnson
 Director
 Service Engineering Operations
 Ford Customer Service Division

SUBJECT: **Customer Satisfaction Program 21B04 – Supplement #3**
 Certain 2017 through 2020 Model Year F550 Equipped with Payload Plus Upgrade Package
 Frame Rail Crack

CERTAIN 2017-2020 MODEL YEAR F550 SUPERDUTY VEHICLES EQUIPPED WITH PAYLOAD PLUS UPGRADE PACKAGE — FRAME RAIL CRACKS

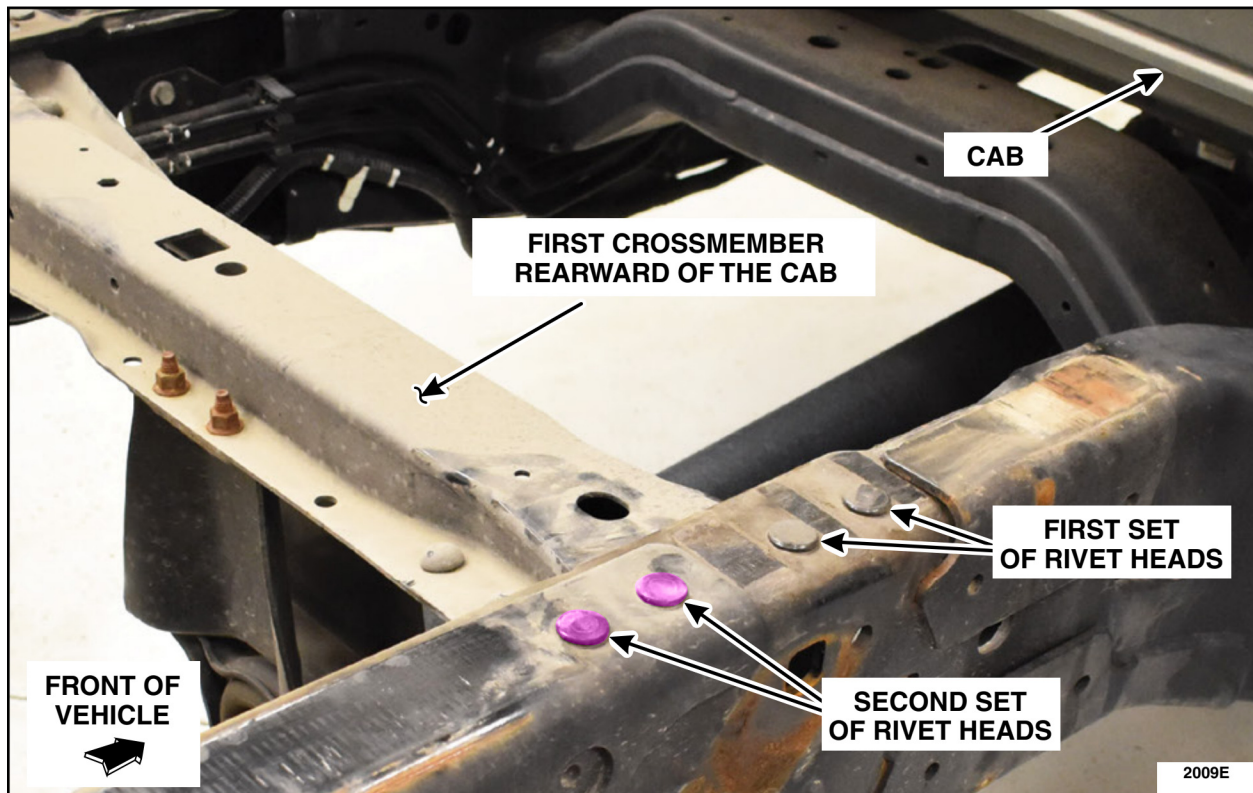
FIGURE 2

1. On the RH side frame rail, locate the second set of rivet heads, rearward of the cab. See Figure 2.

NOTE: Non-60CA frame shown, 60CA frame similar. The first crossmember rearward of the cab will be set further rearward on the 60CA frame.
