# **Technical** Bulletin

Bulletin No: TCH-27-001

#### Bendix<sup>™</sup> SmarTire<sup>®</sup> Tire Pressure Monitoring System (TPMS) Electronic Control Unit Subject: (ECU) Update for PACCAR Vehicles

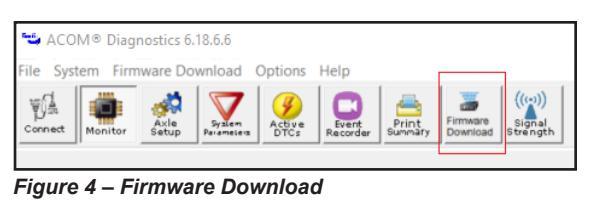
Figure 5 – ECU Window

- 2. Once connected to the TPMS ECU, select the *Firmware Download* icon in the toolbar. *See Figure 4.*
- 3. If the TPMS ECU requires updating, there will be an entry displayed in the ECU window *as shown in Figure 5*. If no entry exists, then it is possible the ECU is already updated. Please read the instructions to check if the ECU requires updating.
