Instructions for navigating the document

Index of models

NEW TOPICS 3

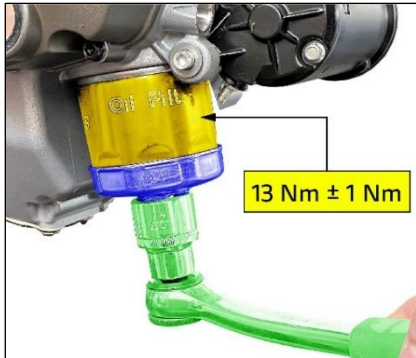
<p>Please, be informed that following changes concerning the engine oil filter cartridge, the tightening torque has been increased from 11 Nm to <u>13 Nm ± 1 Nm</u>.</p> <p>Please be reminded to lubricate the oil filter cartridge seal with engine oil and to use a commercial tool for tightening, as shown in the figure.</p>

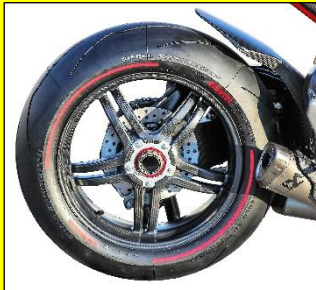
no.	Symptom	Subject	Photo	Notes and Indications - Corrective action
NEW 23	<p><u>ONLY</u> <u>Models equipped with carbon rims</u></p> <p>Possible slow loss of front or rear tyre pressure</p>	Carbon rims

<p>We would like to remind you how to detect a possible slow loss of pressure on carbon rims for all versions.</p> <p>Should you find that the problem is caused by the valve/rim coupling (which can be identified with a simple "bubble check"), it is possible to replace the valve only, part no. 49720081A, following the instructions in the workshop manual (e.g. Panigale 1299 Superleggera).</p> <p>If it is not possible to identify the leakage area in the sealing valve, try removing the tyre and refitting it in a different position (e.g. rotated by 180°). The anti-skid treatment of the carbon rim inside the channel is very rough, so special care must be taken when fitting the tyre.</p> <p>Finally, if the problem is not solved, please fill out a YouTech report.</p>

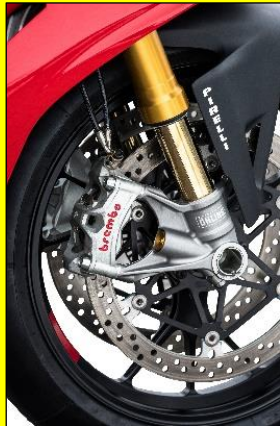
NEW 24	<p>Possible traces of brake fluid on the left or right front brake calliper</p>	Front brake calliper hose

<p>We would like to inform you that as a result of the production process of the front brake callipers, on new motorcycles that are being pre-delivered, there may be traces of brake fluid that could lead to think there is a defect that is not actually present.</p> <p>Should you detect this issue, please:</p> <ul style="list-style-type: none">• wash the area of the brake calliper affected by the fluid trace with water and dry it thoroughly;• fit a self-locking tie (NO elastic band) to the throttle twistgrip so as to keep the brake lever (<i>Figure A</i>) pulled;• leave the front brake system under pressure for a whole day;• ensure there are no oil traces on the calliper. <p>If the leak is confirmed, photograph it and fill out a YouTech service request and replace the affected brake calliper.</p>

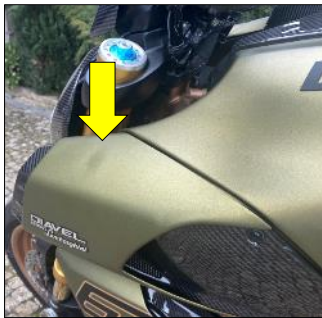
no.	Symptom	Subject	Photo	Notes and Indications - Corrective action
1	<p><u>ONLY</u> <u>Diavel Lamborghini</u></p> <p>Possible indentation of RH and/or LH outer cover of the air conveyor</p>	RH and LH air conveyor covers

<p>We have received some isolated reports about a possible indentation of the RH and/or LH outer cover of the air conveyor.</p> <p>To avoid this phenomenon, it is necessary to position washer (1) 4x14x1 Part no. 85240171A between outer cover (2) and carbon air conveyor (3) in the upper fixing point, as shown in the figure.</p>

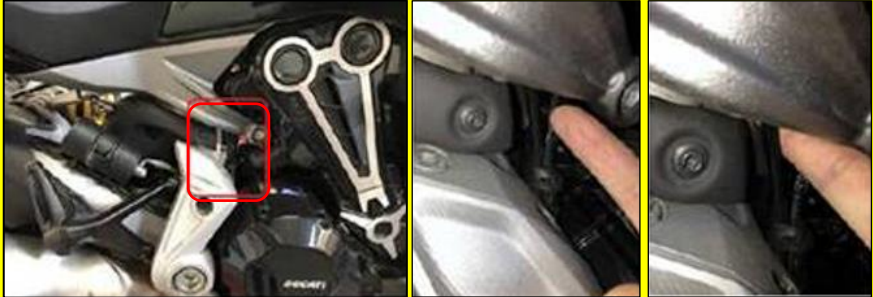
<p>Following the replacement of the rear brake hose or other operations in the same area, the hose may not be correctly positioned inside the retainer shown in the image. For this reason, please pay attention to this step.</p> <p>In addition, when visiting the workshop for the first time or during other work carried out in the same area, we kindly ask you to manually check the fasteners of the concerned hoses.</p> <p>To carry out this check, in the indicated area, slide your finger along the rear brake hose and check that it is correctly secured inside the retaining clip.</p>

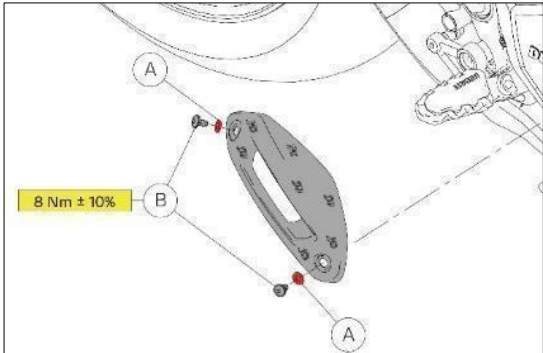
<p>We inform you that the assembly instructions for the carbon horizontal manifold heat guard kit by Ducati Performance part no. 96980251A have been updated. In particular, in order to install the part, <u>you must reuse the 2 washers (A) present on the original heat guard.</u></p> <p>Please always comply with the tightening torque of the 2 screws M6x12 (B) of 8 Nm ± 10%.</p>

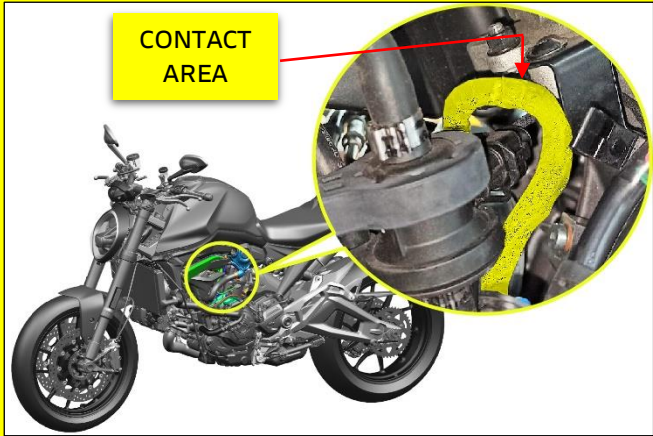
no.	Symptom	Subject	Photo	Notes and Indications - Corrective action
4	<p>NEW</p> <p><u>ONLY</u> <u>Monster 937</u></p> <p>Possible CAN line and speed sensor Errors</p>	ABS wiring	-	<p>We have received some reports of CAN line communication and BUS-OFF errors.</p> <p>Should you detect these types of errors, we suggest that you check the headlight wiring, as per the campaign (SRV-TSB-21-009), as well as the integrity of the ABS connector wiring branch in the area indicated. The outer part of the wiring could be rubbing against the intake manifold to the point of creating a tear in the copper strands.</p> <p>If the copper strands are damaged by wear and tear, we ask that you repair the wiring and fill out a YouTech service request attaching photos detailing the damage.</p>

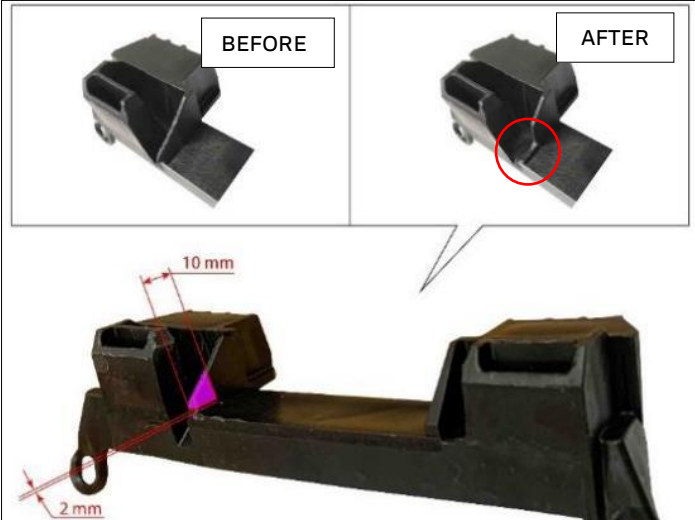
<p>When mounting the rider seat in "high configuration", an excessive gap can be seen between the lower trim and the RH side panel. This is due to interference between the central riser and its support.</p> <p>To avoid such interference and therefore improve the coupling between the rider seat and the side panel, it is necessary to:</p> <ol style="list-style-type: none"> 1) Remove the center riser from the seat; 2) Working on the RH side support, remove the excess material with a cutter, as shown in the figure. 3) Reinstall the center riser to the seat.

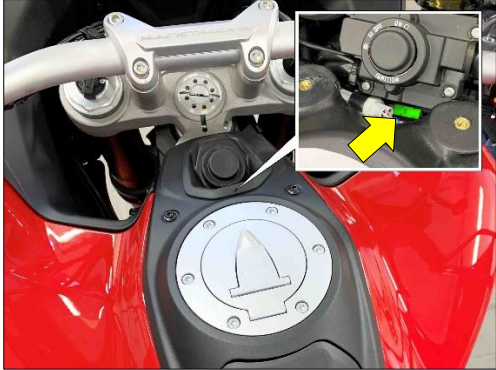
5	<p>ONLY <u>Multistrada V4</u> <u>(all model versions)</u></p> <p>Precaution during the installation of the heated handgrip kit part no. 96680702A</p>	<p>Heated handgrip kit part no. 96680702A</p>

<p>We inform you that for the installation of the heated handgrip kit part no. 96680702A, the main wiring harness connectors where to connect the heated handgrips, are positioned below the ignition switch cover as shown in the figure.</p>

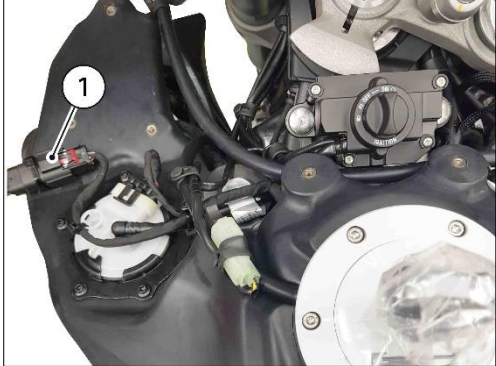
6	<p>ONLY <u>Multistrada V4</u> <u>(all model versions)</u></p> <p>Assembly precaution for the anti-theft system kit part no. 96681081AA</p>	<p>Anti-theft system kit part no. 96681081AA</p>

<p>We inform you that for the installation of the anti-theft system kit part no. 96681081AA, the main wiring connector (1) where to connect the anti-theft device, is positioned near the fuel pump flange, in the front left area of the fuel tank.</p>

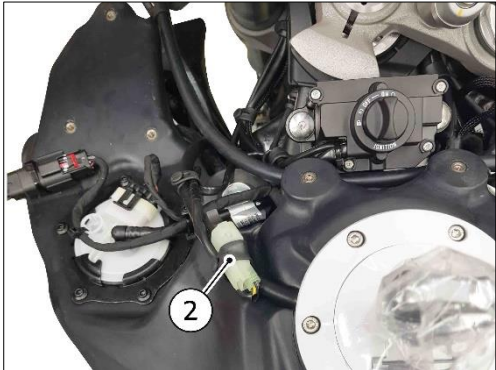
<p>We inform you that for the installation of the Hands Free fuel tank cap kit part no. 96681021AA, the main wiring connector (2) where to connect the Hand Free fuel tank cap, is positioned near the fuel pump flange, in the front left area of the fuel tank.</p>

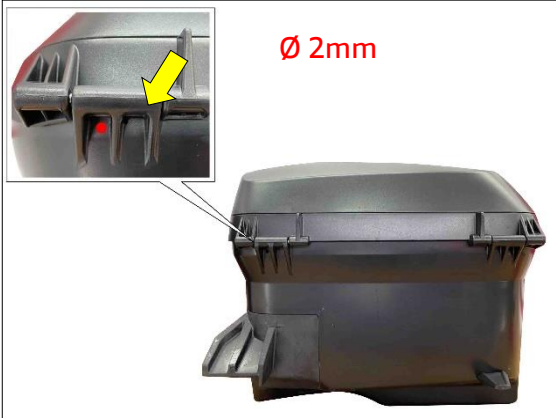
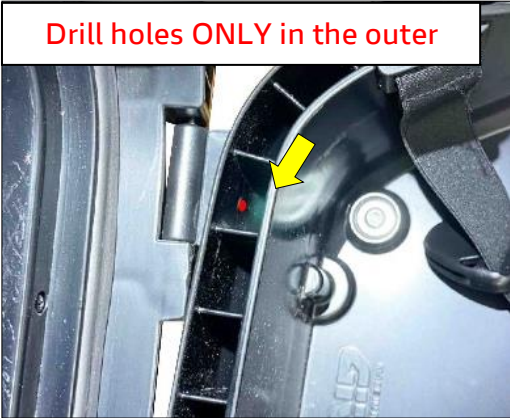
no.	Symptom	Subject	Photo	Notes and Indications - Corrective action
10	<p>ONLY Multistrada V4 (all model versions)</p> <p>Difficulties in opening the side panniers part no. 96781551AA</p>	Side panniers part no. 96781551AA

<p>We have received a few isolated reports of possible difficulties in opening the side panniers due to the “vacuum” effect that occurs when travelling with significant changes in altitude.</p> <p>To avoid this phenomenon, it is necessary to drill a venting hole with a maximum diameter of Ø 2 mm at the bottom of the bag, between the ribs near the rear hinge as shown in the figure.</p> <p><u>DO NOT drill through the second internal wall of the bag.</u></p> <p>This modification has also been implemented by the supplier and does not affect the water tightness.</p>

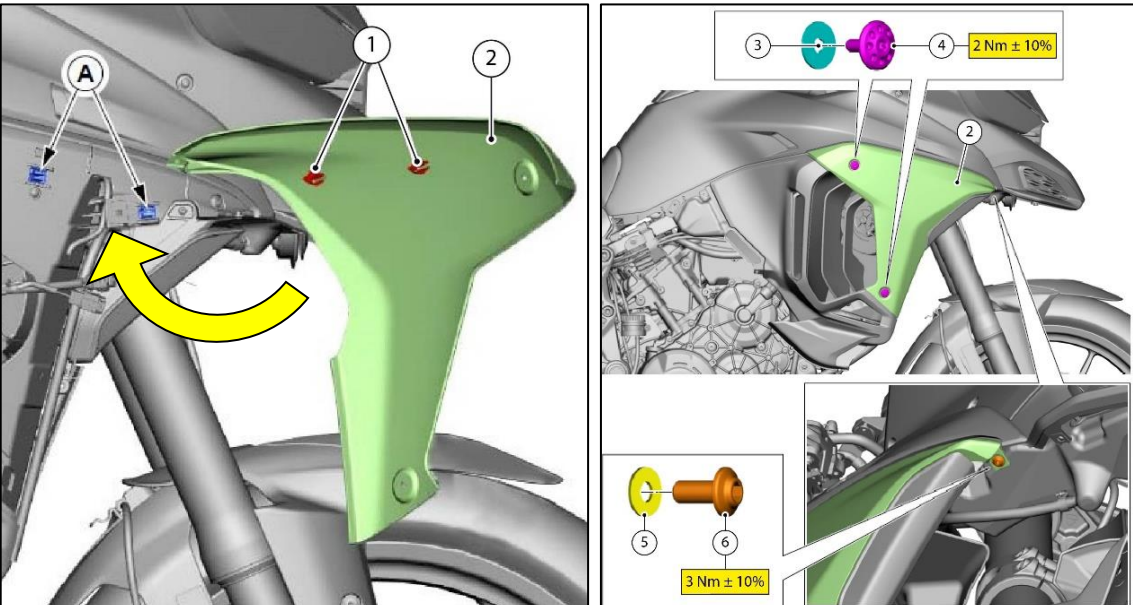
no.	Symptom	Subject	Photo	Notes and Indications - Corrective action																		
34	<p>Multistrada V4 (all model versions) ONLY</p> <p>Installing the RH and LH side cowlings during PDI</p>	RH and LH side cowlings

<p>We would like to inform you that from approx. 1 Nov 2021, in order to avoid transport damage to the cowlings of the Multistrada V4, the kit supplied will also include the RH side cowling, the LH side cowling and the relevant hardware, which you must install during PDI. For this reason we also updated the PDI Checklist SRV-SRB-20-049_PDI Checklist for Multistrada V4 Rev.02.</p> <p>The additional kit will include:</p>

<p>When assembling, fit clips (1) on brackets of cowlings (2). Install cowlings (2) and engage clips (1) in the corresponding housings (A). Tighten the special screws (4) to 2 Nm ±10% and the screw (6) to 3 Nm ± 10%.</p>

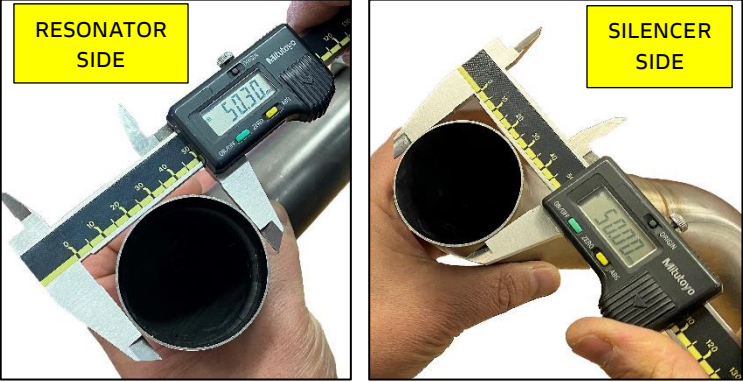
<p>For this reason, we ask you to check the kits in your possession and verify their Serial Number. If the serial number is the same as the one shown above, we ask you to measure the diameter of the holes in the silencer manifolds with a gauge and check that they have a diameter of:</p> <ul style="list-style-type: none"> - 50.0 mm for silencer-side hole - 50.3 mm for resonator-side hole

<p>If the measured values are not correct, it will be necessary to order the conforming manifold using the following part numbers:</p> <ul style="list-style-type: none"> - Silencer front manifold Part no. 96413531A - Silencer rear manifold Part no. 96413541A <p>For warranty claims on components, we ask you to fill out a Yutech report and ask your Service Area Manager for guidance.</p>

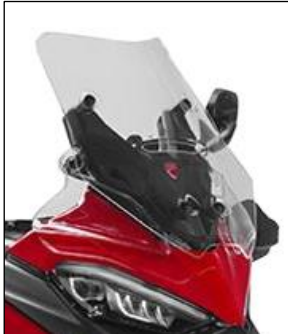
no.	Symptom	Subject	Photo	Notes and Indications - Corrective action
41	<p>ONLY Multistrada V4 (all versions)</p> <p>Possible oxidization of windscreen retaining screws</p>	Windscreen retaining screws

<p>We have received some reports about a possible oxidization of the windscreen retaining screws. Analysis has shown that this phenomenon could be caused by an unsuitable technological process that causes oxidation in the groove of the flat and in the holes made for decreasing part weight.</p> <p>Should you find such a phenomenon, please replace the 4 windscreen screws (Part no. 7791C301AB) and tighten them to <u>3 Nm ± 10%</u>.</p>

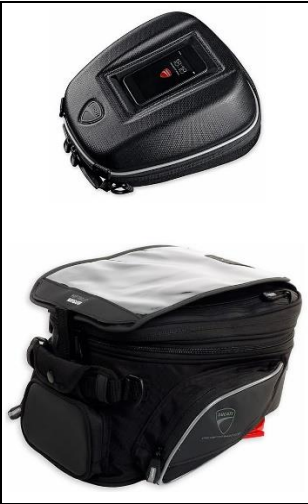
no.	Symptom	Subject	Photo	Notes and Indications - Corrective action														
43	<p><u>ONLY</u> <u>Multistrada V2</u> <u>Multistrada V4 PP</u></p> <p>Possible interference between tank bag and front brake fluid reservoir/clutch fluid reservoir</p>	Tank bag

<p>We have received some reports that there may be a slight interference between the soft tank bag accessory (part no. 96780892A) (or pocket tank bag (part no. 96780262C)) and the front brake fluid reservoir or clutch fluid reservoir when turning left or right. This phenomenon could cause aesthetic defects to the tank bags.</p> <p>For this reason, the kit "<i>Brackets for mounting standard fluid reservoirs with tank bags</i>" was created to mount the brake and clutch fluid reservoirs in such a way as to eliminate possible interference for the models in question. The kits are differentiated by motorcycle model:</p> <ul style="list-style-type: none"> • Part no. 97381991AA for Multistrada V4 Pikes Peak with OEM brake/clutch fluid reservoir • Part no. .97381201BA for Multistrada V4 Pikes Peak with Ducati by Rizoma brake/clutch fluid reservoir • Part no. 97382001AA for Multistrada V2/S/S Travel <p>A dedicated note will be added to the accessories catalogue in the section dedicated to tank bags. The kit will be available from March, so we ask you to order it at the same time that the customer orders the single tank bag or the Urban accessories package (part no. 97980042C) that contains it.</p> <p>The kit comprises the following:</p>

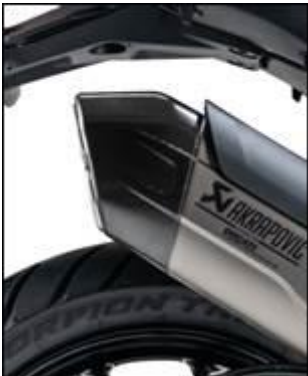
no.	Symptom	Subject	Photo	Notes and Indications - Corrective action	
44	<p><u>ONLY</u> MULTISTRADA V4 (all versions)</p> <p>Possible color change of the Akrapovič silencer carbon endcap</p>	Akrapovič Silencer carbon endcap Type-approved and Racing

<p>We have received some reports of a possible color change of the Akrapovič racing Exhaust Silencer carbon endcap.</p> <ul style="list-style-type: none"> Should the customer experience this phenomenon, please remove the carbon endcap and check for possible traces left by the passage of gas. Should the exhaust show traces of vents, please fill out a Youtech service request attaching photos highlighting the gas passages. <p>If the exhaust does NOT show any traces of gas passages, please fill out a Youtech service request and replace only the carbon endcap Part no. 57315281A and, at the same time, also the 4 aramid washers Part no. 97610991A.</p>

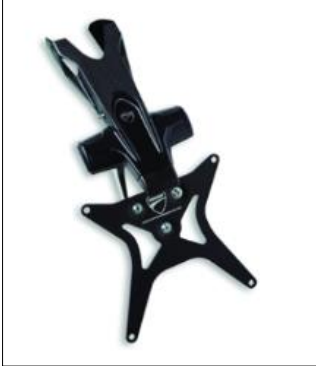
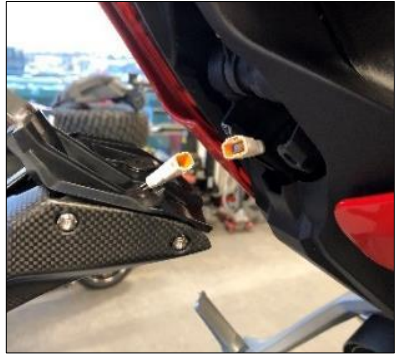
3	<p><u>ONLY</u> <u>Panigale V4</u> <u>(all versions)</u> <u>Panigale V2</u></p> <p>Installation precautions Carbon number plate holder kit part no. 97380921A</p>	Carbon number plate holder kit part no. 97380921A

<p>We kindly inform you that <u>ONLY</u> when installing the carbon number plate holder kit part no. 97380921A to a Panigale V2 model, it is necessary to purchase wiring part no. 5101H931A to connect the number plate holder connector to motorcycle rear wiring harness connector.</p> <p>We also inform you that the new carbon number plate holder kit part no. 97381161AA is now available. It is specific for Panigale V2 and Streetfighter V4 and will include the above-mentioned wiring.</p>

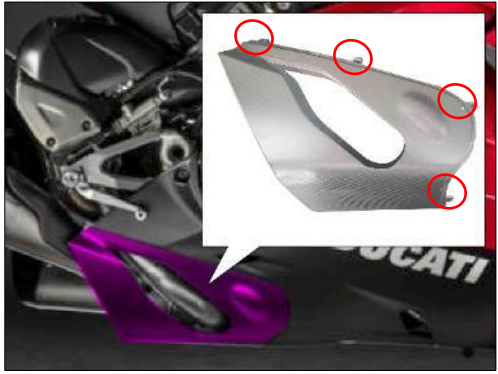
<p>We have received some isolated reports about an incorrect coupling between the silencer covers and the side half fairings in case the complete Akrapovič racing titanium exhaust system, supplied with the motorcycle, is installed. In fact, it is possible to find a misalignment between the mounting holes of the components.</p> <p>To improve this coupling, it is possible to slot-drill the 4 mounting holes of the silencer covers by using a column drill with a <u>6 mm drill bit</u> and setting a high rotation speed to prevent the fiber from flaking off.</p>

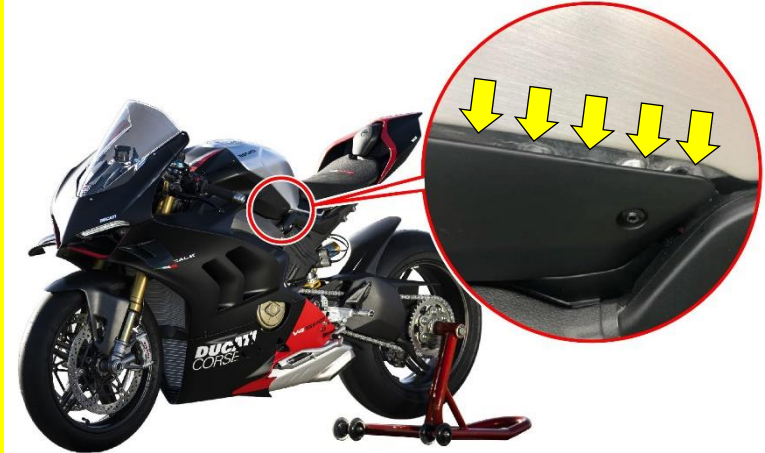
<p>We would like to inform you that the concerned model features the new brushed aluminium tank. This tank has new fixing brackets at the bottom for improved coupling between upper fairing and tank.</p> <p>The area displayed in the following image could show welding points relating to the brackets described above that, due to the characteristics and colour of the tank, may stand out in contrast.</p>

<p>That is why you are kindly asked NOT to fill out warranty orders or Youtech service requests since this possible aesthetic imperfection is in line with the design of the tank, which involves a manual construction process for its finishing.</p>

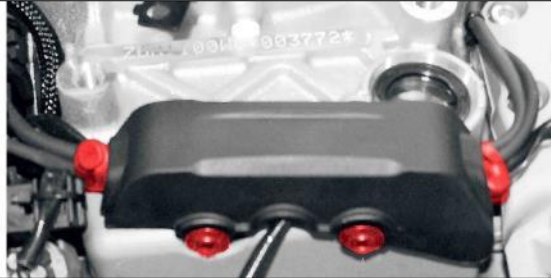
no.	Symptom	Subject	Photo	Notes and Indications - Corrective action
1	Updated layout of motorcycle wiring	Wiring	-	<p>We would like to inform you that the layout of the side stand cable - gear sensor cable - Ducati Quick Shift cable - lambda sensor cable and of the gear sensor connector and cable at the lower crankcase, on the left side of the motorcycle (as shown in the figure) has been updated starting from frame number ZDMFA00AALB003932.</p>

<p>Before installing the wiring cover, apply two L=39 mm button ties respecting the dimensions shown in the figure:</p>

<p>We ask you to respect the new layout of the cables and the gear sensor connector in case of servicing of the mentioned parts.</p>

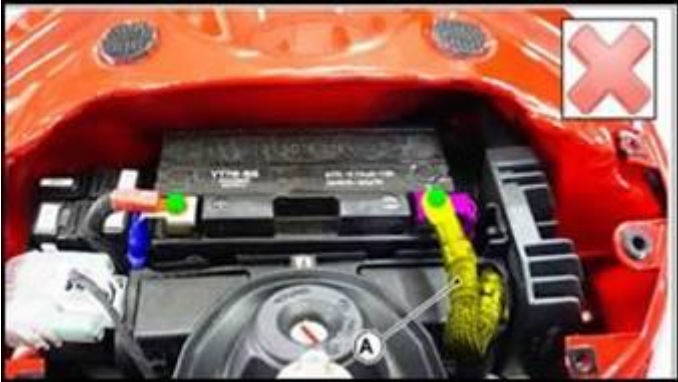
<p>We have received isolated reports of possible interference between the battery negative cable and the battery cover (in particular, the pin fixing the mesh to the cover). To avoid the contact described above, we have updated the battery fitting procedure and in particular that of the ABS negative cable; it is necessary to connect the ABS negative cable (A) orienting it towards the ignition switch as shown in the figure:</p> <div style="display: flex; justify-content: space-around;">

</div> <p>We ask you to follow the new battery fitting procedure during pre-delivery operations and in any case to always check that the battery is fitted correctly the first time the motorcycle is brought to the workshop. <u>This new battery mounting procedure cancels and replaces the information contained in the model introduction bulletin SRV-SRB-20-002.</u></p>

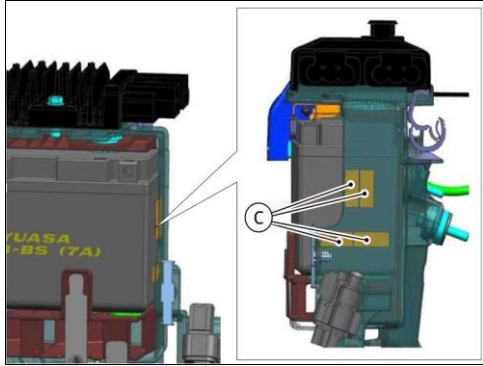
<p>The ongoing tests on the product have revealed the possibility of contact between the battery and its support, which causes marks on both surfaces due to vibration. These marks do NOT affect the correct operation of the electric system and therefore of the vehicle.</p> <p>In order to prevent such marks, 4 adhesive pads (C) in rubber 9X23X1.4 part no. 86612791A have been introduced in the production line to be applied inside the battery support.</p>
