# Instructions for navigating the document

**NEW TOPICS** 3

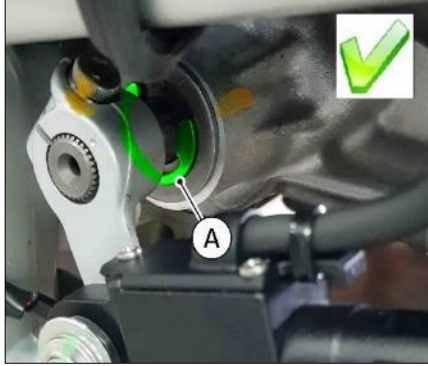
<p>We have received some isolated reports of a possible loss/absence of the <b>snap ring (A)</b> of the gear selector shaft. We would like to inform you that an additional certification on all Desmosedicci Stradale engines between snap ring, washer, and crankcase at the outlet of the gear selector shaft has been added along the production line. The first engine serial number with this new certification is ZDM1100WC #001513#.</p> <p>Upon the first workshop service, you are thus invited to check for the presence of the <b>snap ring (A)</b> on all engine serial numbers preceding the one specified above.</p> <div data-bbox="1771 1070 2197 1437">

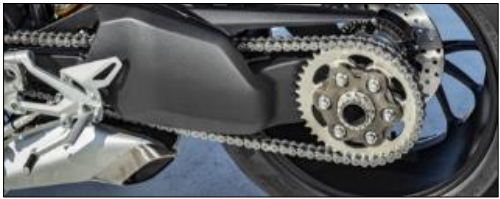
<p>We have received reports of some complaints about rough shifting with DQS, particularly at low rpm. In other words, rough shifting with uncomfortable torque cuts.</p> <p>We have checked that very often <b>the cause is related to an incorrect chain tensioning</b>, especially after the first settling of the chain which takes place at around 200/300 Km (new motorcycle or chain). We therefore invite you to always check the correct tensioning of the final drive chain before making further analysis.</p>

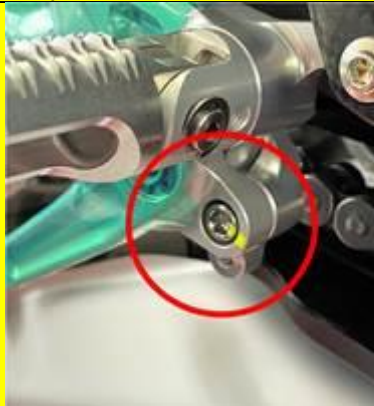
<p style="text-align: center;"><b>Gearchange lever screw certification</b></p>

<p>We have received some isolated reports about the possible poor tightening of gear shift lever adjustment screw. This phenomenon could affect correct gear engagement, since there could be an excessive play inside the slot used to adjust the gearchange lever.</p> <p>This is the reason why, upon the first workshop service or during pre-delivery operations, you are required to check for the presence of the certification mark (as shown in the figure). Should it not be present, <u>make sure that the concerned screw is correctly tightened (12 Nm) and then certify tightening</u> (as shown in the figure).</p> <p>We would like to inform you that, starting from 19 April 2022 the supplier of rider adjustable footpegs has implemented the check of the correct tightening of the concerned screw.</p>

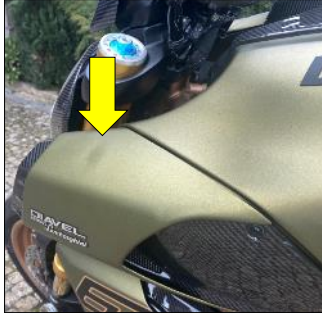
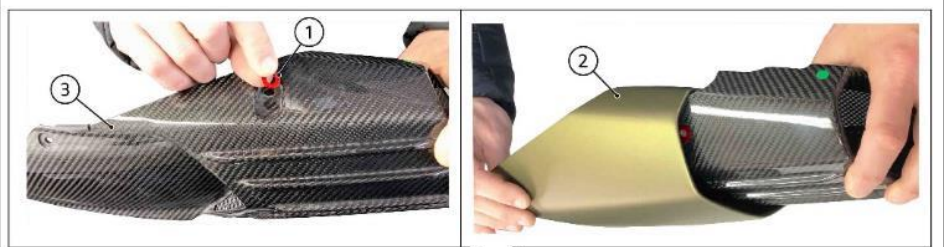
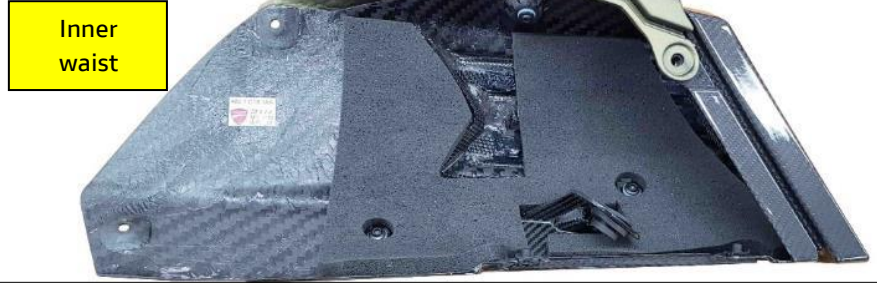
no.	Symptom	Subject	Photo	Notes and Indications - Corrective action
1	<p><u>ONLY</u> <u>Diavel Lamborghini</u></p> <p>Possible indentation of RH and/or LH outer cover of the air conveyor</p>	RH and LH air conveyor covers

<p>We have received some isolated reports about a possible indentation of the RH and/or LH outer cover of the air conveyor.</p> <p>To avoid this phenomenon, it is necessary to position <b>washer (1)</b> 4x14x1 Part no. 85240171A between <b>outer cover (2)</b> and carbon air <b>conveyor (3)</b> in the upper fixing point, as shown in the figure.</p>

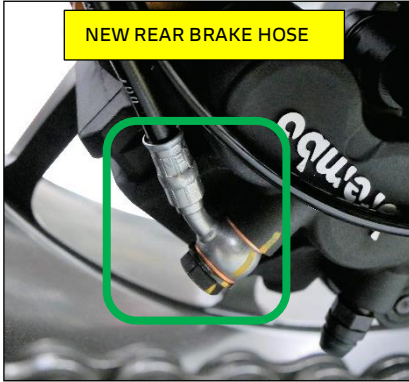
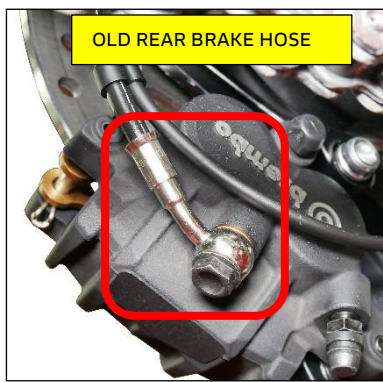
no.	Symptom	Subject	Photo	Notes and Indications - Corrective action												
2	<p><b>ONLY</b> <b>Diavel 1260</b></p> <p>Indication for replacement of brake hoses under warranty</p>	Rear Brake Hose	-	<p>We remind you that from the dates below the DIAVEL 1260 model is equipped with the new brake hoses.</p> <p>In the event that you have to manage a Customer complaint related to a rear brake system, always check the rear brake hoses installed on the vehicle.</p> <p>If the vehicle is already equipped with the modified hoses (FrenTubo), the warranty claim will be NOT accepted or will be charged back.</p>

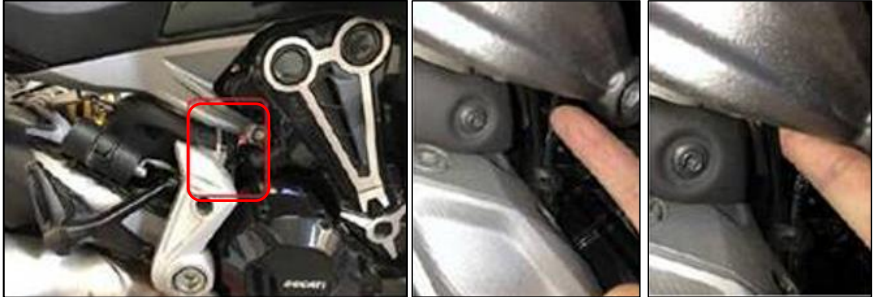
<p>Following the replacement of the rear brake hose or other operations in the same area, the hose may not be correctly positioned inside the retainer shown in the image. For this reason, please pay attention to this step.</p> <p>In addition, when visiting the workshop for the first time or during other work carried out in the same area, we kindly ask you to manually check the fasteners of the concerned hoses.</p> <p>To carry out this check, in the indicated area, slide your finger along the rear brake hose and check that it is correctly secured inside the retaining clip.</p>

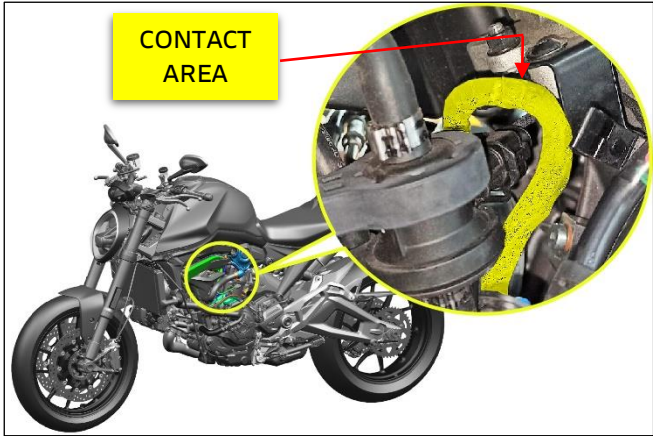
no.	Symptom	Subject	Photo	Notes and Indications - Corrective action
4	<p><u>ONLY</u> <b>Monster 937</b></p> <p>Possible CAN line and speed sensor Errors</p>	ABS wiring	-	<p>We have received some reports of CAN line communication and BUS-OFF errors.</p> <p>Should you detect these types of errors, we suggest that you check the headlight wiring, as per the campaign (<a href="#">SRV-TSB-21-009</a>), as well as <b>the integrity of the ABS connector wiring branch in the area indicated</b>. The outer part of the wiring could be rubbing against the intake manifold to the point of creating a tear in the copper strands.</p> <p>If the copper strands are damaged by wear and tear, we ask that you repair the wiring and fill out a <b>YouTech</b> service request attaching photos detailing the damage.</p>

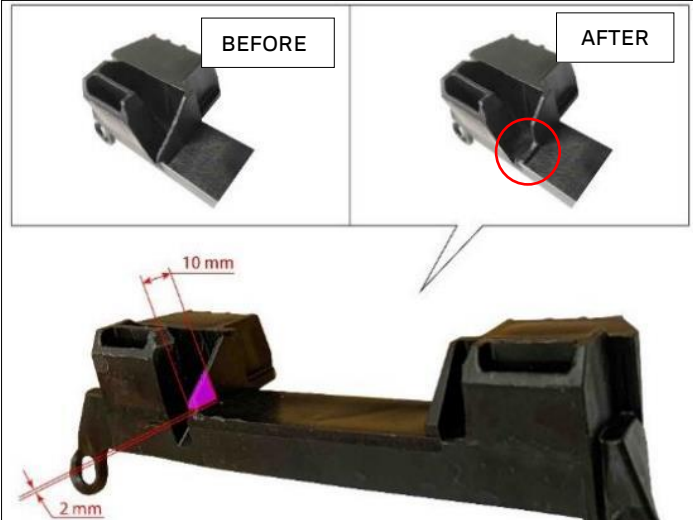
<p>When mounting the rider seat in "high configuration", an excessive gap can be seen between the lower trim and the RH side panel. This is due to interference between the central riser and its support. To avoid such interference and therefore improve the coupling between the rider seat and the side panel, it is necessary to:</p> <ol style="list-style-type: none"> <li>1) Remove the center riser from the seat;</li> <li>2) Working on the RH side support, remove the excess material with a cutter, as shown in the figure.</li> <li>3) Reinstall the center riser to the seat.</li> </ol>

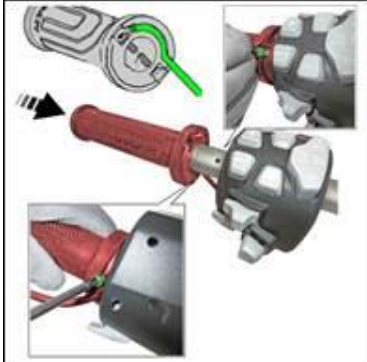
<p>We have received some reports about heated handgrips that have not been installed correctly and so the cable between the handgrip and the switch may be pinched.</p> <p>We kindly ask you to always follow the instructions provided on the DCS under the "accessories catalogue" section or in the model presentation bulletin (SRV-SRB-20-049) and to <u>comply with the correct orientation of the cable and handgrip</u> as shown in the figure.</p>

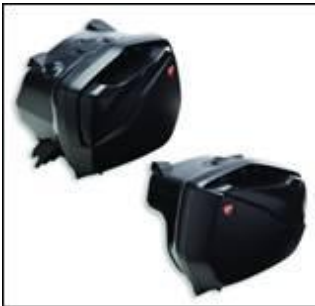
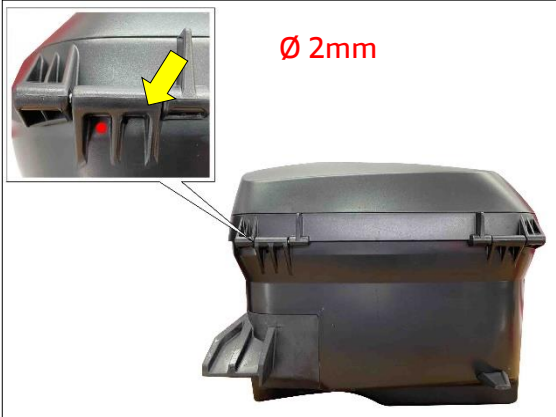
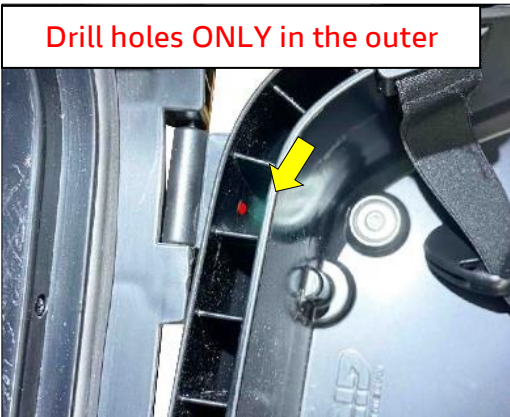
no.	Symptom	Subject	Photo	Notes and Indications - Corrective action
10	<p><b>ONLY Multistrada V4 (all model versions)</b></p> <p>Difficulties in opening the side panniers part no. 96781551AA</p>	<p>Side panniers part no. 96781551AA</p>

<p>We have received a few isolated reports of possible difficulties in opening the side panniers due to the “vacuum” effect that occurs when travelling with significant changes in altitude.</p> <p>To avoid this phenomenon, it is necessary to drill a venting hole with a maximum diameter of Ø 2 mm at the bottom of the bag, between the ribs near the rear hinge as shown in the figure.</p> <p><b><u>DO NOT drill through the second internal wall of the bag.</u></b></p> <p>This modification has also been implemented by the supplier and does not affect the water tightness.</p> <div style="display: flex; justify-content: space-around;"> <div data-bbox="1061 616 1615 1034">

<p><b>Drill holes ONLY in the outer</b></p> </div> </div>

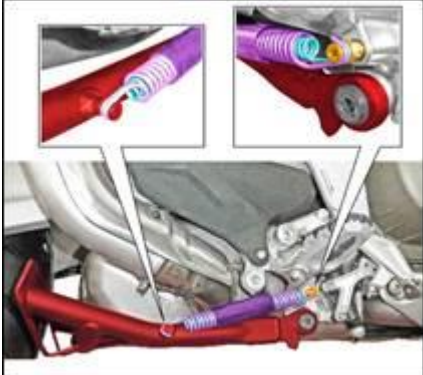
11	<p><b>ONLY Multistrada V4 (all model versions)</b></p> <p>Possible interference between external central stand return spring and footpeg holder plate</p>	<p>Central stand</p>

<p>We have received a few isolated reports of possible interference between the external central stand return spring and the footpeg holder plate when the central stand is closed.</p> <p>We kindly ask you to check that the two side stand return springs are correctly installed and aimed as shown in the figure.</p>

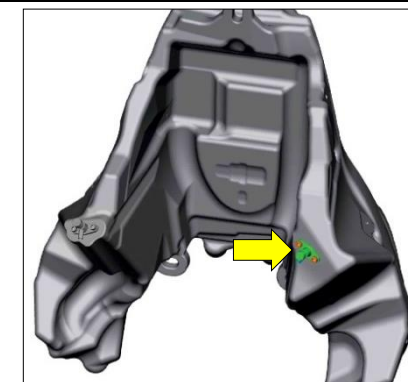
18	<p><b>ONLY</b> <b><u>Multistrada V4</u></b> <b><u>(all model versions)</u></b></p> <p>Incorrect residual fuel in the tank</p>	Fuel tank	-	<p>In some cases, we have found that the tap on the right-hand side of the fuel tank is completely closed instead of open; this leads to an incorrect remaining range when there are only a few liters of fuel in the tank (fuel reserve conditions).</p> <p>If the above-mentioned event occurs, we ask you to ensure that the tap on the right-hand side of the fuel tank is fully open</p>

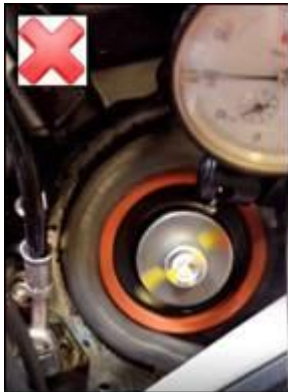
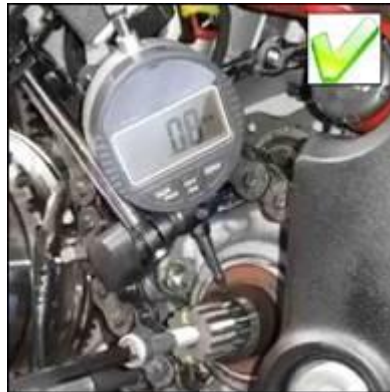
no.	Symptom	Subject	Photo	Notes and Indications - Corrective action
19	<p><b>ONLY</b> <b><u>Multistrada V4</u></b> <b><u>(all model versions)</u></b></p> <p>Possible oscillation of the final drive chain (non-uniform sliding)</p>	Gearbox secondary shaft	-	<p>We have received some isolated reports about a possible oscillation of the final drive chain even if the chain is correctly tensioned. In these cases the customer may complain an uneven sliding of the chain at constant speed.</p> <p>In these cases, you are asked to check for a possible deformation of the gearbox secondary shaft by removing both the chain and the sprocket and taking the measurement with a dial gauge directly on spacer Part no. 713P0011C, as shown in the figure (the measurement should NOT be taken on the sprocket since an uneven wear of the rubber material may occur during the first few kilometers): by slowly rotating the shaft, the value taken with the dial gauge must be at most 0.1 mm.</p> <div style="display: flex; justify-content: space-around;">

</div> <p>a) If the measurement shows values below 0.1 mm, replace the sprocket only. a) If the measurement shows a value greater than 0.1mm, fill out a <b>Youtech</b> service request.</p>

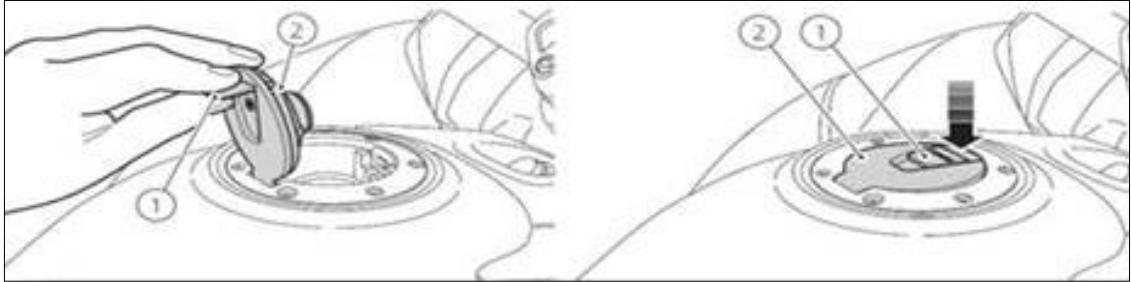
<p>We have received a few isolated reports concerning the hands free fuel cap part no. 96681021AA that proves difficult to open and/or close. <b>DO NOT REPLACE THE FUEL TANK CAP.</b></p> <p><b>Hands-free tank filler plug</b> The hands-free tank filler plug allows the cap to be opened during refueling without using a key.</p> <p><b>Opening</b> To open the cap, the suitable flap must be lifted within 50 seconds of turning the vehicle off (key off). During those 50 seconds, the cap can be opened a maximum of 5 times. If a new opening is desired, the key must be turned on and then back off (key-on &gt;&gt; key-off).</p> <p><u>Caution: the opening flap must be operated gently. Excessively fast movements may impair the cap opening, even though the attempt will still be counted among the 5 available.</u></p> <p><b>Information on instrument panel</b> The instrument panel has an icon indicating “fuel cap open”. If the instrument panel is turned on (key-on) while the cap is open, the icon will be active.</p> <p><b>Closing</b> To close the cap, use your fingers to push it in fully home.</p> <p><u>Caution: After refueling, always ensure that the cap is correctly positioned and closed and that the corresponding icon on the instrument panel is off.</u></p>

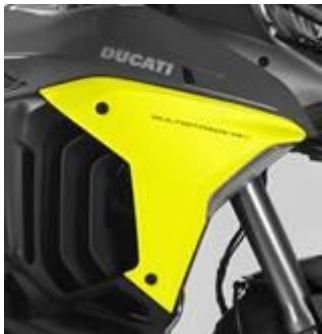
no.	Symptom	Subject	Photo	Notes and Indications - Corrective action																		
34	<p><b><u>Multistrada V4</u></b> <b><u>(all model versions)</u></b> <b>ONLY</b></p> <p>Installing the RH and LH side cowlings during PDI</p>	RH and LH side cowlings

<p>We would like to inform you that from approx. 1 Nov 2021, in order to avoid transport damage to the cowlings of the Multistrada V4, the kit supplied will also include the RH side cowling, the LH side cowling and the relevant hardware, which you must install during PDI. For this reason we also updated the <a href="#">PDI Checklist SRV-SRB-20-049_PDI Checklist for Multistrada V4 Rev.02</a>.</p> <p>The additional kit will include:</p>

<p>When assembling, fit clips (1) on brackets of cowlings (2). Install cowlings (2) and engage clips (1) in the corresponding housings (A). Tighten the special screws (4) to 2 Nm <math>\pm</math> 10% and the screw (6) to 3 Nm <math>\pm</math> 10%.</p>

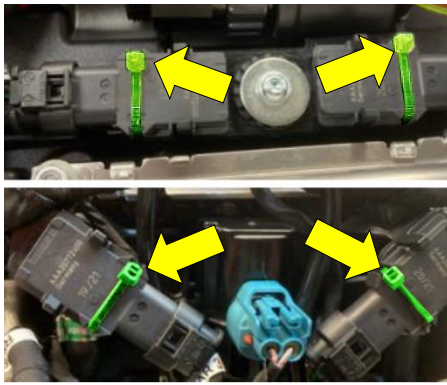
<p>We have received a few isolated reports of erratic engine operation at idle, hard starting, the possibility of the MIL warning light on the instrument panel coming on and/or memorized MAP sensor errors or P061B Torque Monitoring error.</p> <p>Our analysis has shown that this phenomenon could be due to the MAP sensors not fitting perfectly in their seats; we therefore ask you to check the correct installation of the MAP sensors if the symptoms described above should occur, and to fix them properly using self-locking ties positioned as shown in the figure.</p> <p>Create a Youtech for any cases found in your dealership. Attach PDF copy of the DDS Fault Report (with freeze frame parameters) and photos of the MAP sensor(s) as discovered during inspection and after with self-locking ties.</p>

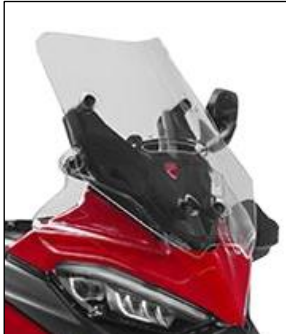
no.	Symptom	Subject	Photo	Notes and Indications - Corrective action
41	<p><b>ONLY</b> <b>Multistrada V4</b> <b>(all versions)</b></p> <p>Possible oxidization of windscreen retaining screws</p>	Windscreen retaining screws

<p>We have received some reports about a possible oxidization of the windscreen retaining screws. Analysis has shown that this phenomenon could be caused by an unsuitable technological process that causes oxidation in the groove of the flat and in the holes made for decreasing part weight.</p> <p>Should you find such a phenomenon, please replace the 4 windscreen screws (<b>Part no. 7791C301AB</b>) and tighten them to <u>3 Nm ± 10%</u>.</p>

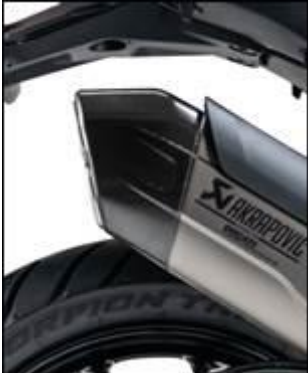
no.	Symptom	Subject	Photo	Notes and Indications - Corrective action	
44	<p><u>ONLY</u> <b>MULTISTRADA V4</b> <b>(all versions)</b></p> <p>Possible color change of the Akrapovič silencer carbon endcap</p>	Akrapovič Silencer carbon endcap Type-approved and Racing

<p>We have received some reports of a possible color change of the Akrapovič racing Exhaust Silencer carbon endcap.</p> <ul style="list-style-type: none"> <li>• Should the customer experience this phenomenon, please remove the carbon endcap and check for possible traces left by the passage of gas.</li> <li>• Should the exhaust show traces of vents, please fill out a <b>Youtech</b> service request attaching photos highlighting the gas passages.</li> </ul>

<p>If the exhaust does NOT show any traces of gas passages, please fill out a <b>Youtech</b> service request and replace only the carbon endcap <b>Part no. 57315281A</b> and, at the same time, also the 4 aramid washers <b>Part no. 97610991A</b>.</p>

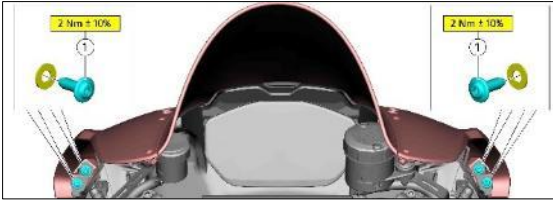
<p>We received some isolated claims about the possible breakage of the top fastener retaining the LH side half-fairing to the headlight fairing.</p> <p>During PDI and whenever removing the side half-fairings, we remind you to pay utmost attention to the tightening of the <b>2 screws M5x0.8 (1)</b> retaining the upper LH and RH half-fairings to the headlight fairing; always comply with the specified tightening torque of <b>2 Nm ± 10%</b>.</p>

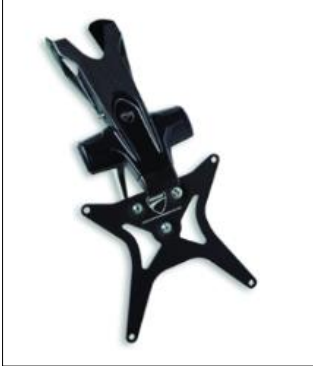
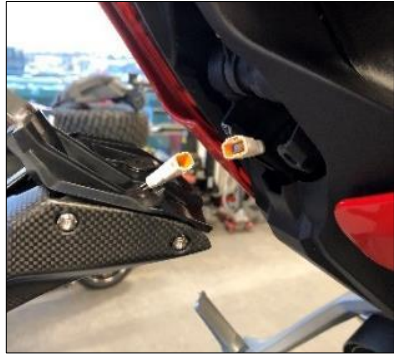
3	<p><u>ONLY</u> <u>Panigale V4</u> <u>(all versions)</u> <u>Panigale V2</u></p> <p>Installation precautions Carbon number plate holder kit <b>part no. 97380921A</b></p>	Carbon number plate holder kit <b>part no.</b> <b>97380921A</b>

<p>We kindly inform you that <u>ONLY</u> when installing the carbon number plate holder kit part no. 97380921A to a Panigale V2 model, it is necessary to purchase wiring <b>part no. 5101H931A</b> to connect the number plate holder connector to motorcycle rear wiring harness connector.</p> <p>We also inform you that the new carbon number plate holder kit <b>part no. 97381161AA</b> is now available. It is specific for Panigale V2 and Streetfighter V4 and will include the above-mentioned wiring.</p>

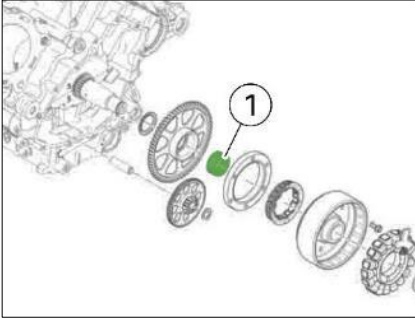
no.	Symptom	Subject	Photo	Notes and Indications - Corrective action
4	<p><u>ONLY</u> <b>Panigale V4</b></p> <p>Starting system update</p>	Starting system	-	<p>To ensure a better starting operation of the engine, we inform you that from engine serial number:</p> <ul style="list-style-type: none"> <li>- ZDM1100W4#<b>007612</b># for EUR version</li> <li>- AGNK<b>007652</b> for CAL version</li> </ul> <p>the <b>roller bearing (1)</b> has been introduced instead of the bushing.</p> <p>Please, note that the spare part catalogue has been updated.</p>

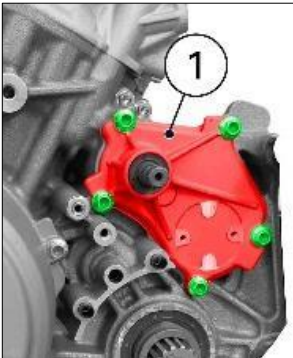
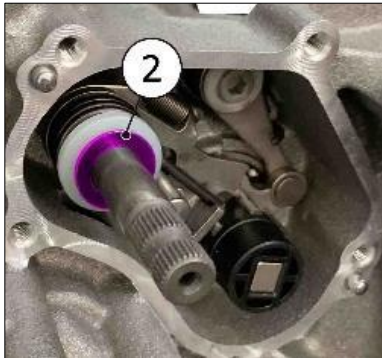
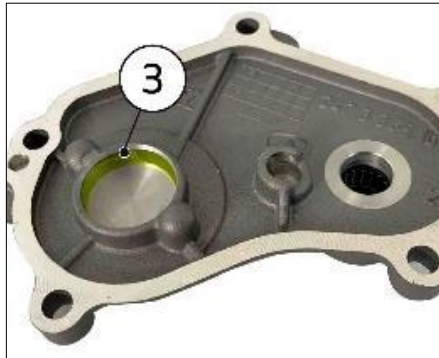
no.	Symptom	Subject	Photo	Notes and Indications - Corrective action									
12	<p style="text-align: center;"><u>ONLY</u> <b>959 Panigale</b> <b>(all versions)</b></p> <p>Possible hardening of gear shift control with difficulty in shifting gears when hot</p>	Gear selector	-	<p>We have received some isolated reports about a possible hardening of the gear shift when hot with consequent difficult selection of gear ratios. Based on the analyses carried out, this phenomenon could be due to a hardening between the gearbox sensor magnet plastic support and the relevant seat inside the cover.</p> <p>You are kindly asked to carry out the following operations:</p> <ol style="list-style-type: none"> <li>1) Remove the <b>gear shift cover (1)</b> on motorcycle LH side</li> <li>2) Check for the presence of <b>shim (2)</b></li> <li>3) Mill the end face of the plastic cage for the selector magnet (3) shorter by 0.1 mm maximum and the outer curved edge where it enters the bore of the cover by 0.1 mm maximum, <u>or</u> mill the internal <b>surface (4)</b> of the cover highlighted in the figure and remove 0.1 mm maximum of material from the end and bore of the recess. Ensure the orientation of the magnet is not changed on the shift selector or the gear position will not be able to be determined by the sensor.</li> </ol> <div style="display: flex; justify-content: space-around;">

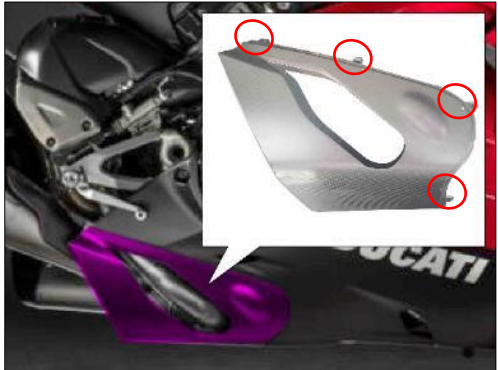
<p>We have received some isolated reports about an incorrect coupling between the silencer covers and the side half fairings in case the complete Akrapovič racing titanium exhaust system, supplied with the motorcycle, is installed. In fact, it is possible to find a misalignment between the mounting holes of the components.</p> <p>To improve this coupling, it is possible to slot-drill the 4 mounting holes of the silencer covers by using a column drill with a <u>6 mm drill bit</u> and setting a high rotation speed to prevent the fiber from flaking off.</p>

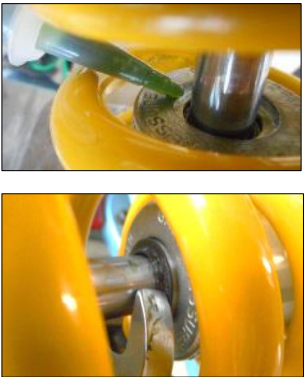
15	<p><u>ONLY Panigale V2</u></p> <p>Possible popping out of the dust seal on the Sachs rear shock absorber buffer support plug</p>	Sachs rear shock absorber

<p>We have received some isolated reports about the possible popping out of the dust seal on the rear shock absorber buffer support plug.</p> <p><u>Do NOT replace the rear shock absorber.</u></p> <p>To avoid the phenomenon described above it is necessary to:</p> <ul style="list-style-type: none"> <li>- apply a few drops of <b>LOCTITE 638</b> on the plug, at the dust seal seat;</li> <li>- place the dust seal on the plug using an open-end wrench and hold it for a few seconds;</li> <li>- carefully clean any residues of LOCTITE 638 that may have fallen accidentally on the rod and on any other surface.</li> </ul> <p>Please note that the supplier, Sachs, has introduced LOCTITE 638 during the assembly stage from <u>week 29-2020</u> (this information can be found on the sticker on the shock absorber body).</p>

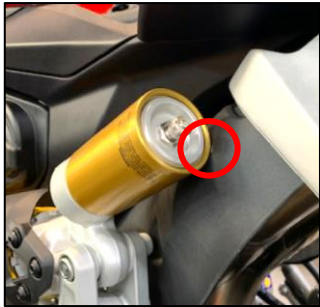
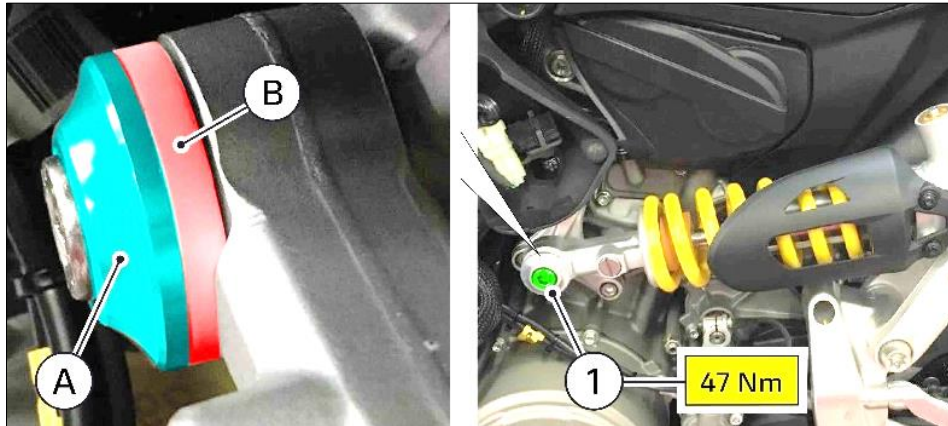
no.	Symptom	Subject	Photo	Notes and Indications - Corrective action
17	<p><u>ONLY</u> <u>Panigale V2</u></p> <p>Possible contact of Sachs rear shock absorber reservoir with vertical head manifold heat guard</p>	Sachs rear shock absorber reservoir

<p>We would like to inform you that starting from the frame number <b>ZDMHAATW2MB003762</b>, a spacer and a Teflon anti-rotation washer have been introduced at the front fixing screw of the shock absorber to prevent possible contact between the rear shock absorber reservoir and the vertical head manifold head guard. The contact results in a cosmetic defect only.</p> <p>In case of complaints from the Customer, it is possible to proceed with the installation of spacer <b>part no. 7111D981AA (A)</b> and washer <b>part no. 7131E352A (B)</b>, as shown in the figure.</p> <p>We remind you to always apply the <b>screw M10x45 (1)</b> with Shell GADUS S2 V220 AD 2 grease and to tighten the screw to the new torque of <b>47 Nm</b> (the previous tightening torque was 45 Nm).</p>

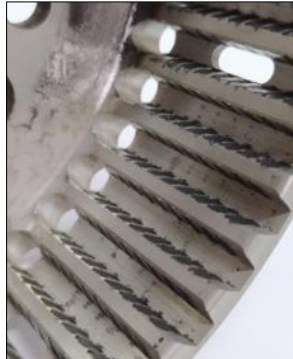
18	<p><u>ONLY</u> <u>Panigale V4R</u></p> <p>Introduction of clutch housing with deep anodizing</p>	Housing clutch

<p>We have received some isolated reports of possible clutch slipping, due to clutch housing indentation, which does not allow the drive and driven plates to come back into contact with each other correctly. This phenomenon depends on the use of the motorcycle and the user, therefore for racing use we suggest replacing the plates approximately every 5000km,.</p> <p>We would like to inform you that the new clutch housing with deep anodizing <b>part no. 19810671C</b>, replacing the natural grey one, is available as a spare part; this treatment improves the reliability of the clutch housing reducing the damaging of the drive plates on its contact surface.</p>

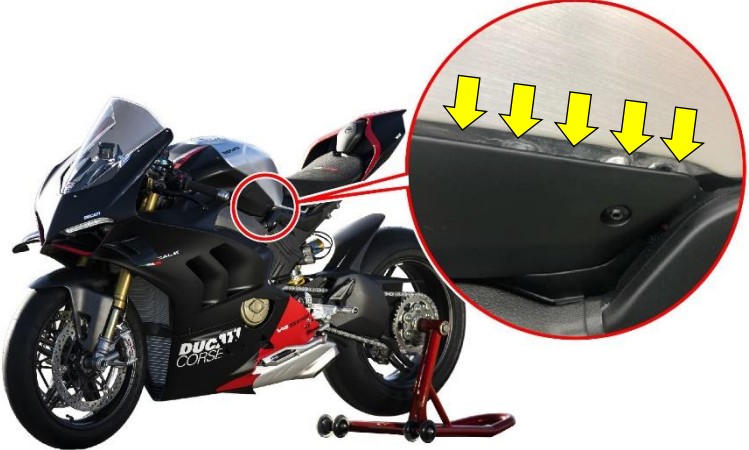
<p>We would like to inform you that the concerned model features the new brushed aluminium tank. This tank has new fixing brackets at the bottom for improved coupling between upper fairing and tank.</p> <p>The area displayed in the following image could show welding points relating to the brackets described above that, due to the characteristics and colour of the tank, may stand out in contrast.</p>

<p>That is why you are kindly asked NOT to fill out warranty orders or <b>Youtech</b> service requests since this possible aesthetic imperfection is in line with the design of the tank, which involves a manual construction process for its finishing.</p>

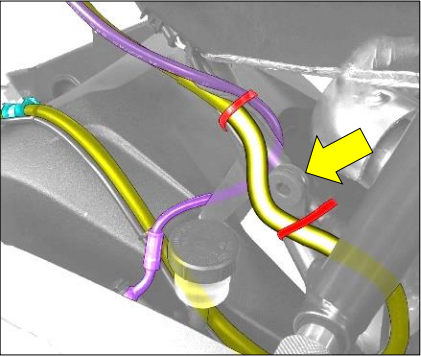
no.	Symptom	Subject	Photo	Notes and Indications - Corrective action				
1	<p><u>ONLY Scrambler 800 (all model versions and MY, excluding Desert Sled model version)</u></p> <p>Precautions when routing the rear brake caliper hose</p>	Rear brake hose	-	<p>We have found that sometimes, during maintenance operations, the rear brake caliper hose is not correctly positioned along the frame due to incorrect installation by the technician during service.</p> <p>Make sure that the rear brake caliper hose (yellow), passes outside the left side cover mounting bracket with respect to the motorcycle centerline and is fixed with the two self-locking ties (red) as shown in the figure.</p> <p>The operation of inspection and possible repositioning is very simple and involves the disassembly of the left side cover only.</p>

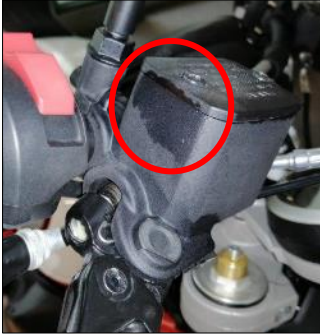
no.	Symptom	Subject	Photo	Notes and Indications - Corrective action
3	<p><u>ONLY</u>  <b>Scrambler Desert Sled</b>  <b>Scrambler ICON</b>  <b>Scrambler Full Throttle</b>  <b>Model Year 2019 - 2020</b></p> <p>Possible oozing out of brake fluid from reservoir cover</p>	Front brake fluid reservoir

<p>We inform you that in case of complaints from Customers about a possible oozing out of front brake fluid from the relevant reservoir. This condition does not affect the operation of the brake system. It is possible to order the following kit part no. 89340331A as spare part to avoid the symptom in question.</p> <p>The kit part no. 89340331A includes:</p> <ul style="list-style-type: none"> <li>• 2 screws (1)</li> <li>• Cover (2)</li> <li>• Membrane (3)</li> <li>• Baffle (3)</li> </ul>

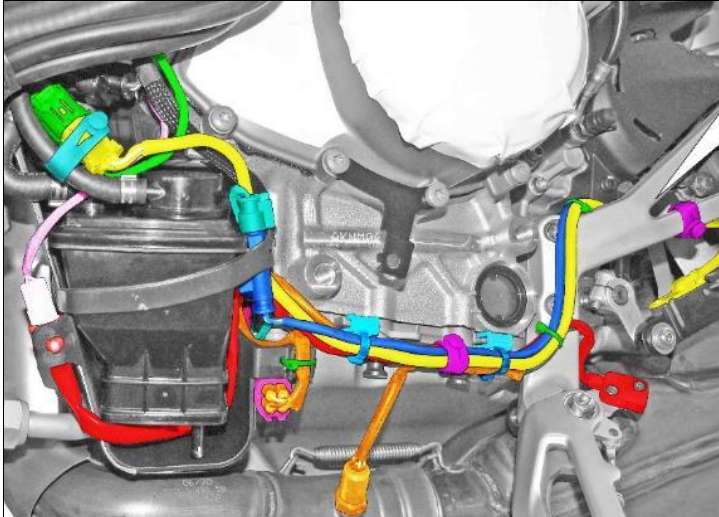
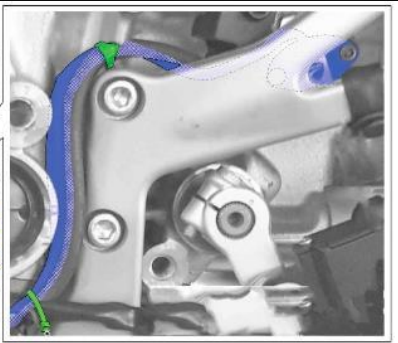
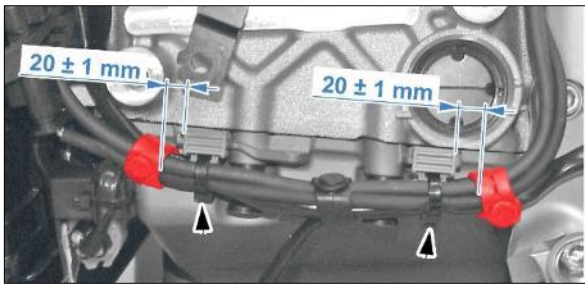
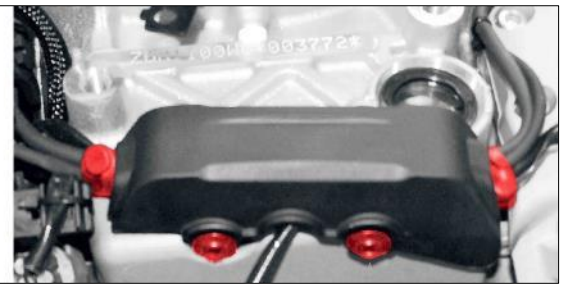
no.	Symptom	Subject	Photo	Notes and Indications - Corrective action
1	Updated layout of motorcycle wiring	Wiring	-	<p>We would like to inform you that the layout of the side stand cable - gear sensor cable - Ducati Quick Shift cable - lambda sensor cable and of the gear sensor connector and cable at the lower crankcase, on the left side of the motorcycle (as shown in the figure) has been updated starting from frame number ZDMFA00AALB003932.</p>

<p>Before installing the wiring cover, apply two L=39 mm button ties respecting the dimensions shown in the figure:</p>

<p>We ask you to respect the new layout of the cables and the gear sensor connector in case of servicing of the mentioned parts.</p>

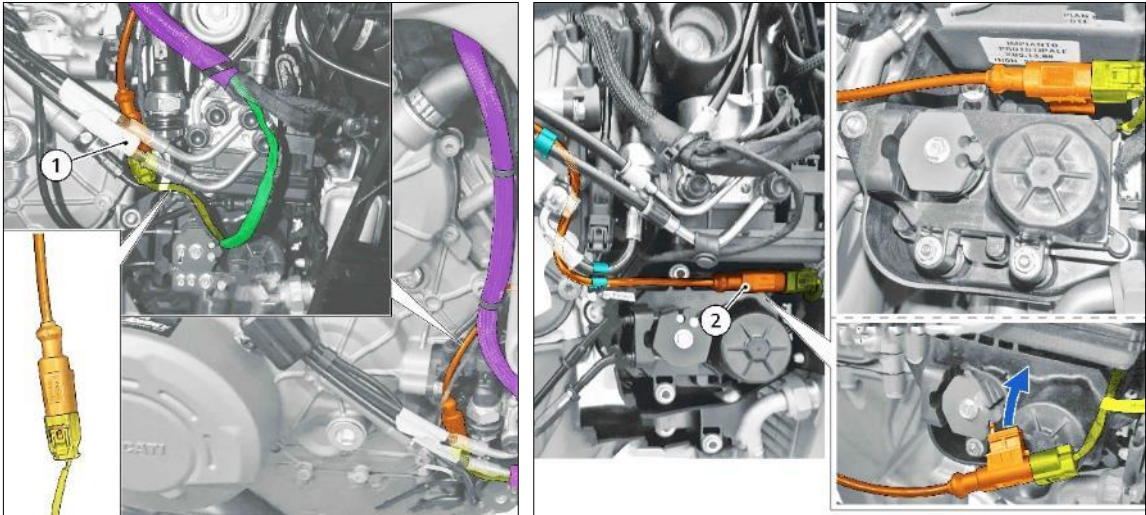
<p>We have received some isolated reports of vehicle speed limitation at values below 50 km/h due to the excessive traction control (DTC) intervention resulting from the installation of the complete titanium exhaust system part no. 96481652AA. The performed analyses have shown that the front and rear speed sensor connections were reversed.</p> <p><u>In case of interventions on the front (1) and rear (2) speed sensor connectors, please take the utmost care to their assembly, as shown in the figure, making sure not to reverse the connections</u></p>

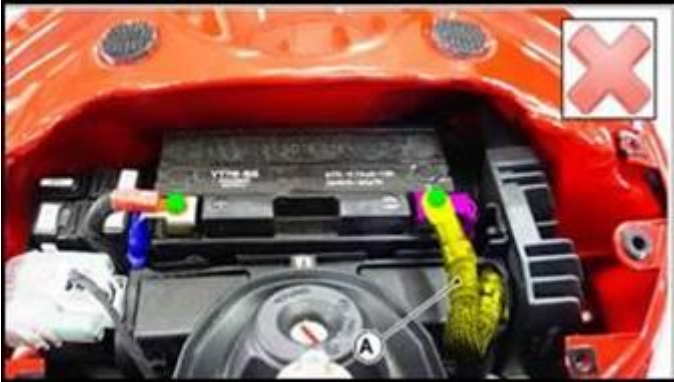
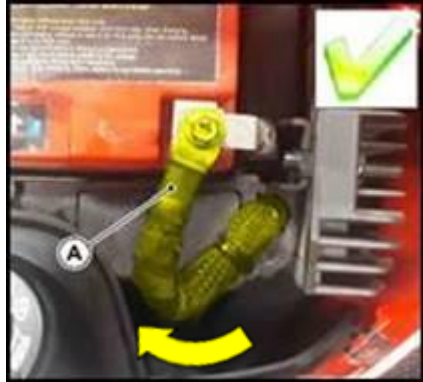
<p>We have received isolated reports of possible interference between the battery negative cable and the battery cover (in particular, the pin fixing the mesh to the cover). To avoid the contact described above, we have updated the battery fitting procedure and in particular that of the ABS negative cable; it is necessary to connect the <b>ABS negative cable (A)</b> orienting it towards the ignition switch as shown in the figure:</p> <div style="display: flex; justify-content: space-around;">

</div> <p>We ask you to follow the new battery fitting procedure during pre-delivery operations and in any case to always check that the battery is fitted correctly the first time the motorcycle is brought to the workshop. <u>This new battery mounting procedure cancels and replaces the information contained in the model introduction bulletin SRV-SRB-20-002.</u></p>

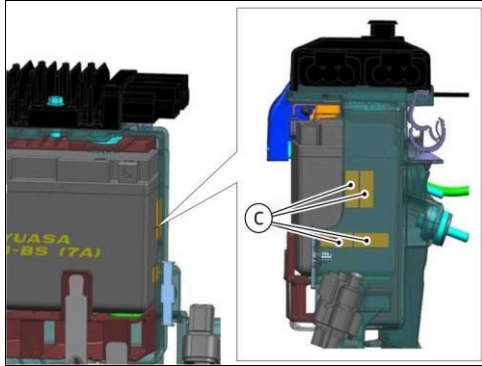
<p>The ongoing tests on the product have revealed the possibility of contact between the battery and its support, which causes marks on both surfaces due to vibration. These marks do NOT affect the correct operation of the electric system and therefore of the vehicle.</p> <p>In order to prevent such marks, <b>4 adhesive pads (C)</b> in rubber 9X23X1.4 part no. 86612791A have been introduced in the production line to be applied inside the battery support.</p>
