# SERVICE BULLETIN

Classification: TF16-001D	Reference: NTB17-003D	Date: March 1, 2022
------------------------------	--------------------------	------------------------

## FLUID LEAK CAUSED BY TRANSFER ASSEMBLY RIGHT SIDE DRIVE SHAFT OIL SEAL

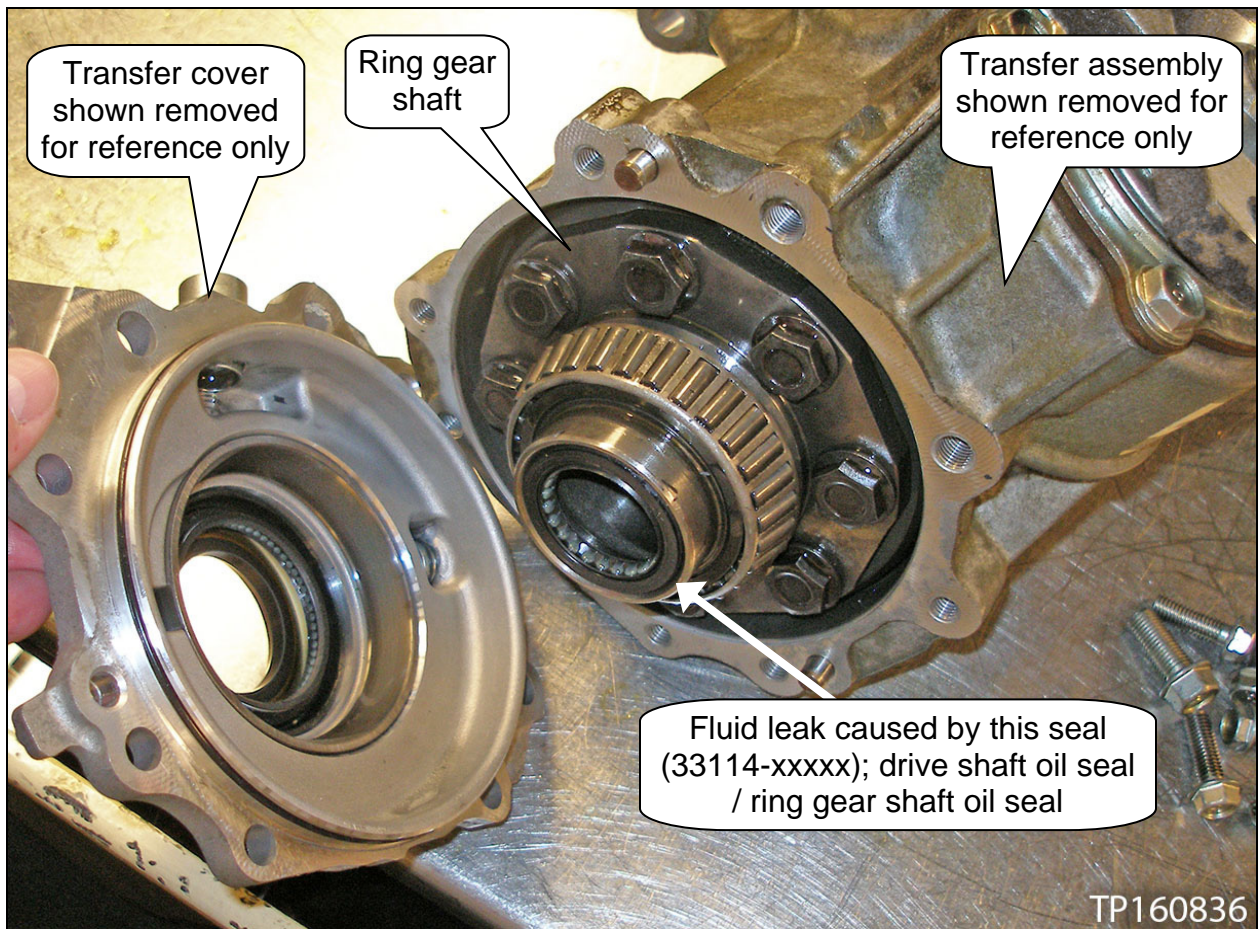
Figure 7

\* The seal causing the leak is called "Drive shaft oil seal" in the ESM for all applied models except Rogue, Rogue Hybrid, Rogue Sport, and Altima. For these vehicles, it is called "Ring gear shaft oil seal".

To avoid damage to the transfer assembly and new seals, use an appropriate seal installer and seal protector during the repair.

- This repair does NOT require transfer assembly removal from the vehicle.
- This repair does NOT require transfer cover removal from the transfer assembly.
