# Service Bulletin

Bulletin No.: 21-NA-149

**Subject: Engine Wire Harness Chafing / IPC Gauges Sweep / IPC Warning Message / SES/Check Engine/MIL / No Start / No Crank / Runs Rough / Stalls / Reduced Engine Power / Various DTCs**

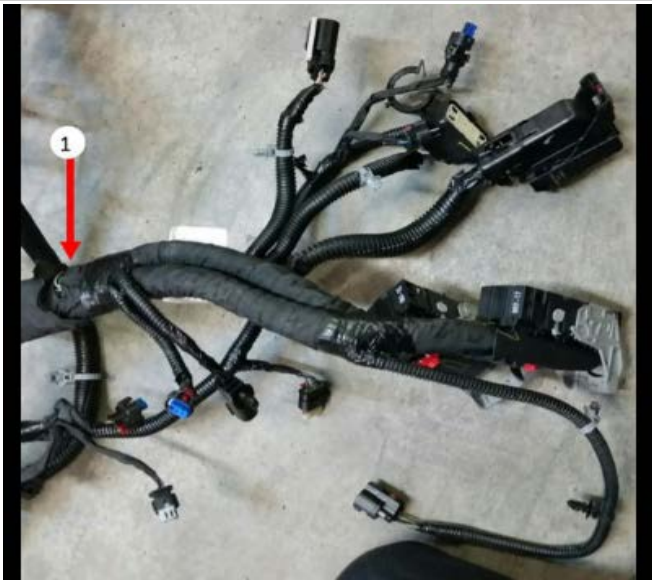
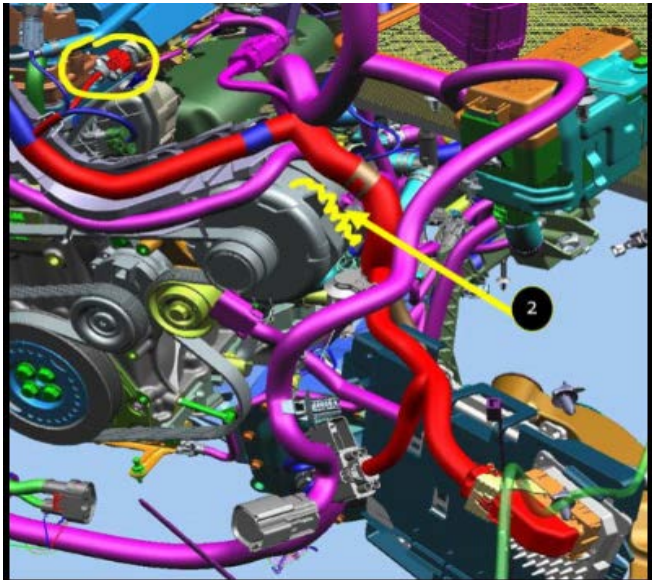
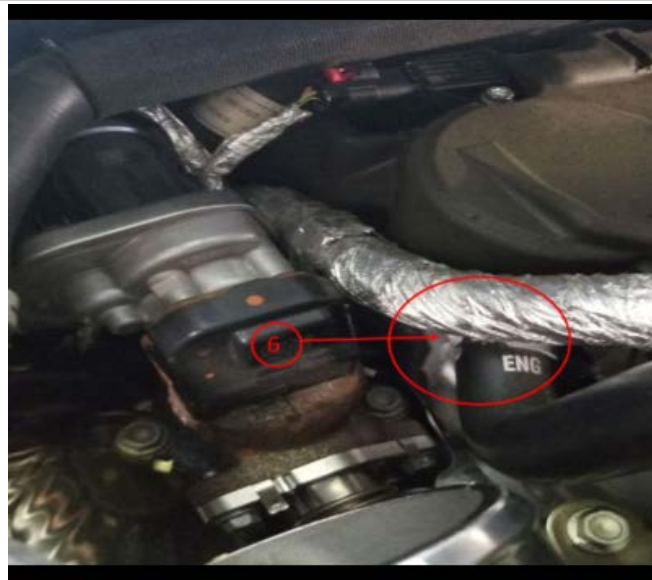
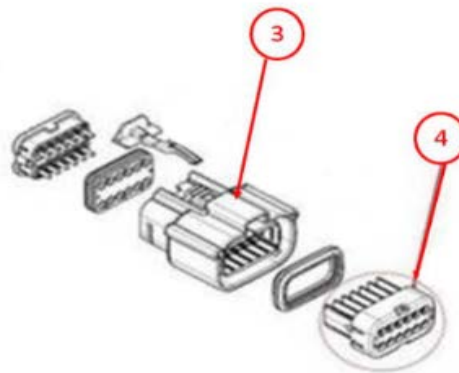
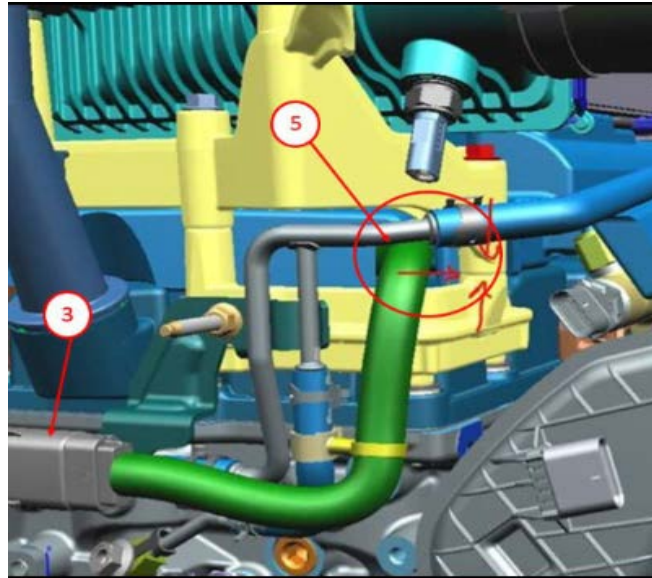
**This Correction pertains to vehicles equipped with engine 3.0L, LM2 only.**

In many cases, the ECM has been unnecessarily replaced for these concerns. Please thoroughly inspect the areas shown above and follow published SI diagnostics before any parts are replaced. If any concerns are found, then follow SI Wiring and Connector repair instructions to correct the concern.
