Re: 49 C.F.R. § 579.5 Compliance Report

Subject: Gen2 Electronic Clutch Actuator (ECA) Interference

Document Number: TAIB0862

Date: February 22, 2016

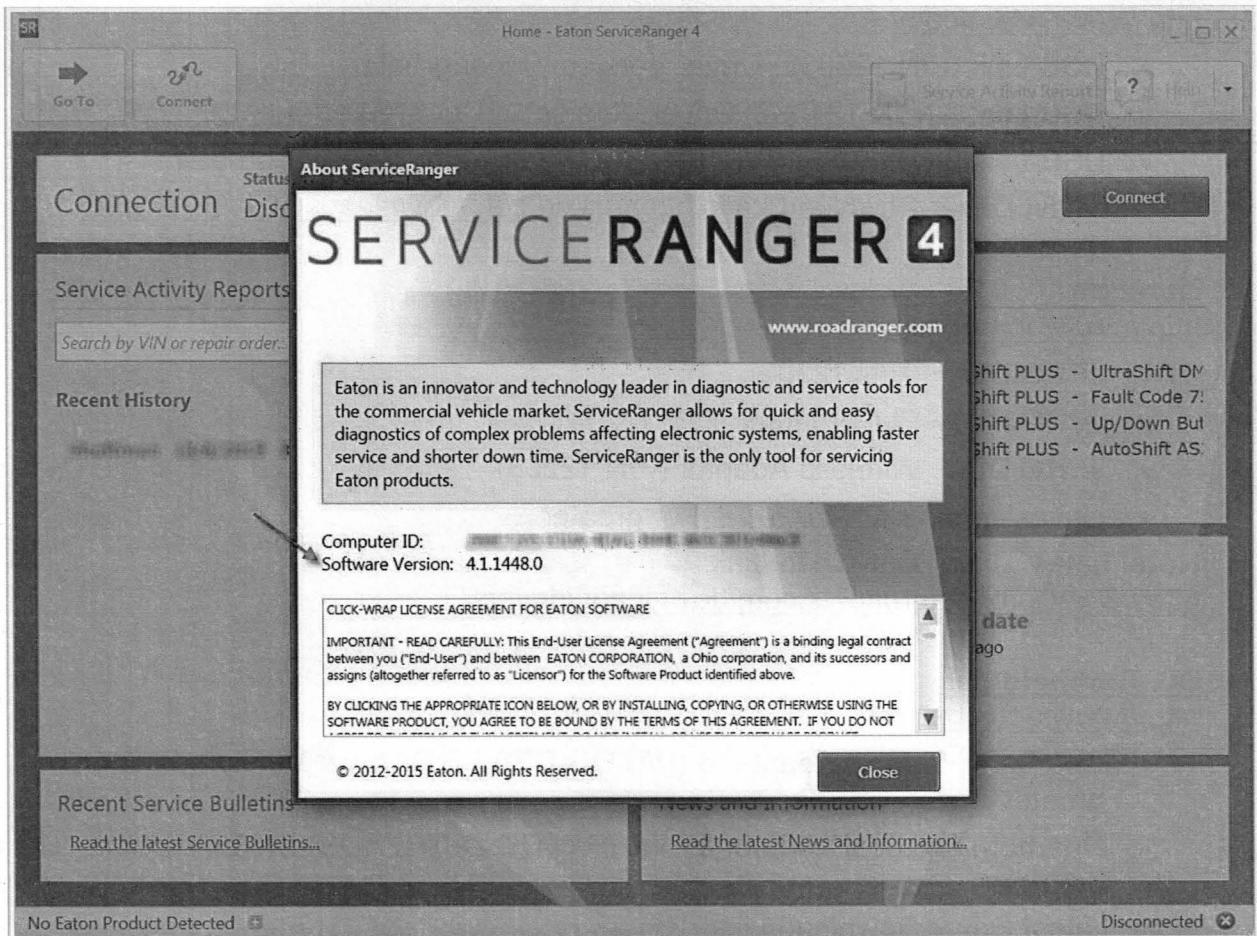
1. Click on ServiceRanger 4 Desktop icon to launch the software
2. Click on **Help** in the upper right corner and **About ServiceRanger** to confirm the ServiceRanger version is up-to-date then Close window.

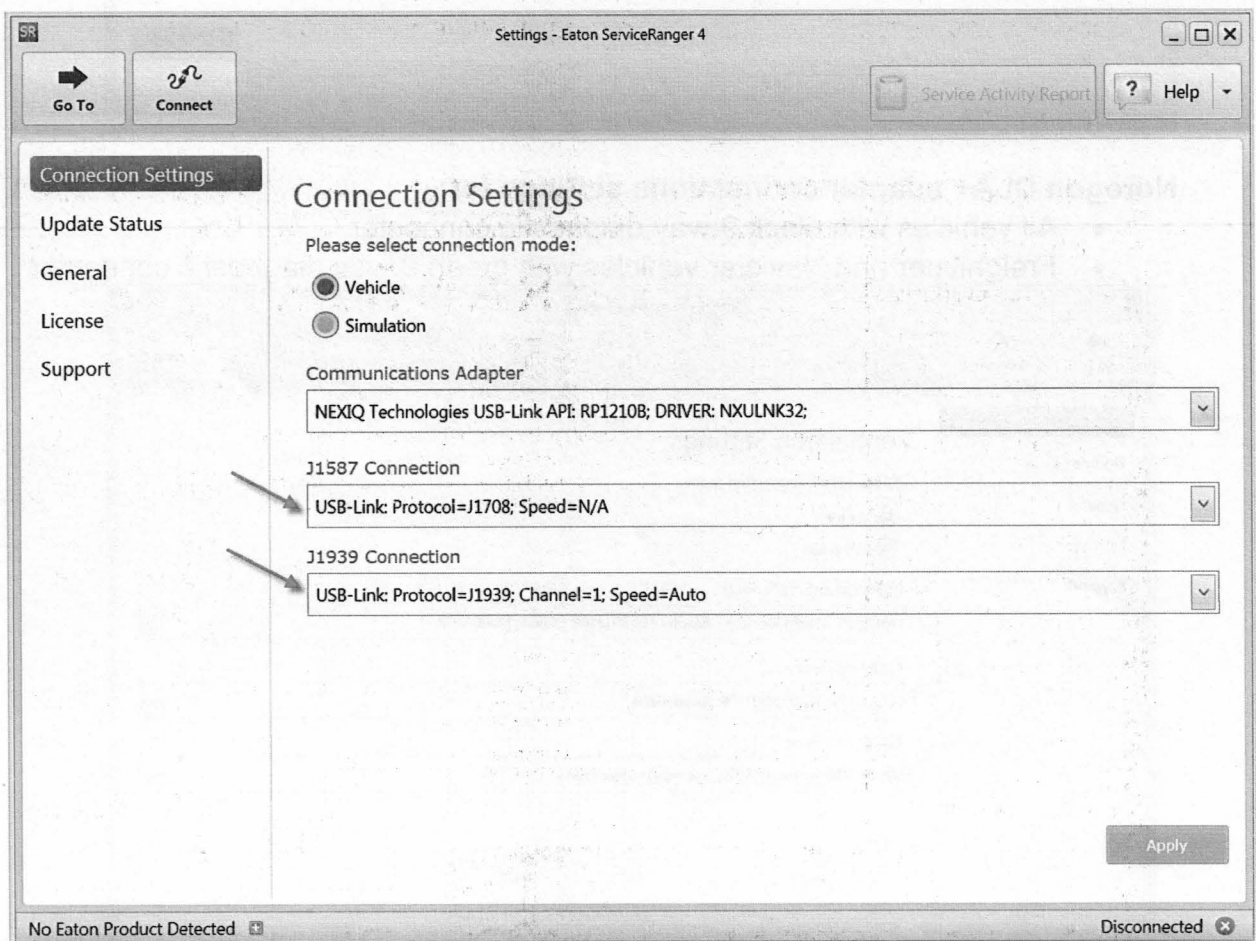
Nexiq USB-Link adapter connections settings for:

- All vehicles with black 9-way diagnostic connector
- Freightliner and Navistar vehicles with green 9-way diagnostic connector

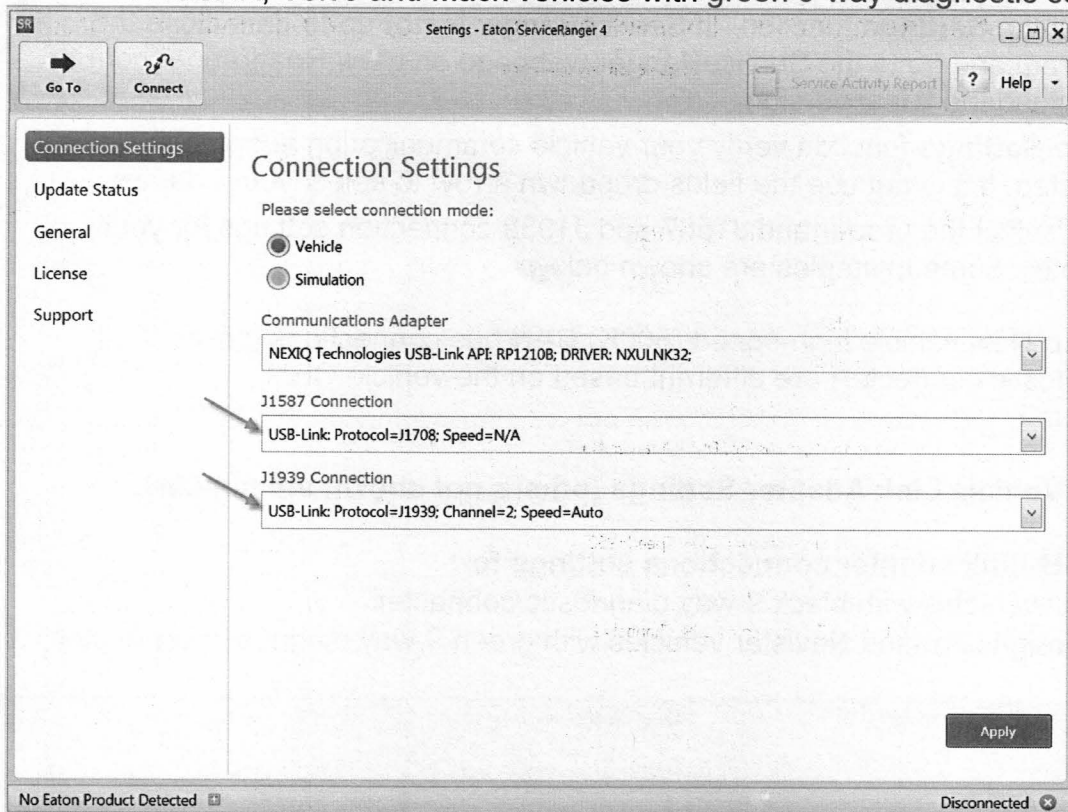
Nexiq USB-Link adapter connections settings for:

- PACCAR, Volvo and Mack vehicles with green 9-way diagnostic connector

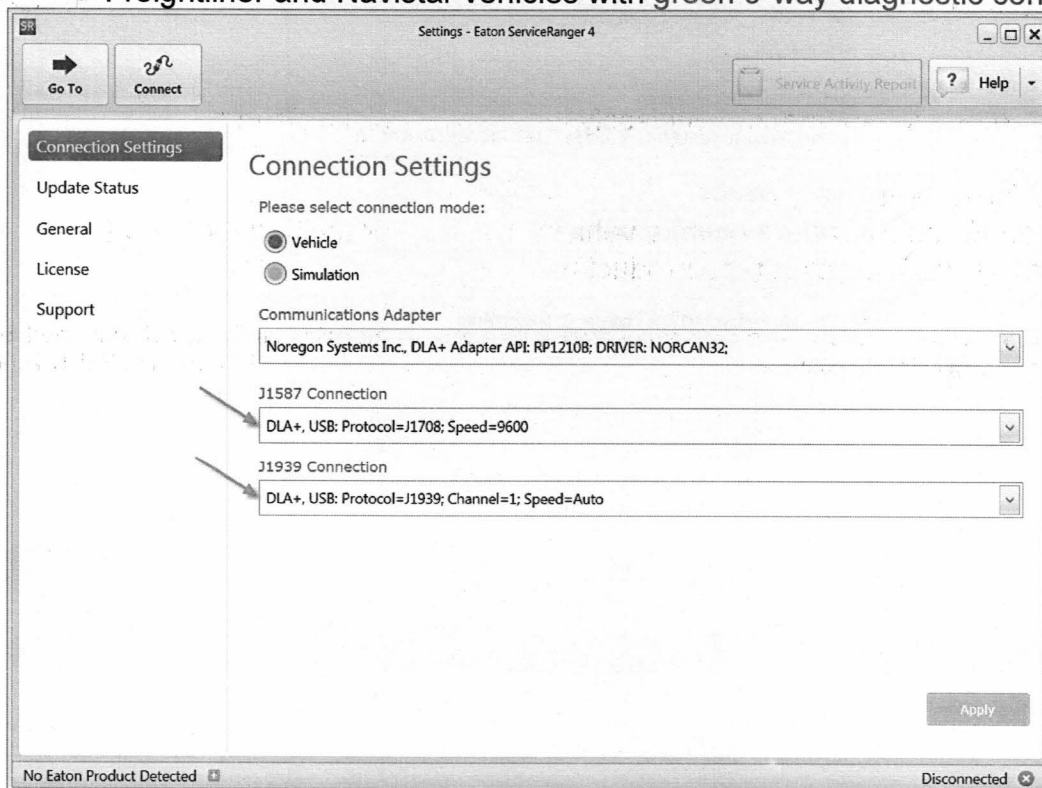
Noregon DLA+ adapter connections settings for:

- All vehicles with black 9-way diagnostic connector
- Freightliner and Navistar vehicles with green 9-way diagnostic connector

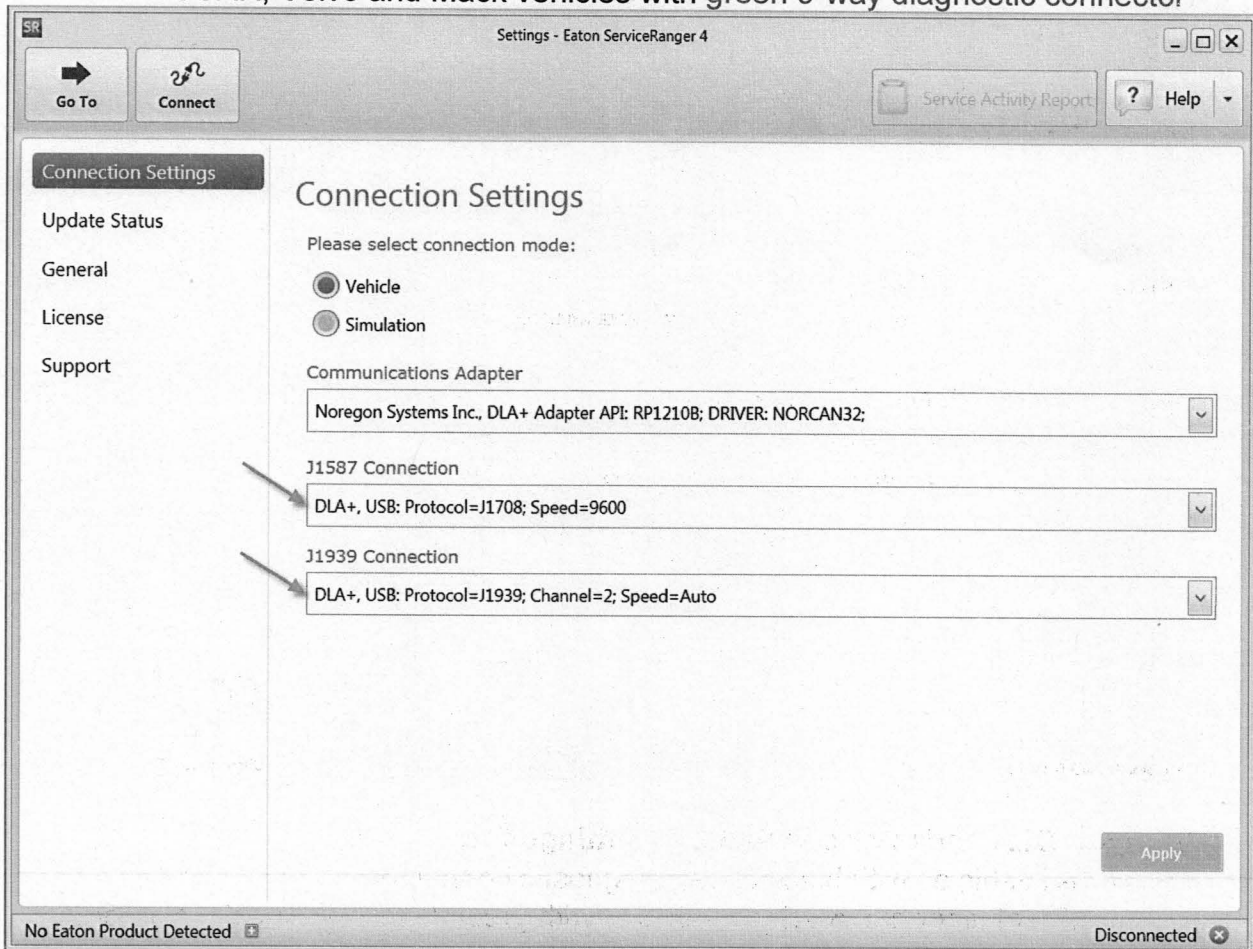
Noregon DLA+ adapter connections settings for:

- PACCAR, Volvo and Mack vehicles with green 9-way diagnostic connector
