(Back Office Only) Volvo Chassis - Equipped With A Catalyzed Exhaust Aftertreatment System (EATS) - Regeneration (Regen) Failure Diagnostic Process - US07 to US16 Emissions

Engine Turbocharger Compressor Bypass Valve Deletion Kit, Installation

V-258-029

REGENERATION FAILURES

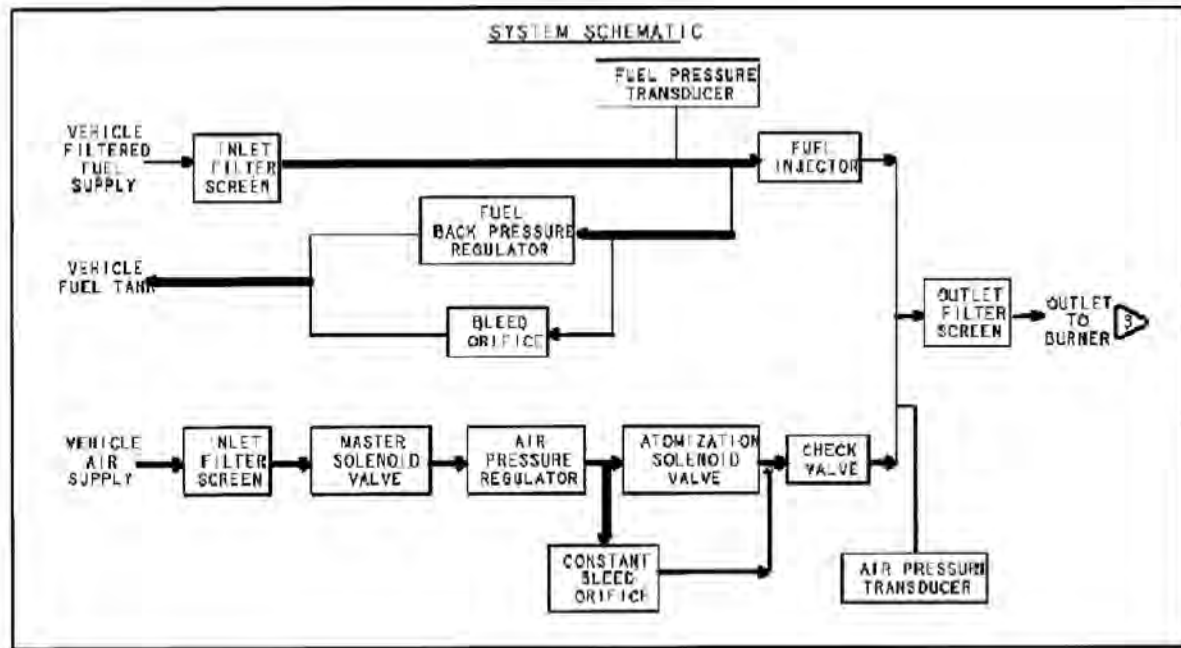
(Air Atomization Module flow chart)

100 PSI fuel pressure Nominal. Range is 95 to 105. 95 psi is at the hairy low limit. 94 or less will give you reliability issues. The pressure is controlled by the Atomization Module (AAM) and not the pump.

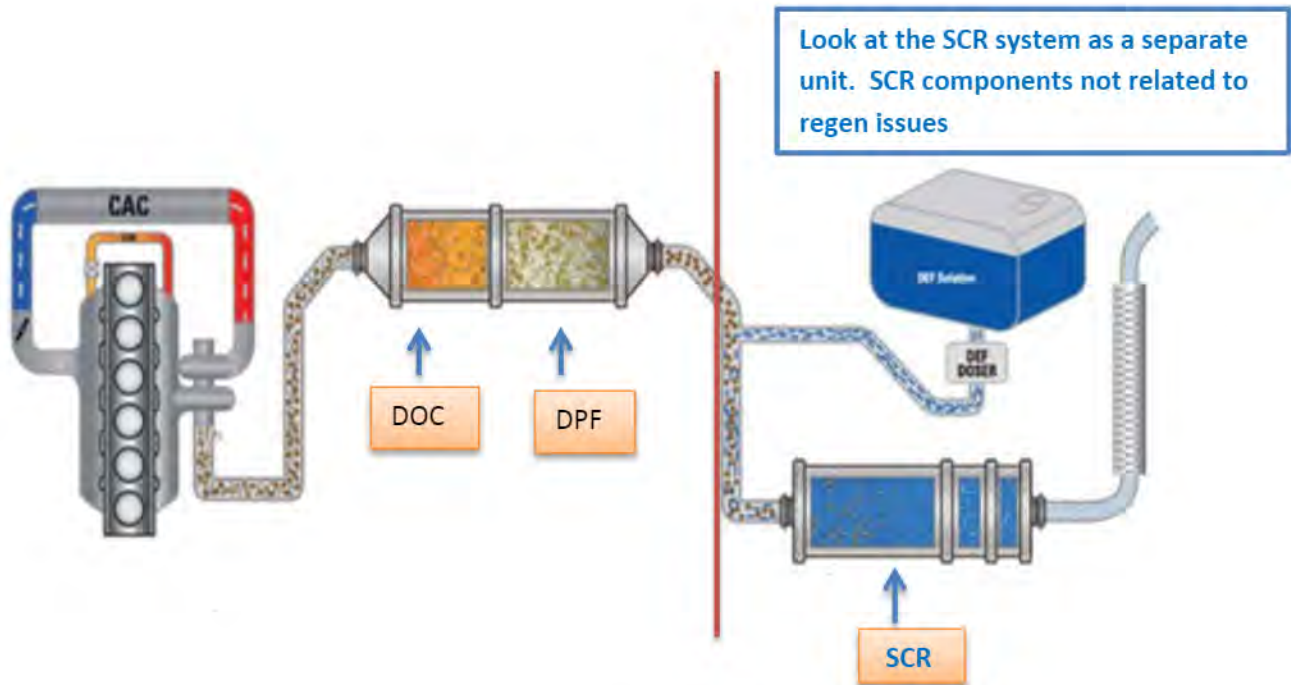
Scenario 1

REGEN OVERTEMP
