Service Bulletin

Bulletin No.: 18-NA-020

Subject: Malfunction Indicator Lamp Illuminated with DTCs P0300, P0299, P0234 and/or P2227 Set

Brand:	Model:	Model Year:		VIN:		Engine:	Transmission:
		from	to	from	to		
Chevrolet	Equinox	2018	2022	-	-	Equipped with 2.0L or 1.5L Engine (RPOs LTG, LYX)	All
GMC	Terrain

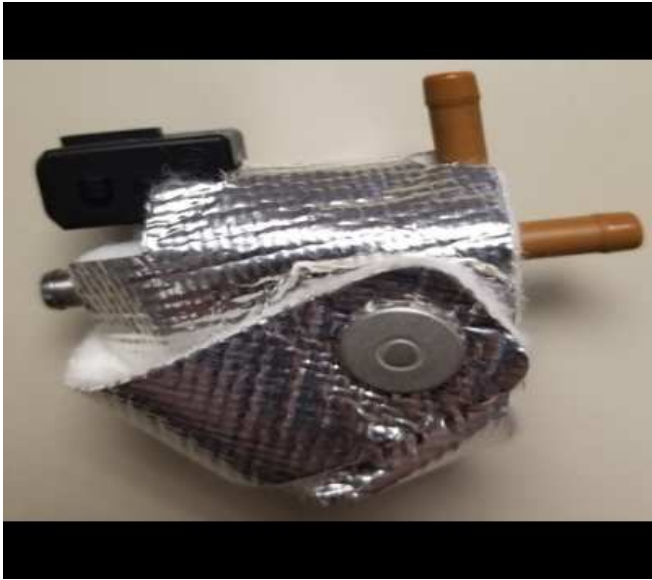
6055079

4. Prior to reinstalling the TCV, pre-position the thermal wrap, as shown in the picture above. This will aid in installation of the wrap once the TCV is reinstalled.

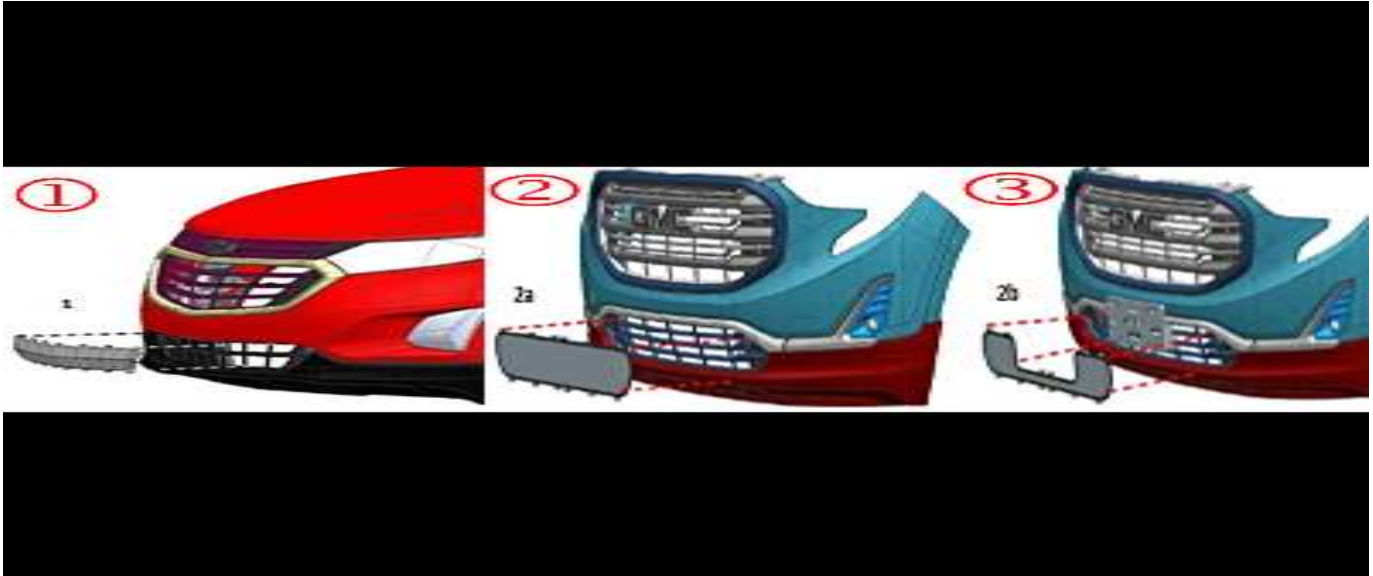
5776421

Shown in the picture above are examples of the grill opening covers for the Equinox (1), Terrain without (RPO VK3) (2) and Terrain with (RPO VK3) (3).

Examples of the Grill Opening Covers (Installation instructions included in the part packaging)
