### **DEF Level (UQLS) Sensor Troubleshooting Guide -US17+OBD16 Emissions and Newer**

# 25068-9 FSB 258-040, Aftertreatment Diesel Exhaust Fluid (DEF) Tank, Level Sensor, Replacement

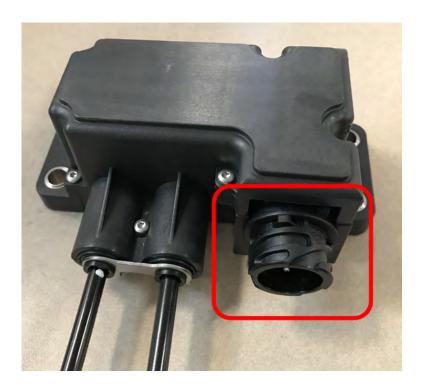
- **1.** Check the sensor wiring harness connection.
  - · Disconnect the harness and make sure there is no damage to the wires or pins, corrosion, or water ingress in either of the connectors. If damage is found replace in accordance with Technical Service Bulletin 258-040 - Aftertreatment Diesel Exhaust Fluid (DEF) Tank, Level Sensor, Replacement. Located in Impact.
  - 1. Navigate to the Service tab.
  - 2. In the Info Type box, make sure Technical Service Bulletins is selected.
  - 3. In the Additional search values box select Keyword
  - **4.** Enter 258-040 into the text entry box, press the Search button.
  - 5. A link for the article will be shown in the results. Click on the title, then choose one of the options from the window that opens.

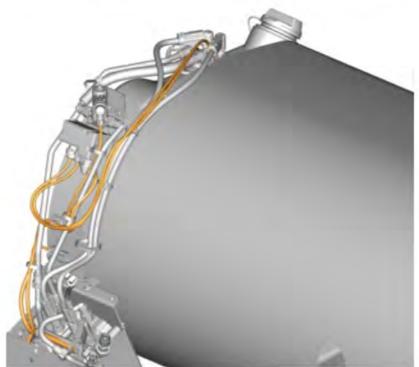
Note: Use cable tie (C).
