Service Bulletin

Bulletin No.: 21-NA-284

Subject: 60% Rear Seat Will Not Fold Down

Brand:	Model:	Model Year:		Date Breakpoints:		Engine:	Transmission:
		from	to	from	to		
Cadillac	Escalade Models	2021	2022			All	All
Chevrolet	Suburban						
	Tahoe						
GMC	Yukon Models

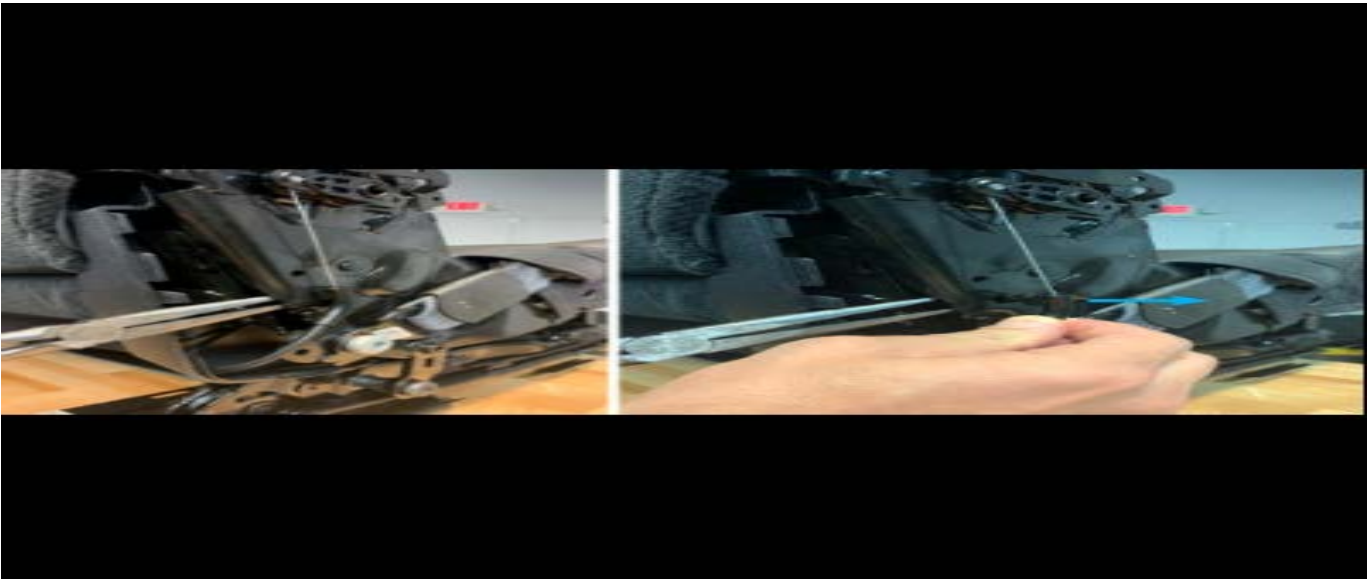
5932665

Note: If the metal cable strand is frayed or kinked, the cable must be replaced.

- 5.2. Remove fitting by pinching snap fingers and pulling fitting outward.
