MIL ON With DTCs P0AA649 and/or P1C8049 or AM Radio Static/Distortion

Service Category Engine/Hybrid System

Section Hybrid/Battery Control System

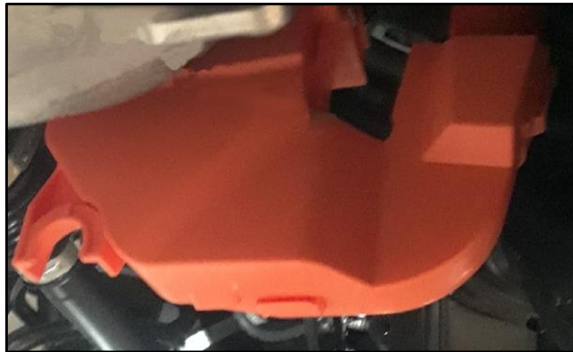
Figure 4. Original Part Installed

As shown in Figure 5, the HV Floor Under Wire may have a different appearance than the original part, shown in Figure 4. This is a normal condition.

4. Replace the HV Floor Under Wire.
