New Trim Codes May Need To Be Reprogrammed Following Engine Replacement With 7/8 Reman Or Complete (Engine With Both New Injectors And Engine Control Module); Possible Uneven Operation/Rough Running At Idle Following EMS Programming With Data Transfe

Service News

То:	General Managers Service Managers Service Technicians Warranty Managers	Region:	⊠U.S. ⊠CAN	Bulletin: SNM19-002 Date: January 28, 2019 Valid to: N/A Action Required? □Yes ⊠No
From: Subject:	Greg Holderfield – Director, Techni AMT Oil filter Housing Corrosion	cal Support	t l

AMT oil filter housing corrosion

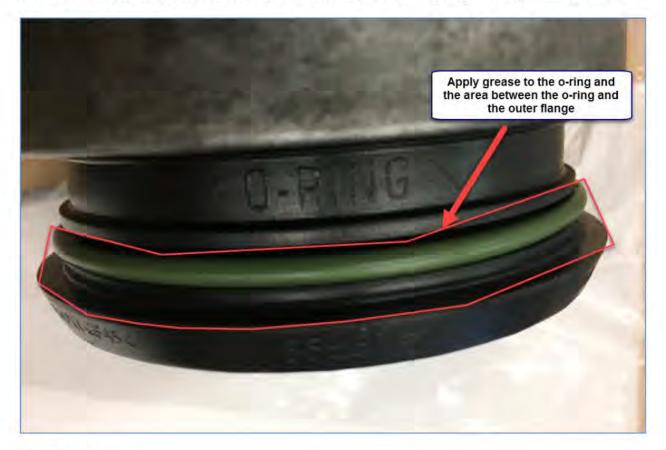
Filter housings that show normal dirt build up (left image) can be cleaned with a Scotchbrite pad or equal. Some residual staining of the aluminum housing (right image) may still be present after cleaning. Clean the threads and sealing surfaces before reassembly. Apply a small amount of silicone grease that meets the specification below on the o-ring, filter housing sealing area and the cap flange below the oring prior to assembly to help seal out moisture and dirt. There must be enough grease present to allow squeeze-out under the flange so the dirt and moisture is sealed out of the area of concern. Clean the filter cap of any excess grease squeeze-out after assembly to prevent giving false impression of a leak.

Inspection and cleaning of the sealing surface for the cap o-ring is important to avoid this damage. When cleaning is required DO NOT use power tools or grinders to clean the sealing area as this can damage the housing beyond repair. Gently scrape by hand or use abrasive paper to clean the area. If the area cannot be reliably cleaned or there is damage to the sealing surface for the o-ring, the housing must be replaced.
