**SERVICE BULLETIN**

**APPLICABILITY:** 2017-18MY Impreza  
 2018MY Crosstrek  
 2018MY Legacy and Outback  
 2018MY BRZ\*

**NUMBER:** 15-211-17R  
**DATE:** 06/13/17  
**REVISED:** 06/27/22

**SUBJECT:** Reprogramming File Availability for Additional Optimization of Harman Gen 3 Audio and Navigation Head Units

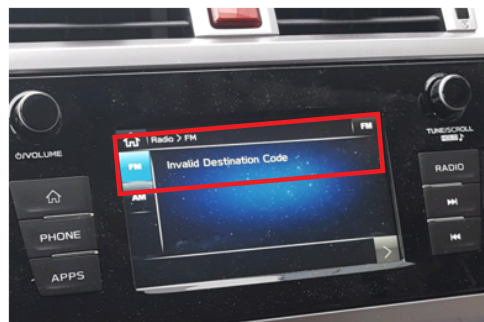
- Update to address display of “Invalid Destination Code” message

- Update to change “Scan” text display to “Tune Scan” when SXM starts to tune channels.

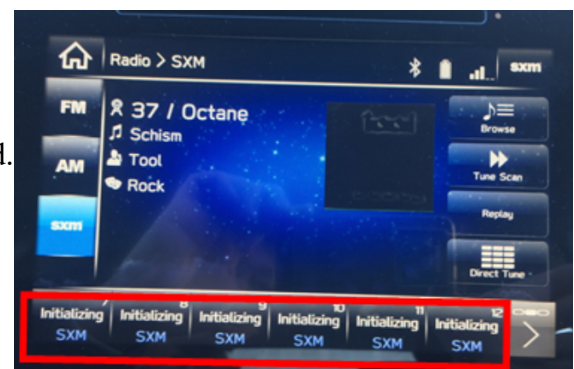
- On 2018MY Legacy / Outback models with Navigation (High) head units, the update corrects a condition where the head unit remains powered even after the ignition is OFF and the driver door is opened.
- Update for a condition where the SXM presets become lost and only “Initializing” appears as shown below.
- Update for condition where only the star field background is displayed (without icons) after the HOME button is pressed.

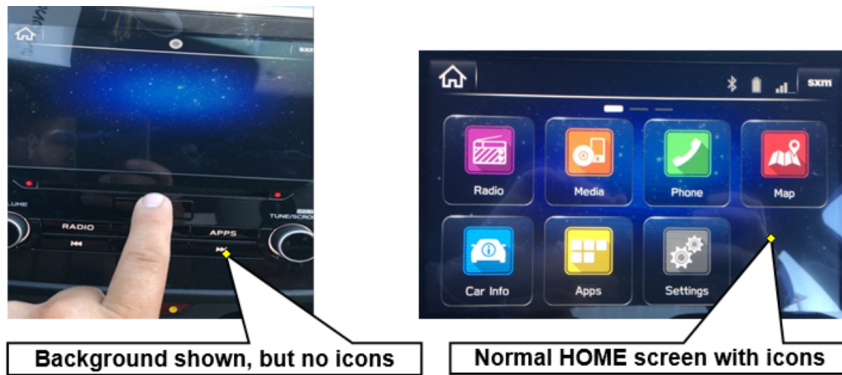
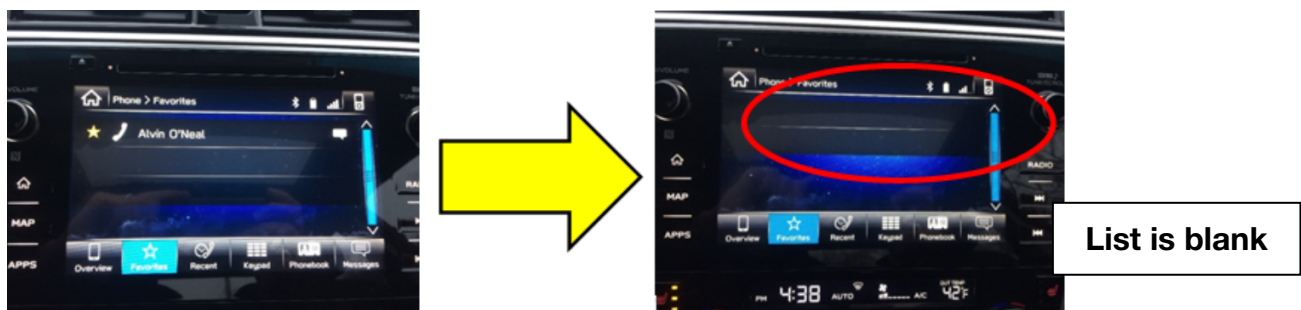
- Update for a “Pop” or “Crackling“ sound concern when listening to AM radio.
- Update for a concern of the head unit continually resetting itself.
- Update for a concern of after selecting a contact to be a “Favorite” and the “Favorite” list display is blank.

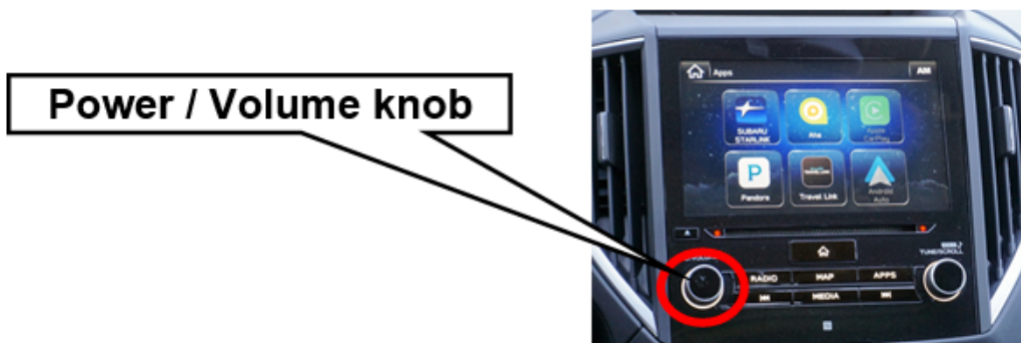
- Operation of the head unit after switching the ignition off and back on has been revised:  
**PREVIOUS Version:** The head unit power is turned OFF by pressing the Power/Volume knob for 4 or more seconds. On the next ignition ON, the display remains OFF / black while the audio begins playing automatically. This was the prior characteristic operation.

**NEW Version:** The head unit power is turned OFF by pressing the Power/Volume knob for 4 or more seconds. On the next ignition ON, the display remains OFF / black and the audio will also be OFF until the Power/Volume knob is pressed to turn the head unit back ON.

**NOTE:**
  - The Mute function of the Power / Volume knob (a brief press and release of the Power / Volume knob to mute audio output) is unchanged.
  - A “system reboot” function is initiated by pressing and holding the Power / Volume button for 10 seconds. This feature was included as part of the previous (11/2017) software update.
