# RCA-78-22-009-1: Trapped Jump Start Wire Harness

<b>Document Type</b>	Customer Satisfaction Campaign Bulletin
<b>Date</b>	June 10, 2022
<b>Affected Region(s)</b>	USA
<b>Affected Model(s)</b>	R1T
<b>Model Year(s)</b>	2022
<b>Approximate Build Dates</b>

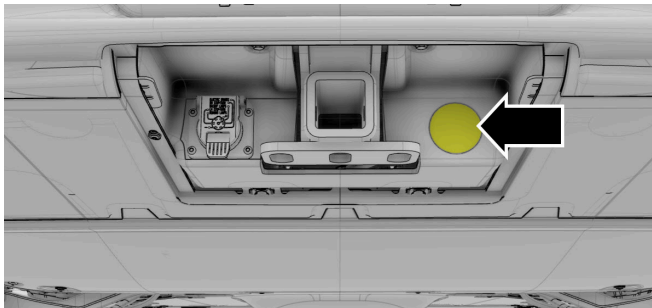
1. Remove: Panel, Access, Tow Hitch (refer to service manual procedure 525820010).
- 2.

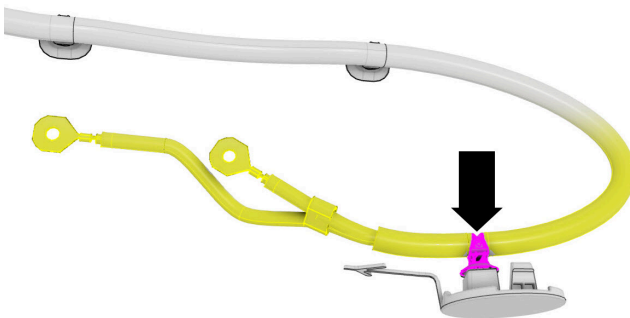
4.

**Note:** Shown with components removed for clarity.

5. Look through the gaps between the trailer hitch and closeout panel.

6. On both sides: Insert a shim or similar tool through the gap(s) between the trailer hitch and closeout panel. Use the tool to push the harness off of the bracket so that it is not trapped.
