Preliminary Information

PIT5921 Rear View Camera Coaxial Related Issues-B395A - B395B - B395C - B101E - B101D

Product Investigation Review Required

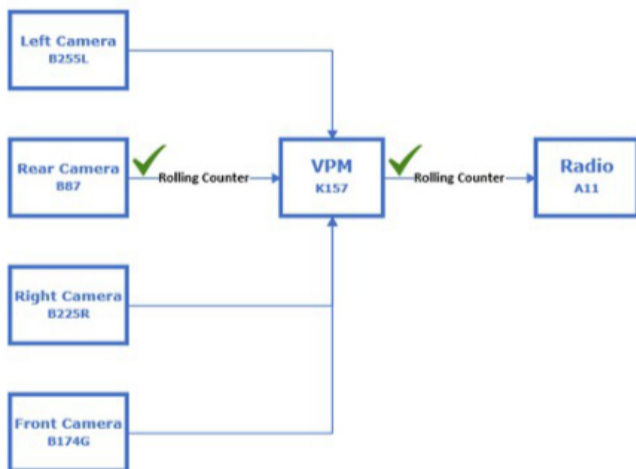
The Radio requires a rolling counter to ensure a video output on the radio screen. This counter prevents a frozen image to be displayed to the vehicle owner when shifting into reverse.

This rolling counter is monitored continuously to ensure we have video signal from the rear camera. It goes from the rear camera to the VPM and from the VPM to the Radio.
