Location: Chassis

Topic: Information relating to the replacement and diagnosis of steering pumps

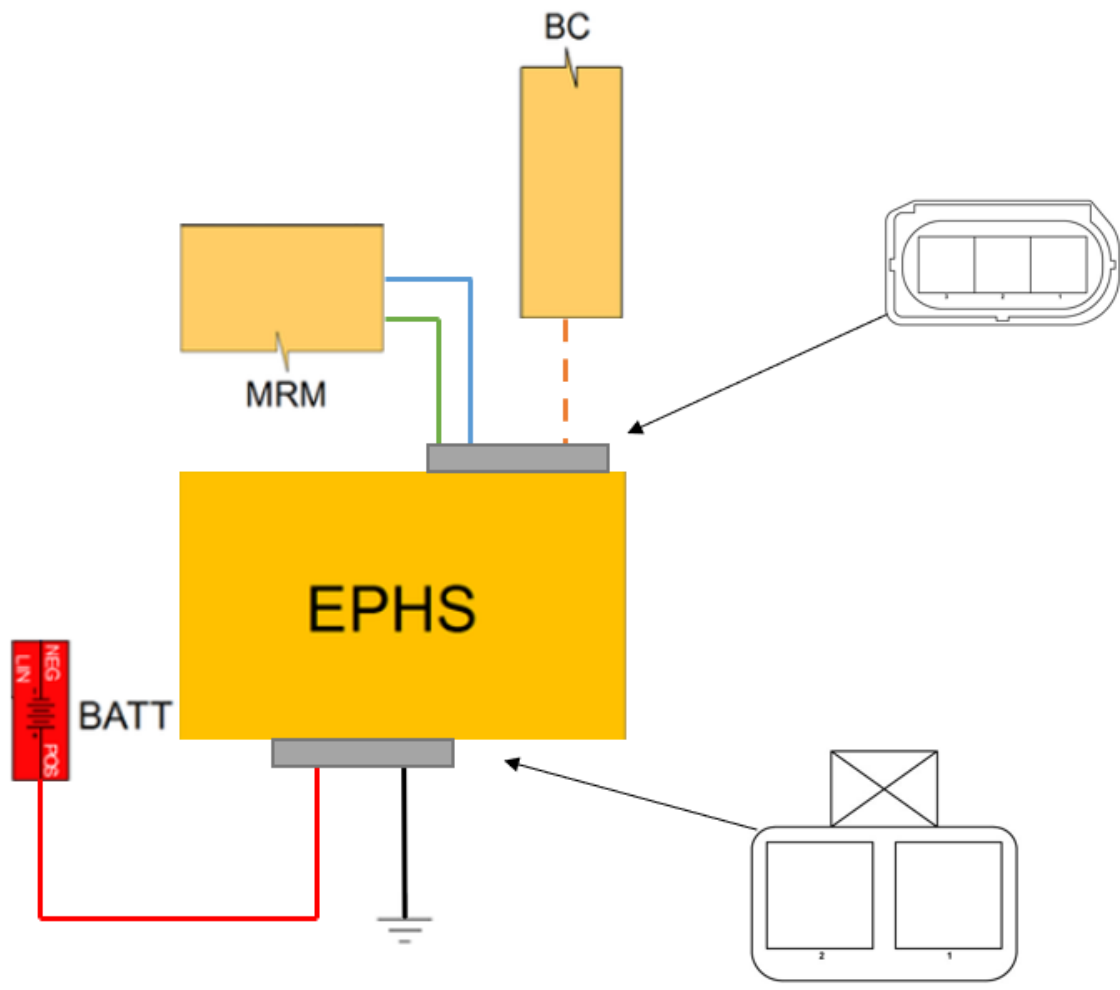
Figure 1.1 – Reference Diagram for EPHS Circuit

During the replacement or diagnosis of a suspected faulty steering pump (EHPAS), it is necessary to inspect the ground for the pump power supply circuit. Poor grounding of the steering pump can lead to intermittent warning messages or sporadic steering pump behaviour.
