- JEP (Jamestown Engine Plant) has received 35 BIS (Before In Service) reports of ECM's (Electronic Control Modules) with No Communication;
 - 1 reported by DTNA Cleveland
- RMEP (Rocky Mount Engine Plant) has received 15 BIS reports of ECM's with No Communication;
 - 9 reported by DTNA (4 at DTNA Santiago, 2 at DTNA Mount Holly, 2 at DTNA Cleveland, and 1 at FCCC Gaffney)
- There have been no failure reports from units at the supplier or at Cummins plants
- Cummins is investigating 1 reported failure from the field

ROOT CAUSE AND GOAL STATEMENT

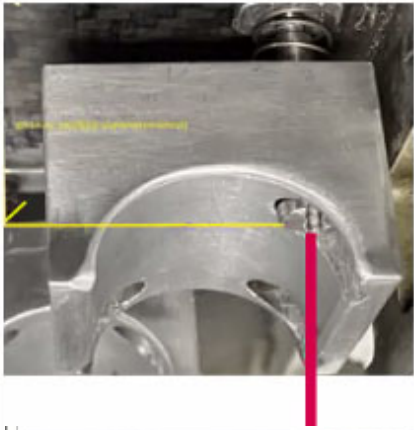
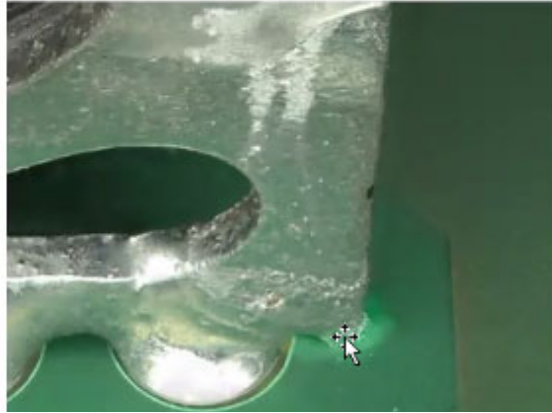
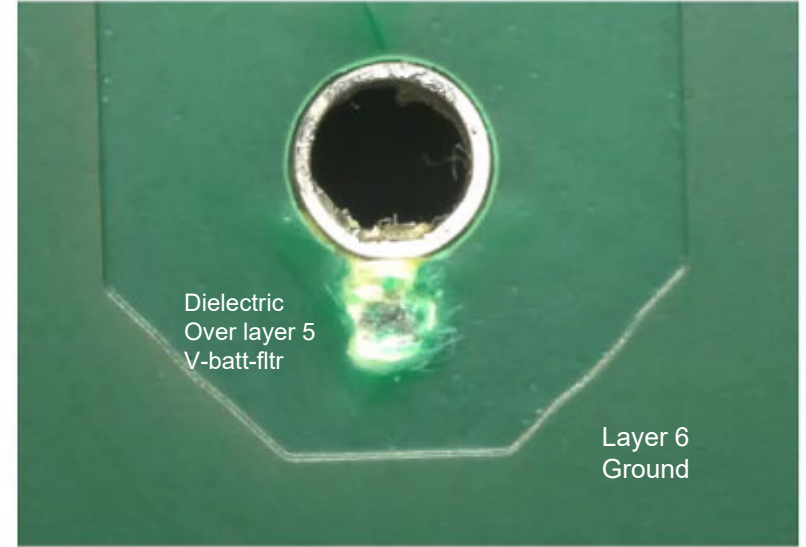
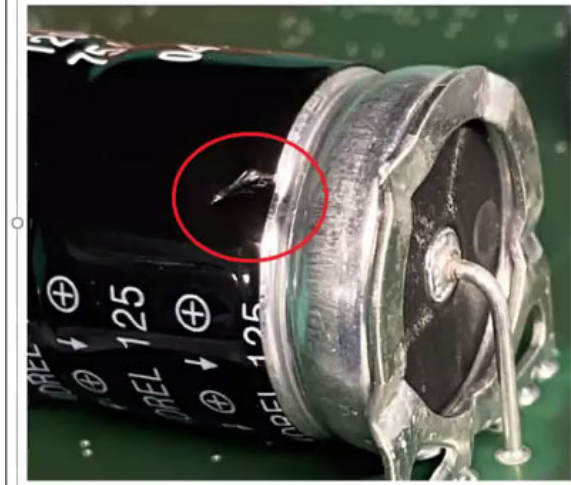
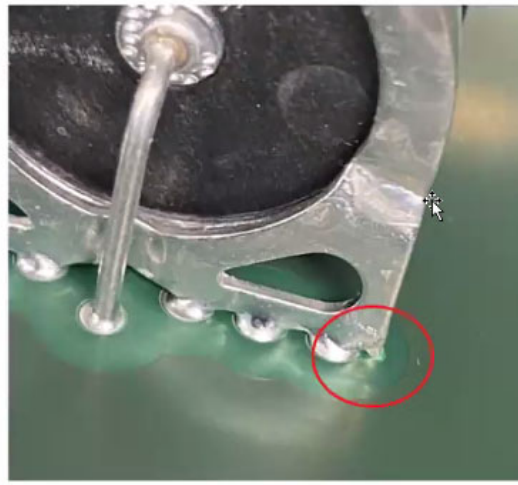
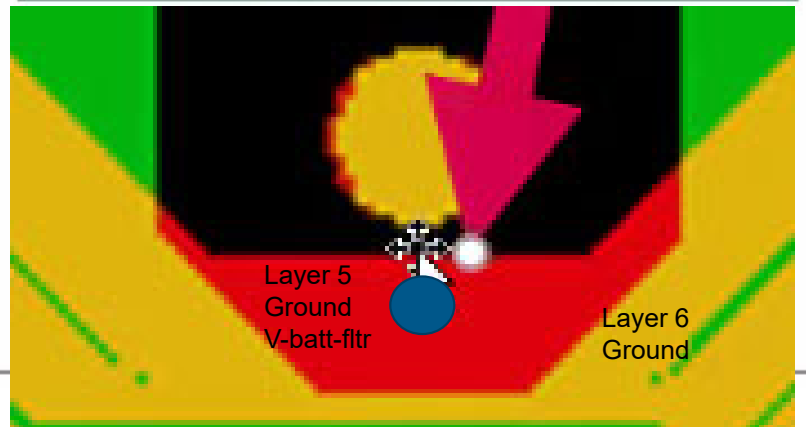
- Selective Solder Fixture had a screw loose. Screw was contacting the Lytic cap and applying excess force into the PCB (Printed Circuit Board). Vitesco can detect a direct short of capacitor ground post to V-Batt layer. However, when the capacitor post ground is pressed into the dielectric layer, there is no short to detect. Some scrubbing or movement of PCB & capacitor wears through the dielectric layer into the V-Batt layer resulting in high current draw and heat leading to L2002 reflow and ECM No communication.

PC Board layers
