TECHNICAL SERVICE BULLETIN

Water Leak From The A-Pillars, Overhead Console/Upfitter Switches And/Or Sun Visors

22-2403

Ford 2021-2022 Bronco

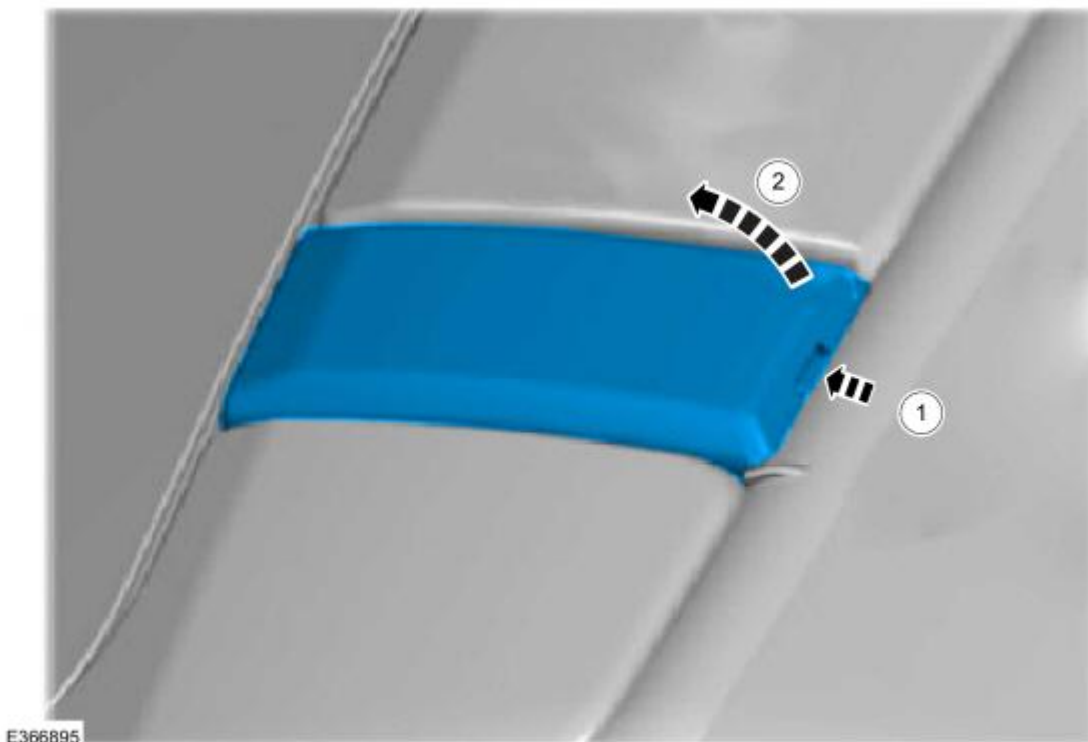
Figure 9

11. Remove both windshield trim covers by pressing the button on the rear of the cover and rotating it forward. If a roof rack is installed on the vehicle, it needs to be removed using the assistance of a second person. Refer to the Digital Owner's Manual for removal instructions. (Figure 9)

26. Pull/remove the cord that runs along the inside of the new header seal groove.
27. Install both windshield trim covers. If a roof rack was installed on the vehicle, it needs to be reinstalled with the assistance of a second person. Refer to the Digital Owner's Manual for installation instructions. (Figure 9)

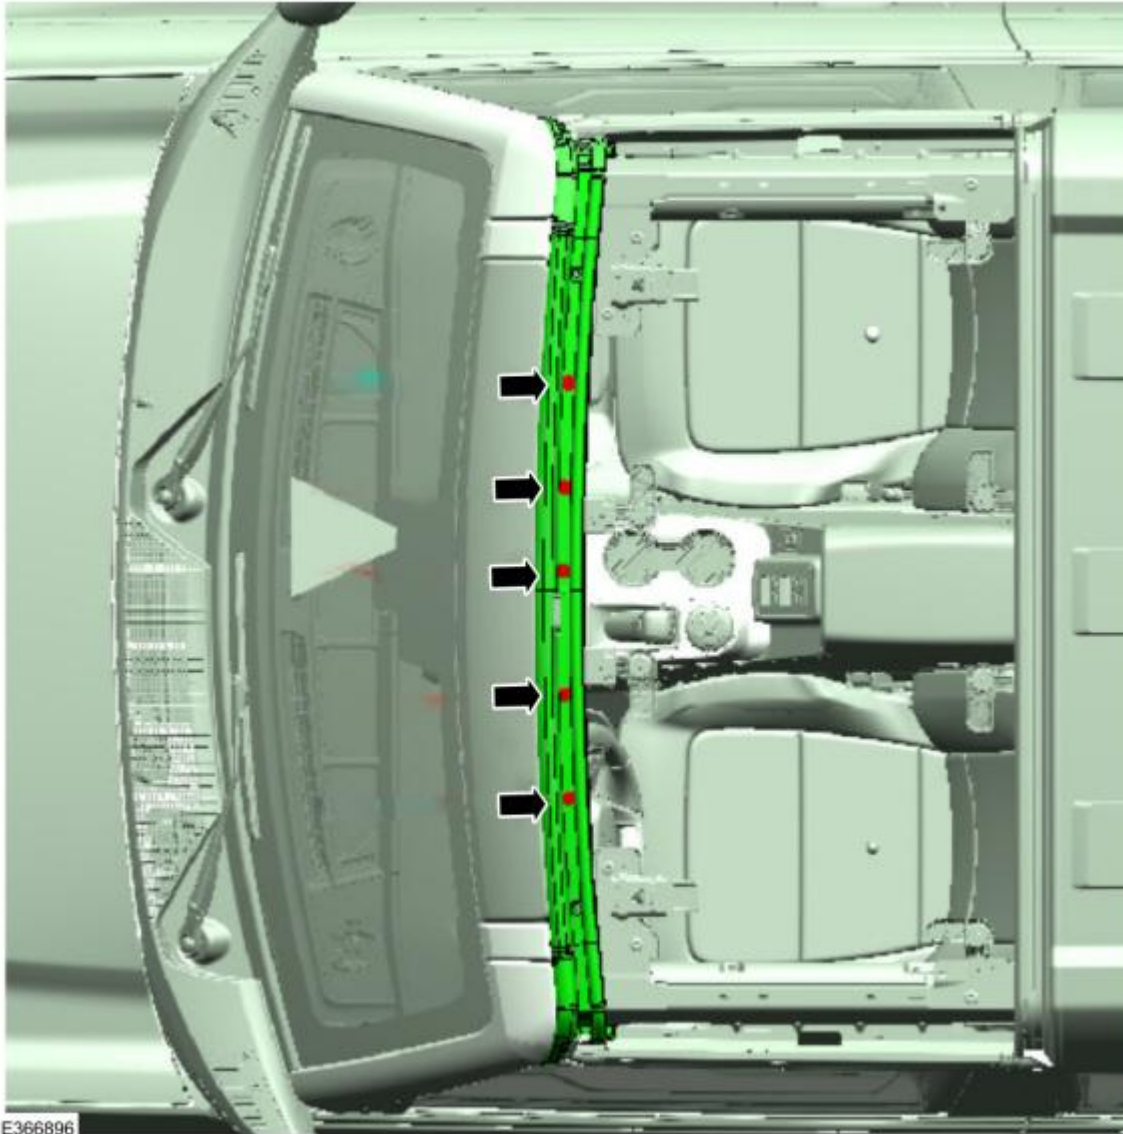
Figure 10

13. Remove the 5 center bolts and nuts securing the header seal to the body. (Figure 10)

22. Install all header seal attachments.
 - (1). Tighten the 5 center bolts and nuts securing the header seal to the body to 9 Nm (80 lb-in). (Figure 10)

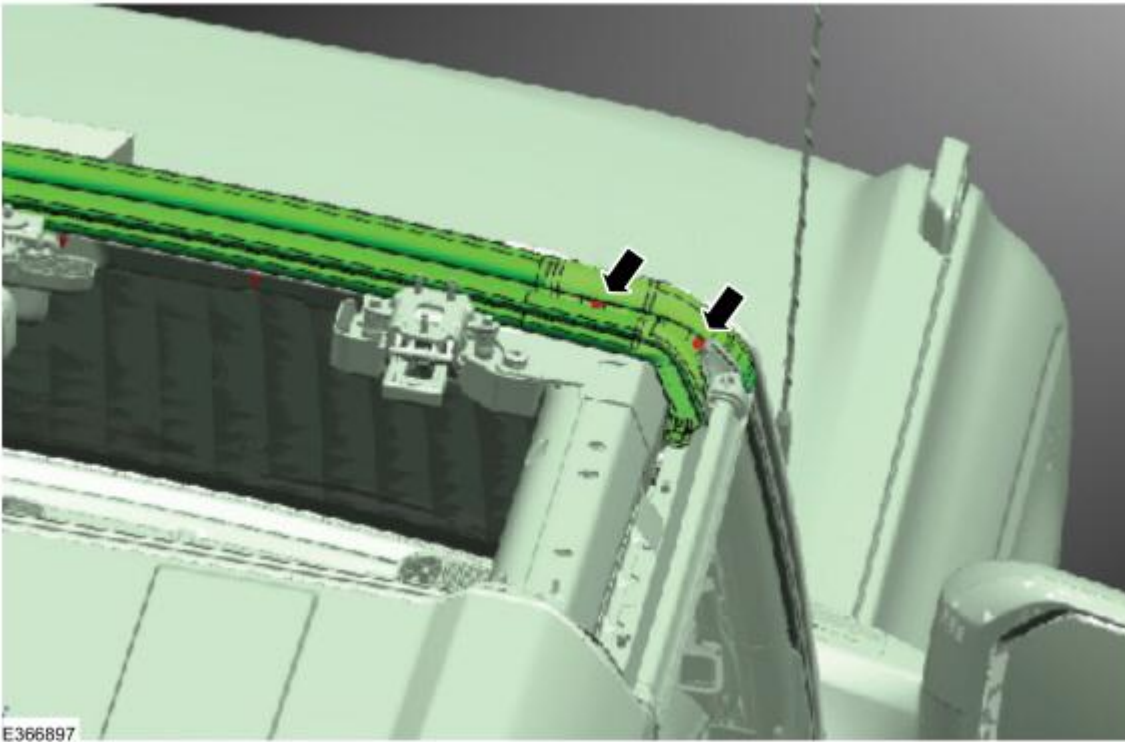
Figure 11 - Right side shown, left side similar

14. Remove the 4 bolts (2 on each side) securing the header seal to the body. (Figure 11)

- (2). Tighten the 4 bolts (2 on each side) securing the header seal to the body to 3 Nm (26 lb-in). (Figure 11)
 - (3). Install the 2 pushpin fasteners, 1 located at each end. (Figure 12)

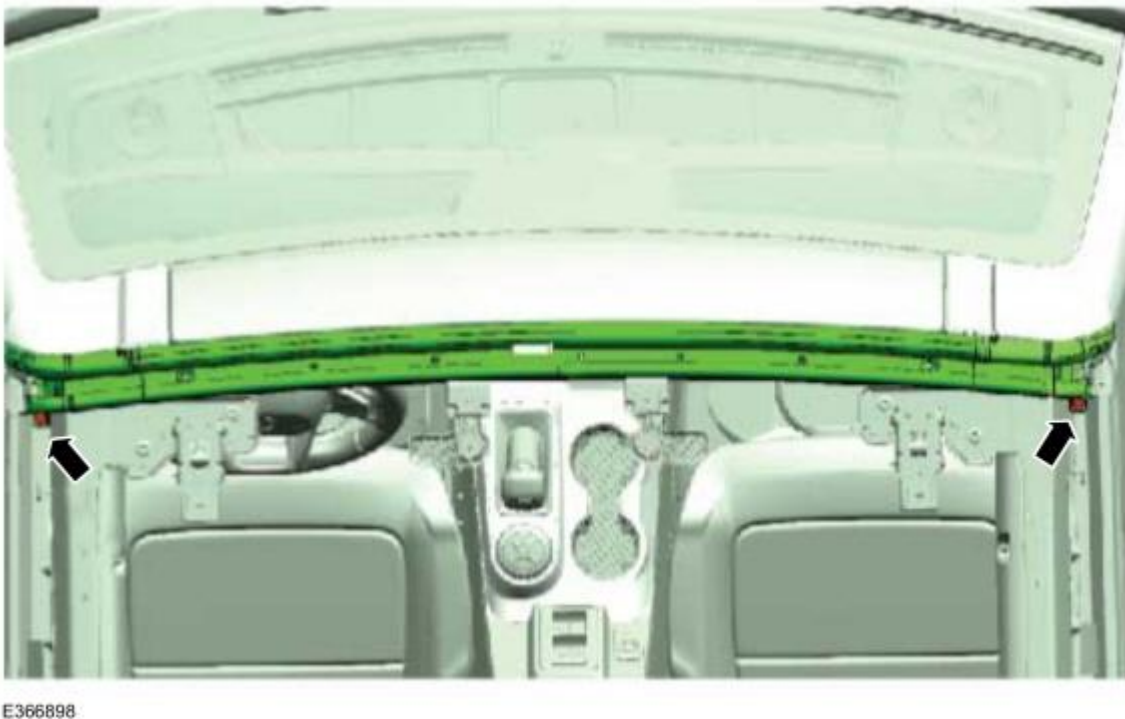
Figure 12

15. Remove the 2 pushpin fasteners (1 on each end). (Figure 12)
