# Service Alert

<b>Subject:</b>  CONNECTED VEHICLE SYMPTOM TROUBLESHOOTING	Service Alert No.: SA-017/22
	Last Issued : 10/10/2022

2019-2023 Mazda3  
2020-2023 CX-30  
2021-2023 CX-5  
2021-2023 CX-9  
2022 MX-30  
2023 CX-50

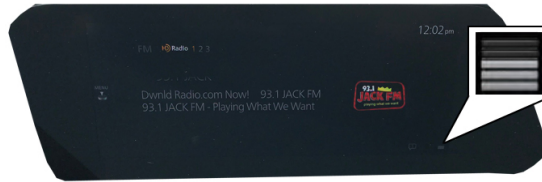
Confirm the customer's phone and vehicle have good to strong reception during the concern as shown in the table below.

- If the reception is weak, move the vehicle to a location where the reception is good to strong as shown in the table, then try to get the Authorization Code and/or operate the remote functions before proceeding to the Repair Procedure if there is still an issue.
- If the reception is good to strong, proceed to the Repair Procedure.

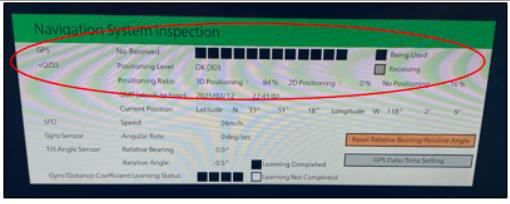
<p>No reception</p>		<p>1. Go to <a href="#">eMDCS Vehicle Inquiry</a>. Does eMDCS show <a href="#">CSP04</a> status closed?</p> <ul style="list-style-type: none"> <li>• Yes - Customer opt-out. No action needed.</li> <li>• No - CSP04 is not shown. Go to next step.</li> </ul> <p>2. Check for DTCs. Are there any DTC's stored?</p> <ul style="list-style-type: none"> <li>• Yes: Go to MGSS for normal DTC diagnosis.</li> <li>• No: Go to next step.</li> </ul> <p>3. Confirm TCU software version is at the following using <a href="#">TCU Software Version Check</a>.</p> <ul style="list-style-type: none"> <li>• Mazda3 - 10006 or later</li> <li>• CX-30 - 10006 or later</li> <li>• CX-5 - 10023 or later</li> <li>• CX-9 - 10023 or later</li> <li>• MX-30: 10019 or later</li> <li>• CX-50: N/A</li> </ul> <p>4. Disconnect battery terminal for 30 seconds, then test drive the vehicle. Is the reception strength signal normal?</p> <ul style="list-style-type: none"> <li>• Yes: Repair complete.</li> <li>• No: Go to next step.</li> </ul> <p>5. Perform TCU activation. Go to <a href="#">SA-004/21</a>. Is the reception strength signal normal?</p> <ul style="list-style-type: none"> <li>• Yes: Repair complete.</li> <li>• No: Go to next step.</li> </ul> <p>6. Compare Tel antenna No. 1 signal strength with good known vehicle near by. Go to DIAGNOSTIC ASSIST FUNCTION [CONNECTIVITY MASTER UNIT (US)] Functional Inspection / Adjustment -&gt; Navigation System Inspection</p> <p><b>Good</b> - Contact Hotline for technical support</p>

<p><b>No Good - Swap Tel antenna No. 1 with known good vehicle</b></p>
