SERVICE PROGRAM BULLETIN

APPLICABILITY: 2023 MY Legacy
2023 MY Outback

NUMBER: WRI-22

SUBJECT: Telematics DCM Replacement

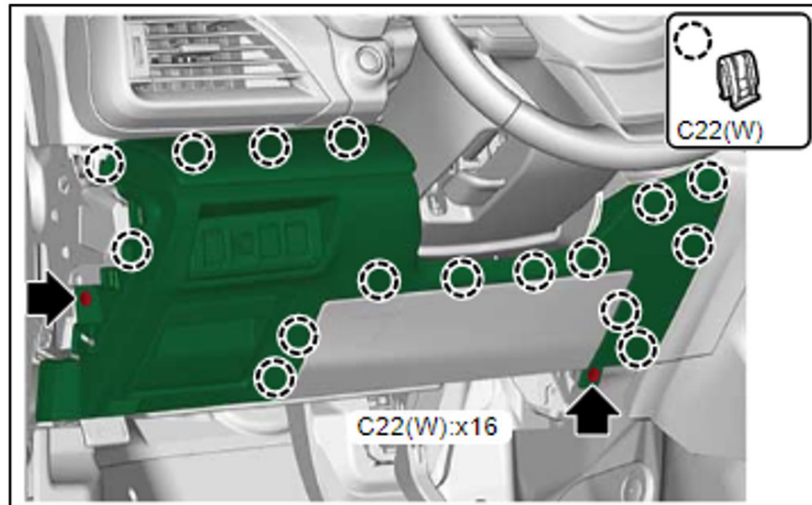
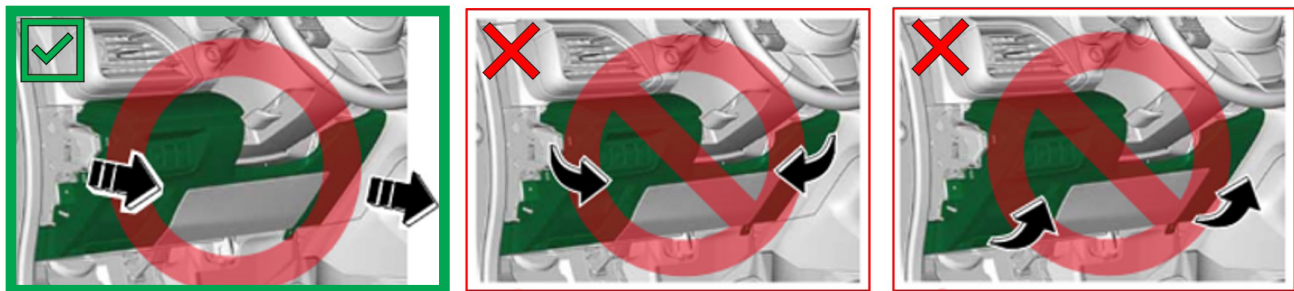
CAUTION: When removing the lower driver cover, **ALWAYS** pull the cover in a straight direction. Pulling in a lateral or upward direction may cause damage to the lower driver cover.

STEP 5: Remove the two mounting screws securing the lower driver cover. Once removed, pull the cover in a straight direction toward the rear of the vehicle to release the mounting clips.

CAREFULLY disconnect all electrical connections. Remove the lower driver cover from the vehicle.

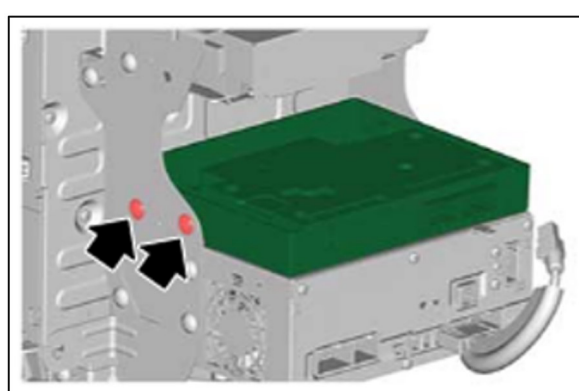
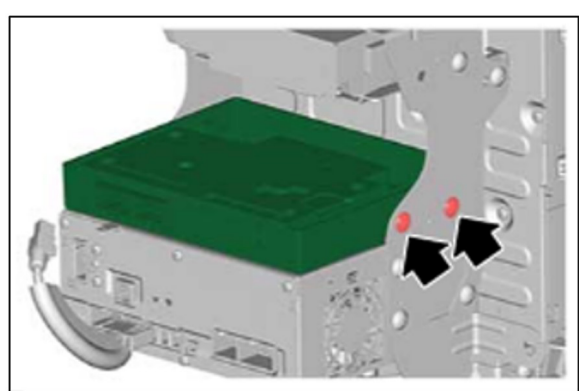
CAUTION: DO NOT apply any impact to the CID assembly or DCM during this process.

STEP 14: Remove the four DCM mounting screws located on the left and right side. The DCM can then be removed.
