SERVICE BULLETIN

APPLICABILITY: 2020-22MY Legacy and Outback Models **NUMBER:** 15-261-20R
SUBJECT: Reprogramming File Availability for Optimization of Gen 4 Denso CP1 Infotainment Systems **DATE:** 03/10/20
REVISED: 10/31/22

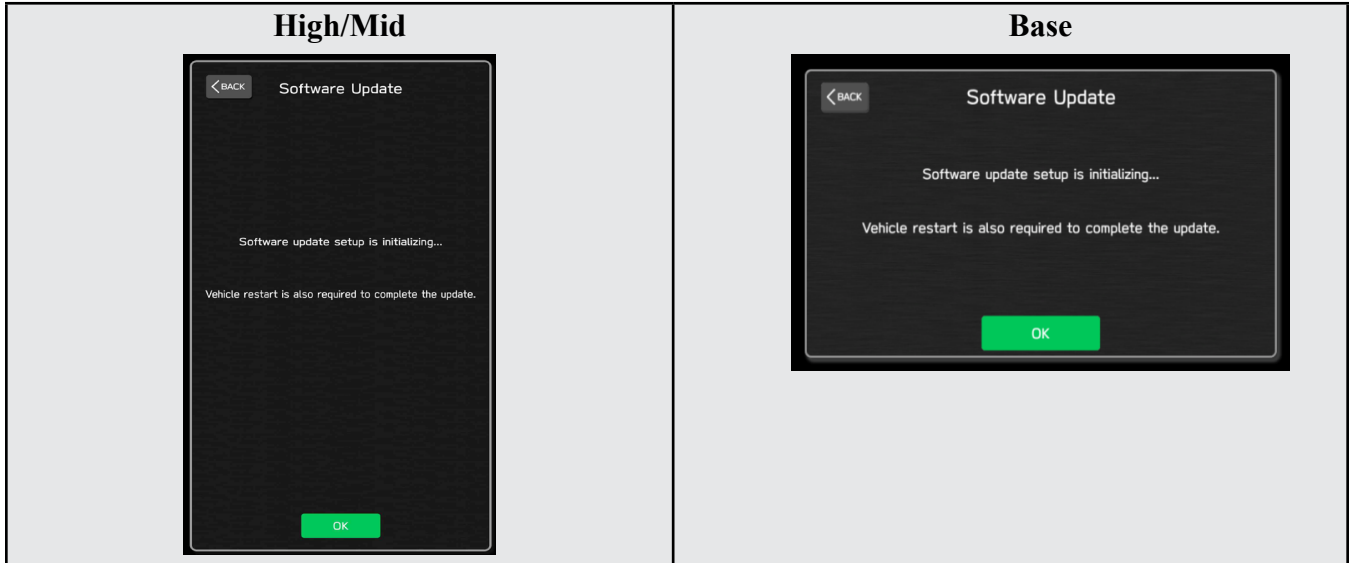
Follow this procedure in the RARE case of “Software update setup is initializing...” message is displayed:

- If the screen shown below appears, **WAIT** for approximately 30 minutes or as long as necessary (waiting for longer than 60 minutes might indicate system malfunction). In that case please perform recovery according to the instructions in “Appendix B ” to allow the Software update setup initialization process to complete.

1. Turn the ignition OFF, open the driver’s door, close the driver’s door and **WAIT** for 3 or more minutes before proceeding further.
2. Open the driver’s door again and either turn the ignition ON (if a charger is connected) or start the engine.
3. Go to Dealership Mode menu again (PRESS and HOLD the RIGHT-side temperature control buttons (both up and down) and press the Tune / Scroll knob 6 times then release all to display the Dealership Mode) and select Software Update as in **STEP 4c** beginning on pg. 11.

IMPORTANT NOTE: If this procedure is required, contact Techline as additional action may be necessary.

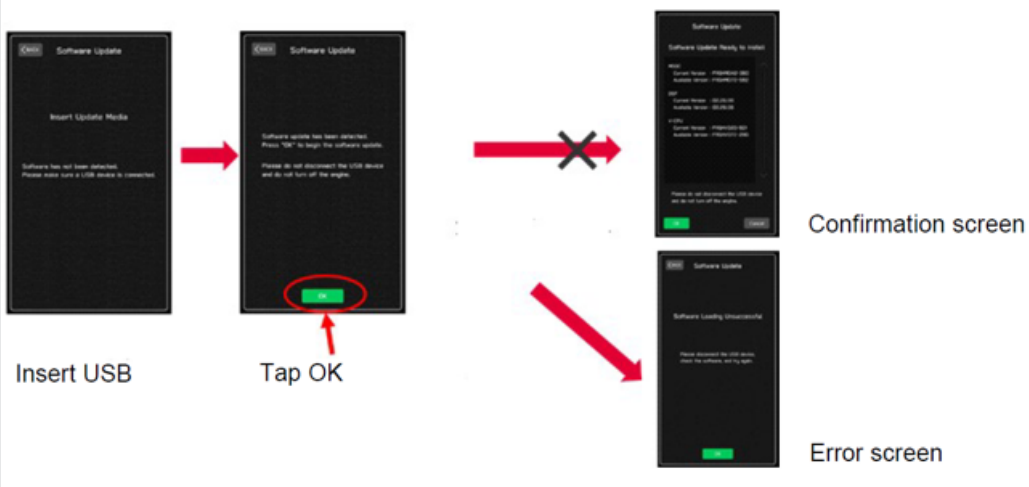
Number	Symptoms to be Improved:
<p>12</p>	<p>When conducting USB reprogramming, the screen transition to error screen instead of confirmation screen.</p>

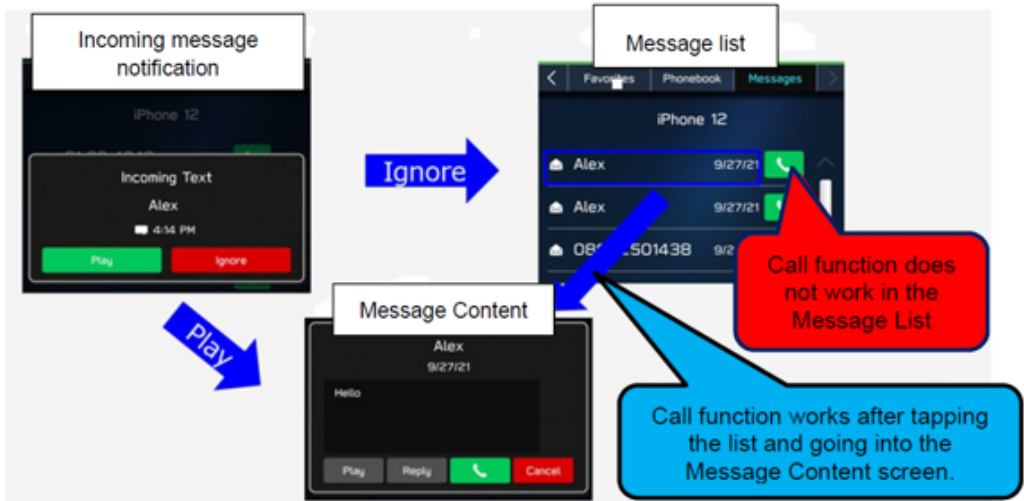
Number	Symptoms to be Improved:
<p>15</p>	<p>Call function does not work in the Message List (after ignoring the incoming message notification.). However, the call function can still be used after getting into the Message Content screen by tapping the message list.</p>

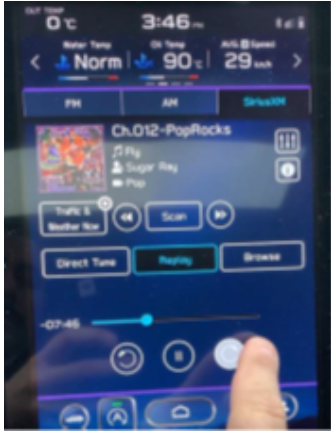
Number	Symptoms to be Improved:
28	SXM has blank screen and no sound when the audio source is change to SXM.
29	<p>“Fast forward” does not work in SXM replay function. (Fast Rewind works.)</p>

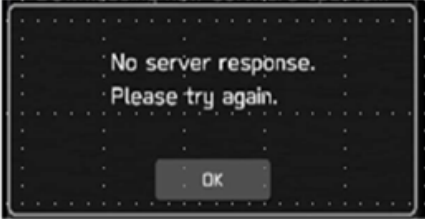
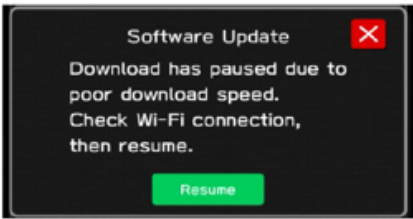
Number	New Functions and Enhancements
1	Icons of home screen change to those of the US specifications even though the original specification is not of the US.
2	Two ways of MOTA operations, i.e., by connect CCM to Wi-Fi or by transferring the downloaded map data to CCM via smart phone are executed simultaneously by error.
3	<p>"One of the Pop-up Error Messages displayed during the FOTA operation in case of weak Wi-Fi signal is not intuitive. Even if the customer tap "OK," it does not transit to another screen.</p> <div style="display: flex; align-items: center; justify-content: center;">

</div> <p>As the improvement for this inconvenience, the message is changed so that the customer finds the reason why the FOTA operation has been paused. Also a "Resume" button is prepared so that the customer can do the rest of operations after necessary action (moving the vehicle to another place with better Wi-Fi connection**, or tethering the CP1 to a mobile phone, etc.)</p> <p>Note** The FOTA operation can be paused when the Wi-Fi indicator at the upper right corner of the CID is not in "Good" or "Excellent" as shown below.</p> <div style="text-align: center;">

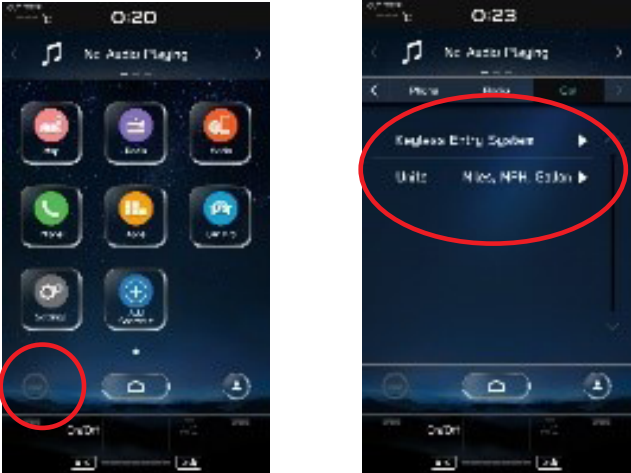
Number	Symptoms to be Improved:
4	<p>Vehicle Setting Icon in <Home> menu is grayed out. Menu list in the “Car” tab in the Setting Menu is not displayed.</p>

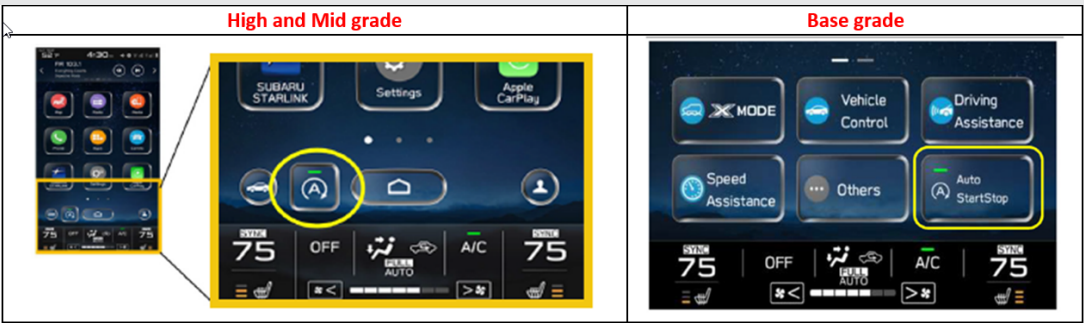
Number	Symptoms to be Improved:
3	Currently, the microphone level indication is incorrect. The indicator level has been corrected. More microphone level indication information is included in TSB 15-275-20.
4	A reduced (low) volume (-6db) concern during handsfree conversation when using CarPlay has been addressed to make the volume level consistent.
5	Voice recognition (VR) has been enhanced to improve recognition of short words (e.g. YES).
6	The program has been corrected to prevent repeated rebooting and system freeze-up immediately after activation of Android Auto.
7	Eliminate CP1 MOTA update error message “Something went wrong. The system is unable to install any map updates. Contact your dealer for more information.”
8	<p>The Auto Stop-Start On/Off function button has been moved from the bottom to top layer of the system for easier use. A screenshot of how the button will appear is shown below.</p>

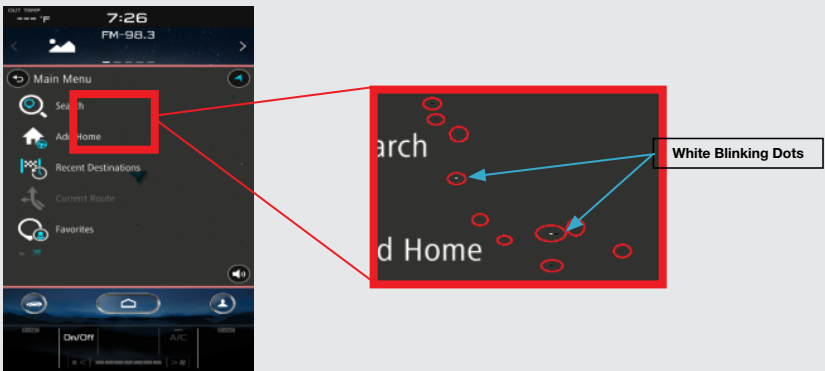
Symptom #	Description of Symptom:
1	Several minutes after Engine start, the Center Information Display (CID) reboots.
2	<p>After an extended period of usage, some white blinking dots appear on the display.</p>

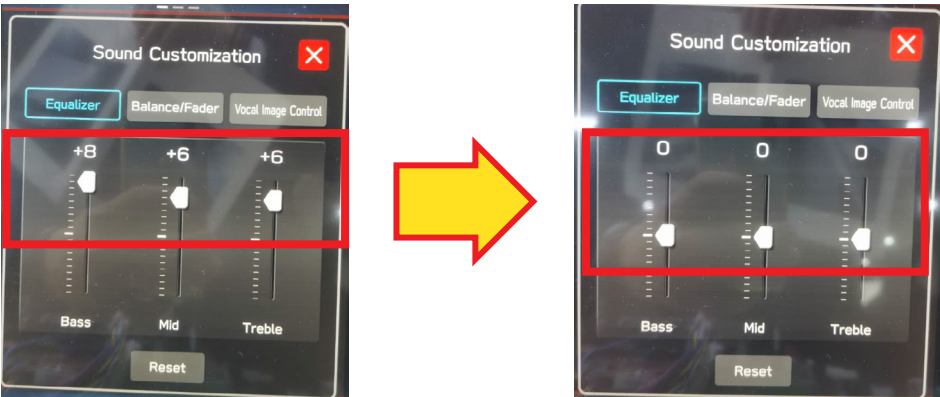
7	Customer-selected Equalizer settings are lost. Equalizer returns to the default settings after ignition switch is turned OFF and back ON.

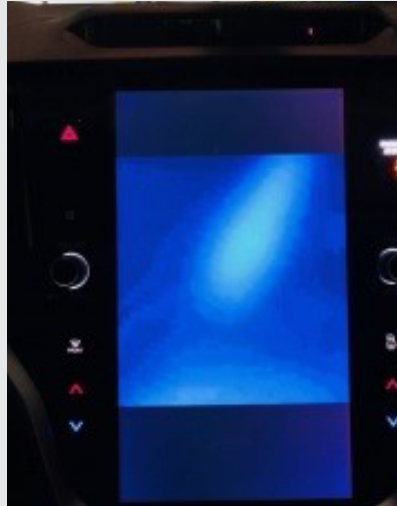
Symptom #	Description of Symptom:
13	CarPlay connection cannot be established. When connecting an iPhone via USB, "CarPlay Unavailable" is displayed and CarPlay does work.
14	The HOME screen goes blank. When the screen is switched from Camera mode to HOME, no icons are displayed as shown below.

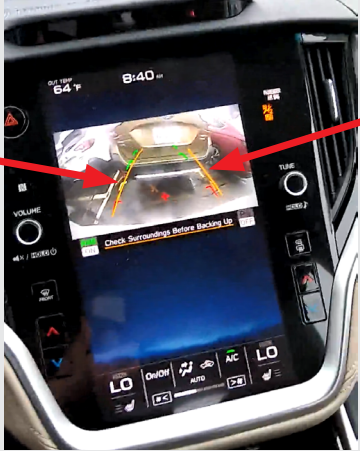
Symptom #	Description of Symptom:
2	<p>Delayed response of rear view camera guide lines. When the rear view camera is activated and the steering wheel is turned, there is a delay before the steering-responsive guide lines respond to the steering wheel input.</p>
