Technical product information

Topic	Rotating screen alignment - Minimum standards could not be achieved
Market area	Russische Föderation (5RU),Australia E04 Bentley rest Asia and Australia (6E04),China 796 VW Import Comp. Ltd (Vico), Beijing (6796),Germany E02 Bentley rest Europe (6E02),Japan E03 Bentley Japan (6E03),Korea, (South) E08 Bentley South Korea (6E08),United Arab Emirates E06 Bentley Middle East and Africa (6E06),United Kingdom E01 Bentley UK (6E01),United States E05 Bentley USA and rest America (6E05)
Brand	Bentley
Transaction No.	2065896/2
Level	EH
Status	Approval
Release date

New Continental GT - New Continental GTC and New Flying Spur

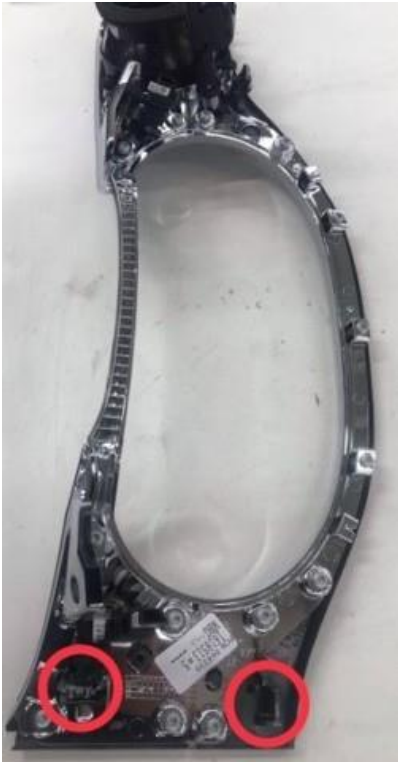
Figure 7

- Remove the Driver's side fascia panel - Rep.Gr 70
- Repeat the re-work process on the drivers side fascia panel as detailed in the passenger side rework section

- Before re-fitting the drivers side fascia panel, anti creak tape must be applied to the BRD mating face at the locations shown in Figure 6
