TO: Mercedes-Benz Dealer Principals, General Managers, Sales Managers, Service Managers, Parts Managers	FROM: Anthony Washington, Department Manager, Regulations and Certifications
Re: Service Campaign Notification Model 907 (Sprinter) Model Year 2022 Retrofit PTC Heater	DATE: August, 2022

Service Campaign Bulletin

Campaign No. 2022070014 August, 2022

SUBJECT: **Model 907 Model Year 2022**
Retrofit PTC Heater

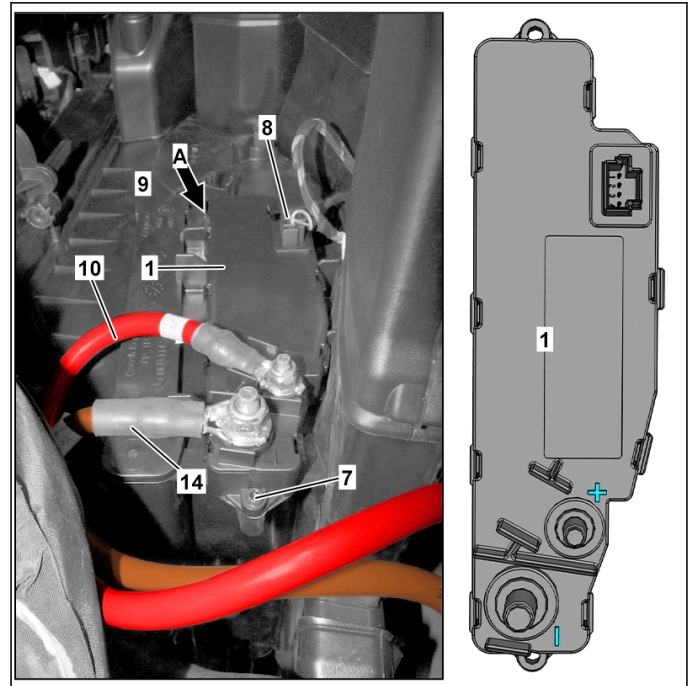
D83.70-A028-82

- 1 PTC heater booster
- 7 Screw
- 8 Connector
- 9 Heater housing
- 10 Positive line
- 14 Ground cable

4	Remove the cover (6).	<p>i To do so, unscrew screw (7) and release retaining tab (arrow A).</p> <p>i The cover (6) is no longer required.</p>	
5	Disconnect plug (8) from air conditioner box (9).	<p>i The plug (8) must not be connected to the air conditioner box (9).</p>	
6	Remove protective cover of positive line (10).	<p>i To do so, separate cable tie. The protective cover is no longer required.</p>	
7	Cut cable tie (20).		
8	Detach cover (17) from positive terminal of on-board electrical system battery.	Model 907	
9	Remove protective cover of positive line (10).	<p>i To do so, separate cable tie. The protective cover is no longer required.</p>	
	Retrofit PTC booster heater (1)		
10	Retrofit PTC booster heater (1).	<p>! Install PTC booster heater (1) straight into air conditioner box (9). When installing, do not tilt the PTC booster heater (1). Otherwise damage at the PTC heater booster (1) could occur.</p> <p>i Lock PTC booster heater (1) at retaining tab (arrow A).</p>
