Timing Gear Plate, Inspection

V-212-001

(December 2022)

All Volvo Powered Trucks 2017 to current

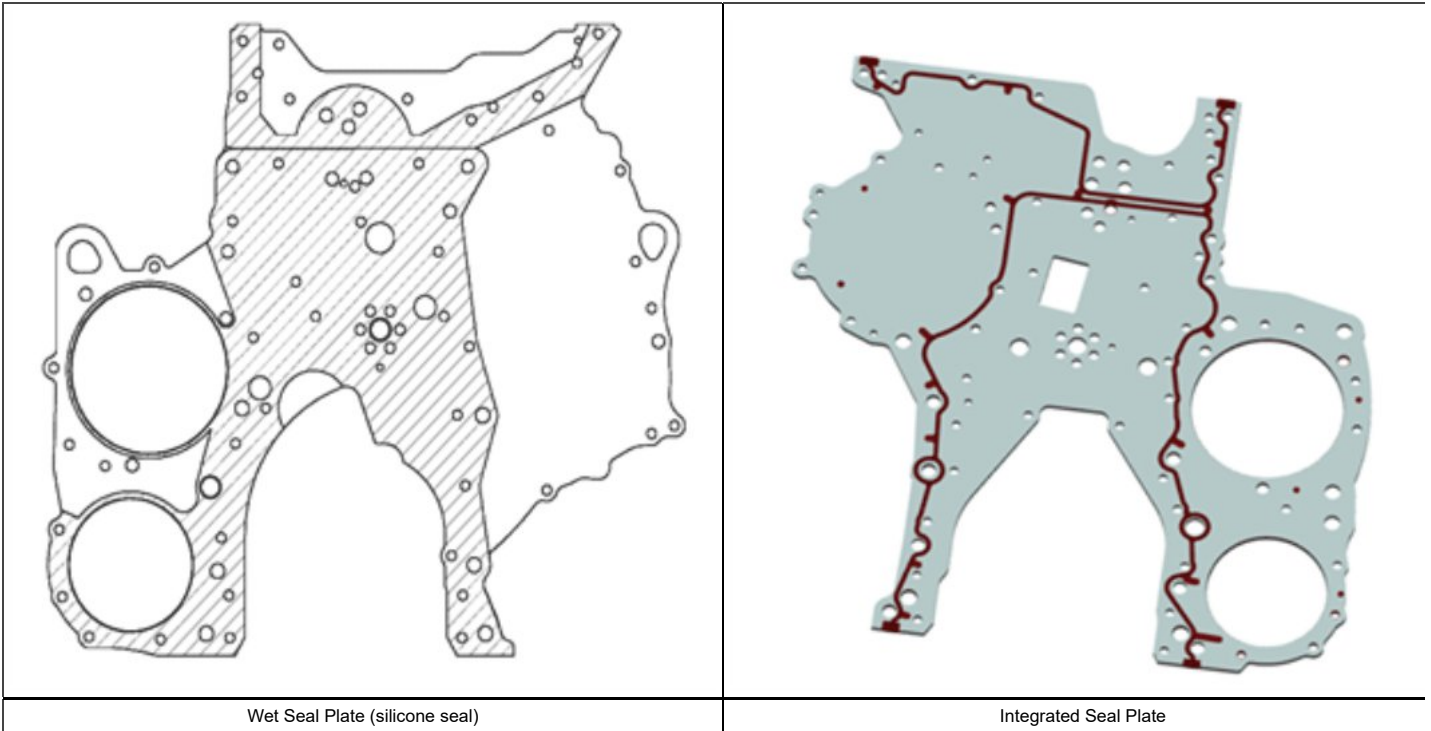
Wet seal plates are multiple time use and can be removed, cleaned and reinstalled with new sealant. Wet seal plates are used on 11L-13L engines from the start of production to current on the 11L and through April 2018 on the 13L VGT engines. The 13L turbo compound engine has never been built using the wet seal plate.

Integrated seal plates were introduced into production in 2017 models built with the 13L Turbo compound engine and 13L VGT engines built after April 2019. If a leak is found on an integrated seal plate or any damage is found to the integrated seal the plate must be replaced. The integrated plate is not repairable and must be replaced if any damage is found.

13L Engine with a wet seal plate can be upgraded to the new integrated seal plate but will require additional components to be replaced. Refer to [TPI 212-031, Timing Gear Plate](#) for required parts list.
