SERVICE BULLETIN

APPLICABILITY: 23MY Outback/Legacy Models

NUMBER: 15-305-22R

SUBJECT: Reprogramming File Availability for Optimization of Gen 4 Denso CP1.5 Infotainment Systems

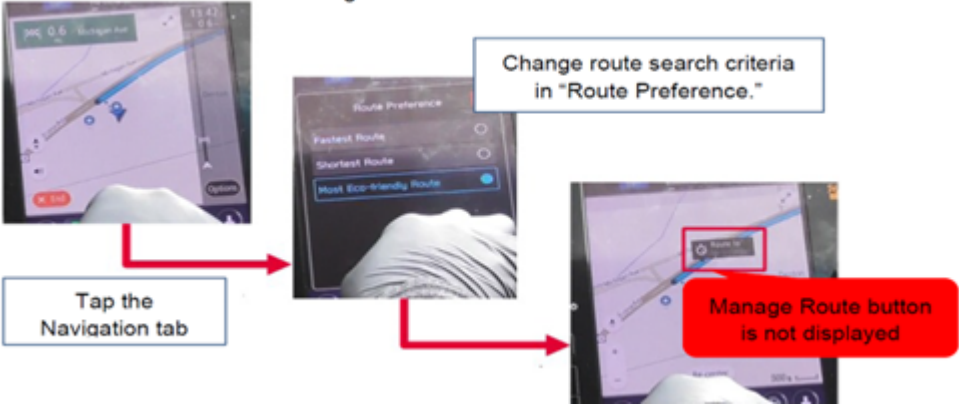
<p>The screenshot shows a 'Select Point of Interest' dialog box with a 'Please speak now' button. Below it, a list of search results is displayed. The first three items are 'Toll Place' with a distance of '24 mi'. The last two items are 'Llano' and 'Tongoro', both with a distance of '27'. A red box highlights the 'Llano' and 'Tongoro' entries.</p>
10	<p>Navigation restarts itself, when the letters are rashly entered or deleted using keyboard function to search destination.</p>
11	<p>“Manage Route” button is not displayed when touching the route line on Navigation system, when the route search criteria got changed in the Route Preference Screen after a route had been searched.</p>

<p>The sequence of screenshots shows the following steps: <ol style="list-style-type: none"> A navigation map with a route line. A red arrow points to the bottom navigation bar with the text 'Tap the Navigation tab'. The 'Route Preference' screen, showing options for 'Fastest Route', 'Shortest Route', and 'Most Eco-Friendly Route'. A red arrow points to this screen with the text 'Change route search criteria in "Route Preference."'. The navigation map again, but the 'Manage Route' button is missing from the bottom bar. A red box highlights the area where the button would be, with a red text box saying 'Manage Route button is not displayed'. </p>
