## TECHNICAL SERVICE BULLETIN

### SB-65 2022 & 2023 Allegro Open Road 8K Hollow Leg Jack Replacement

January 3, 2023

# JACK INSPECTION, REMOVAL AND REPLACEMENT (IF NEEDED) FOR 8K JACKS ON MOTORIZED UNITS

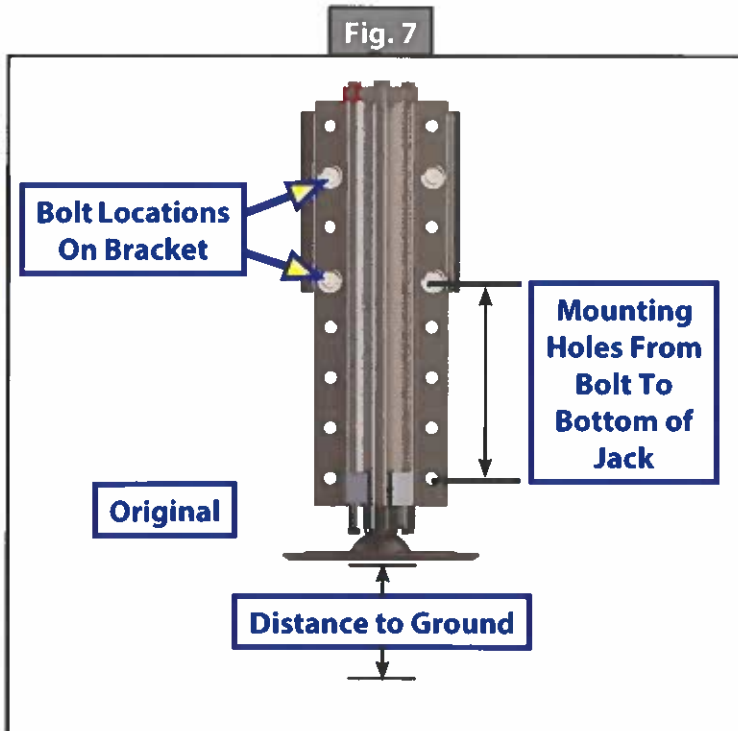
1. Before removing the original jack, note the location of the mounting holes on the jack and the mounting bracket (Fig. 7 or Fig. 8).

**NOTE:** Count the number of mounting holes from the first bolt to the bottom of the jack.

2. Measure the distance from the ground to the footpad of the retracted jack (Fig. 5 or Fig. 6).
3. When reinstalling jacks, match the number of mounting holes from the first bolt to the bottom of the jack (Fig. 7 or Fig. 8).
4. When reinstalling jacks, be sure to install bolts in the same location based on the number of mounting holes to the bottom of jack.
5. Once installation of the Gen II jack has been completed, measure the distance from the footpad to the ground to verify installation is correct.

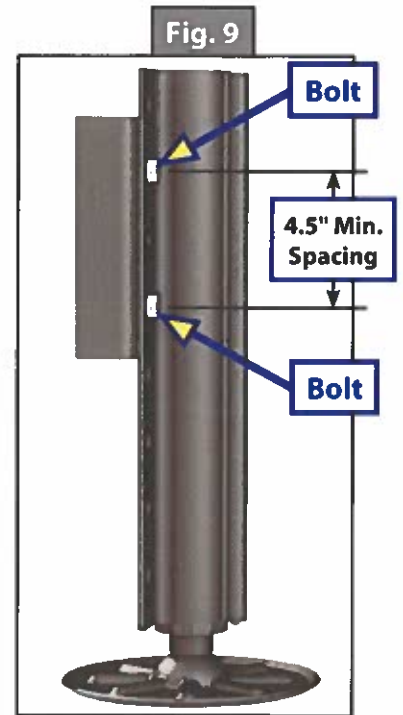
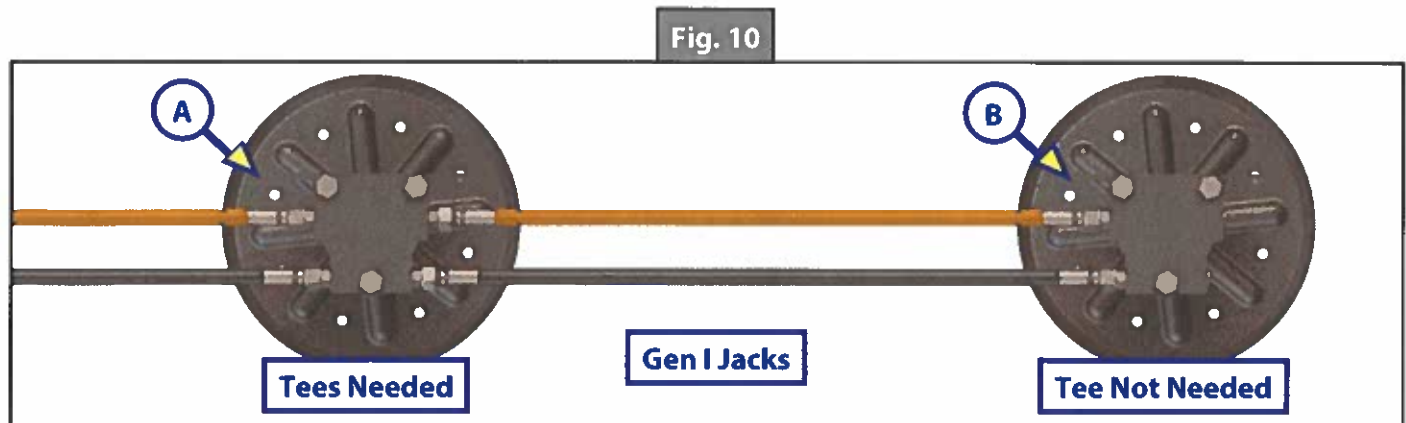
**NOTE:** On motorized leveling, the extend hose is black and the retract hose is orange.

- A. If the Gen I jack has two orange extend hoses and two black retract hoses (Fig. 10A), an O-ring face tee fitting (Fig.11) must be used to connect the hoses to the single extend and retract hoses on the Gen II jack (Fig. 11).
- B. If the Gen I jack has only one orange extend hose and one black retract hose (Fig. 10B), a 90-degree O-ring face elbow fitting (Fig. 11) will be needed to connect the single black and orange hoses to the Gen II jack (Fig. 11).
