# TECHNICAL SERVICE BULLETIN

Classification: AN22-031	Reference: NTB23-004	Date: January 13, 2023
-----------------------------	-------------------------	---------------------------

## MISSING OR CORRUPTED MAP DATA

**APPLIED VEHICLES:** 2021-2023 Armada (Y62)  
2021-2023 Maxima (A36)  
2022-2023 Pathfinder (R53)  
2021-2023 Rogue (T33)  
2020-2023 Titan/Titan XD (A61)

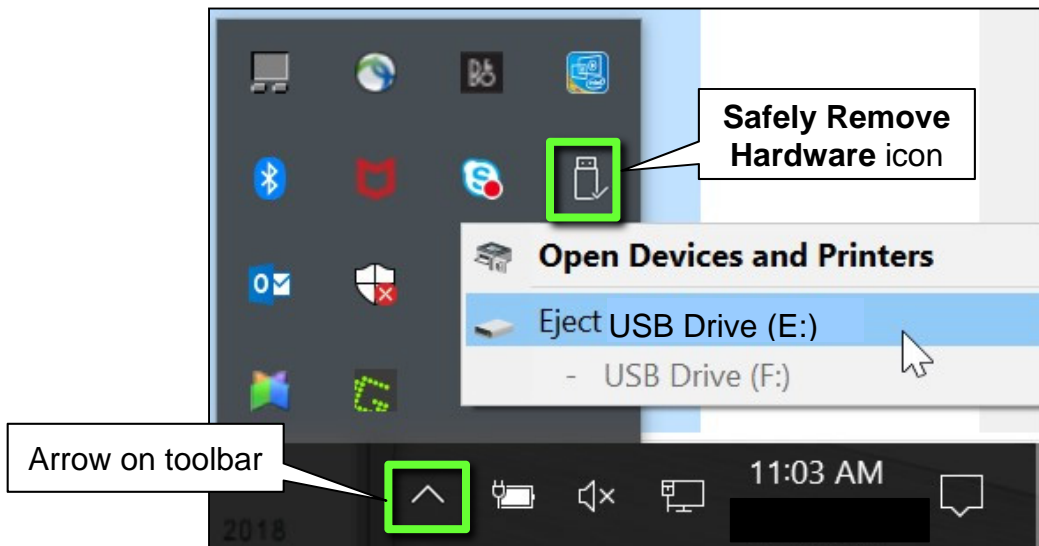
Figure 6

Follow the steps to safely remove the USB drive. If not followed, the USB drive may corrupt the infotainment map data.

8. Once the transfer is complete, safely remove the USB drive from the CONSULT PC.
  - a. From the PC toolbar, select the **Safely Remove Hardware** icon.
    - o The icon is on the toolbar, or can be found after selecting the arrow.
  - b. Select the USB drive to be removed, and then remove the USB drive from the CONSULT PC.

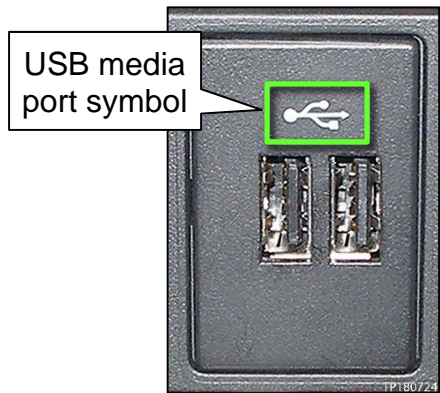
Figure 7

Do not insert the USB drive into a charging port. If used, the map data and/or USB drive may become damaged. Only insert the USB drive in a USB media port.

12. Insert the USB drive with the map data into the vehicle's USB media port (Figure 7).
- Do not remove the USB drive during the update to the vehicle until instructed to.
