Service Bulletin

Bulletin No.: 23-NA-007

Subject: Black Radio Display Screen (Triangle and Camera with Slash Through it) with DTCs B1A62 82 and 86 Setting Current in Video Processing Module (VPM)

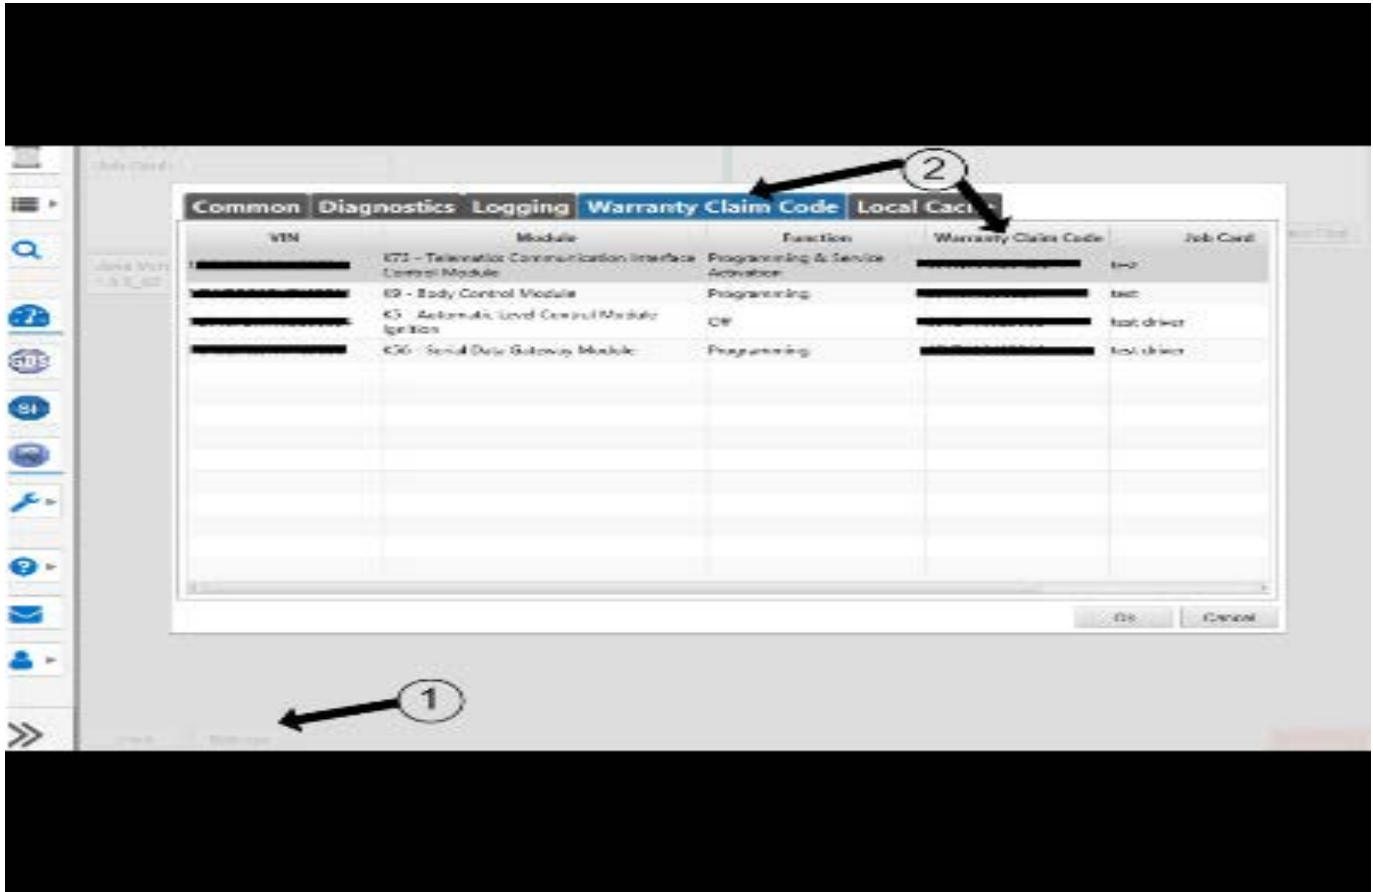
If the Warranty Claim Code was not recorded on the Job Card, the code can be retrieved in the SPS2 system as follows:

1. Open TLC on the computer used to program the vehicle.
2. Select and start SPS2.
3. Select Settings (1).
4. Select the Warranty Claim Code tab (2).

The VIN, Warranty Claim Code and Date/Time will be listed on a roster of recent programming events. If the code is retrievable, dealers should resubmit the transaction making sure to include the code in the SPS Warranty Claim Code field.
