GLOBAL SAFETY FIELD INVESTIGATIONS
DCS6461
URGENT - DISTRIBUTE IMMEDIATELY

Subject: N222375790 - Customer Satisfaction Program
Park Assist Retrofit

Models: 2022 – 2023 Chevrolet Corvette

N222375790 Park Assist Retrofit

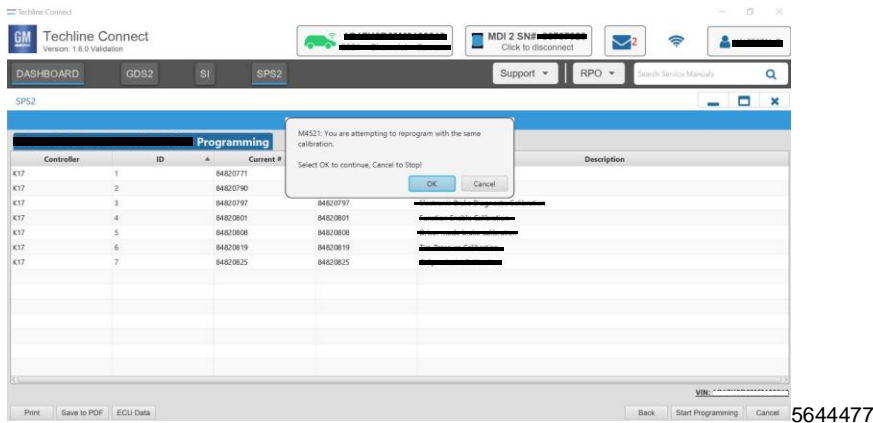
Important: Techline Connect screens shown above.

Important: If the same calibration/software warning is noted on the TLC Summary screen, select OK and follow screen instructions. After a successful programming event, the WCC is located in the Service Programming System dialogue box of the SPS Summary screen. No further action is required. Refer to the Warranty section of the bulletin.
