Service Bulletin

Bulletin No.: 22-NA-235

Subject: Wireless Charging is Intermittent When Using Samsung Phones at Offset Positions

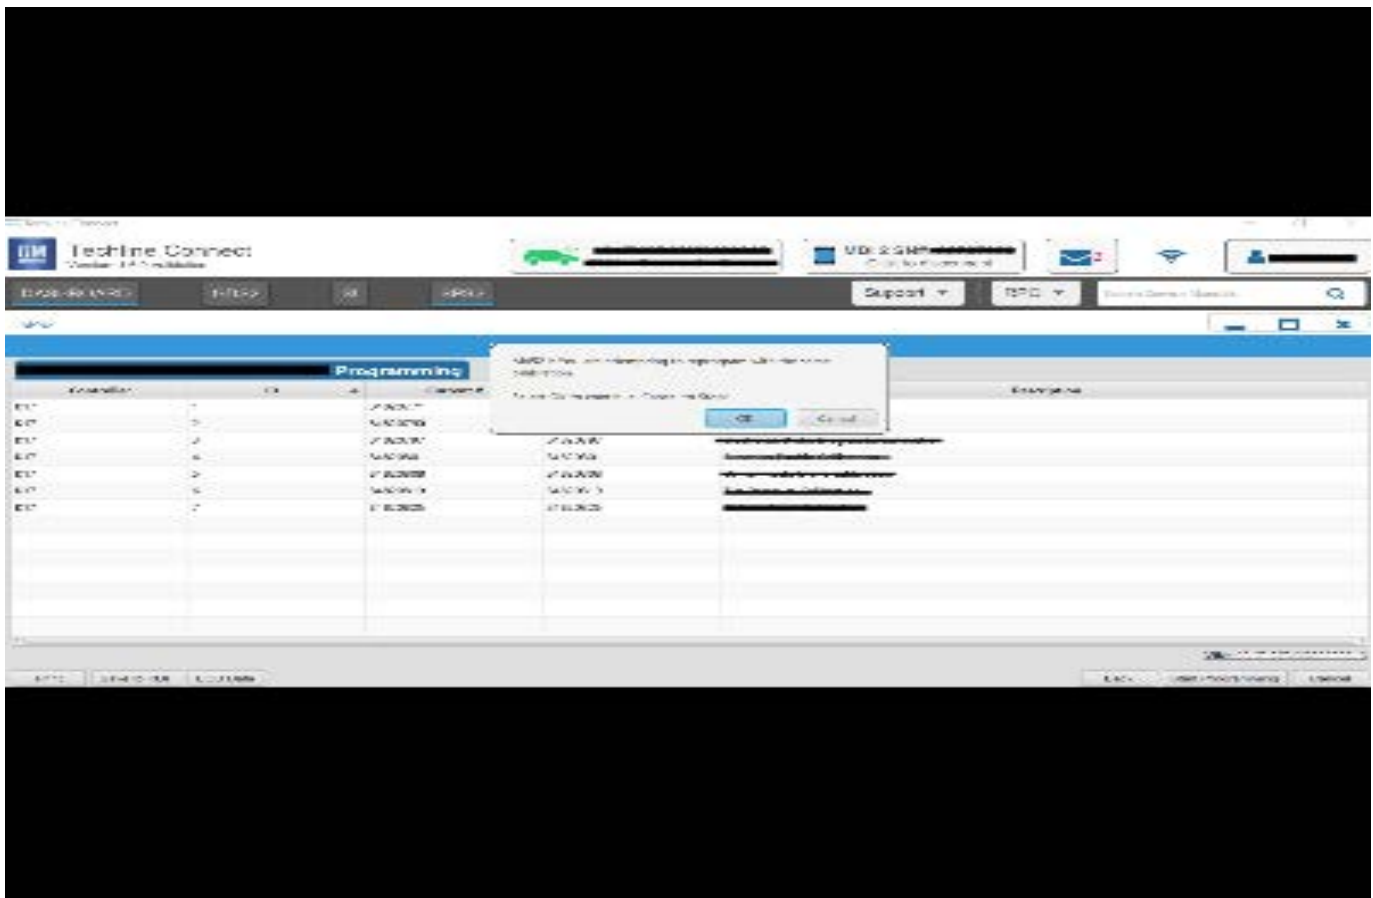
5877000

Important: Techline Connect screen shown above.

Important: If the same calibration/software warning is noted on the TLC or SPS Summary screen, select OK and follow screen instructions. After a successful programming event, the WCC is located in the Service Programming System dialogue box of the SPS
