Service Bulletin

Bulletin No.: 01-08-42-001O

Subject: Exterior Lamp Condensation and Water Leak Information and Replacement Guidelines

Models: 2023 and Prior GM Passenger Cars and Trucks (including Medium Duty Trucks)
(Excluding LCF Medium Duty Trucks)

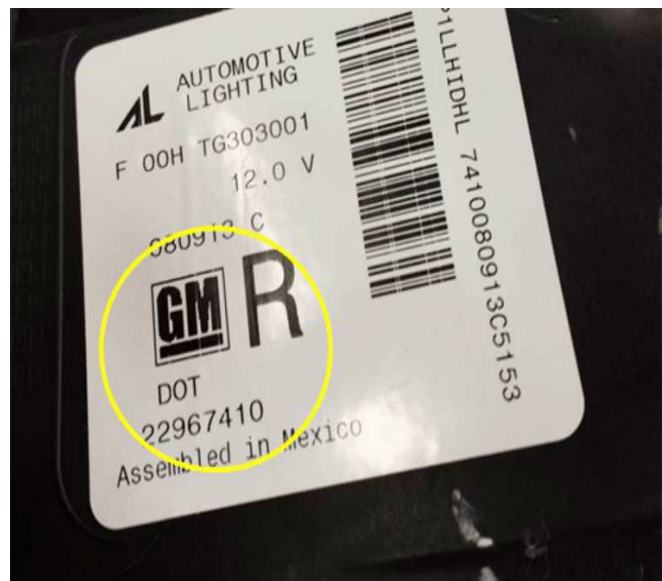
Example of GM Trademark

Note: The graphic below is an example of a GM Trademark that appears on some lamp assemblies. Current assemblies contain the trademark on a label affixed to the assembly.
