Complaint - Cylinder Head Cover Near the Injector Holes Leaking: Subsequent Work on Cylinder Head (180/18)

Vehicle Types: **Panamera (971) / Panamera 4 (971) / Panamera 4 Sport Turismo (971) / Panamera 4S (971) / Panamera 4S Sport Turismo (971) / Panamera 4 E-Hybrid (971) / Panamera 4 E-Hybrid Sport Turismo (971) / Panamera 4S E-Hybrid (971) / Panamera 4S E-Hybrid Sport Turismo (971)**

Concerns: **Cylinder head cover**

Cause: **Complaint about injector hole leaks**

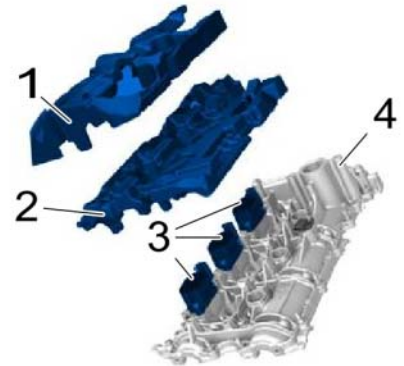
Cylinder head cover component overview

- 1 – Insulation on top of cylinder head cover
- 2 – Insulation on bottom of cylinder head cover
- 3 – Solenoid hydraulic valve for valve lift adjustment
- 4 – Cylinder head cover
