Subject: REVISION: N192266181-01 – Special Coverage
Wiper Transmission Arm Linkage Failure
Population Update

Models: 2010-2012 Chevrolet Equinox
2016-2017 Chevrolet Equinox
2010-2012 GMC Terrain
2016-2017 GMC Terrain

N192266181 Wiper Transmission Arm Linkage Failure – USA Only

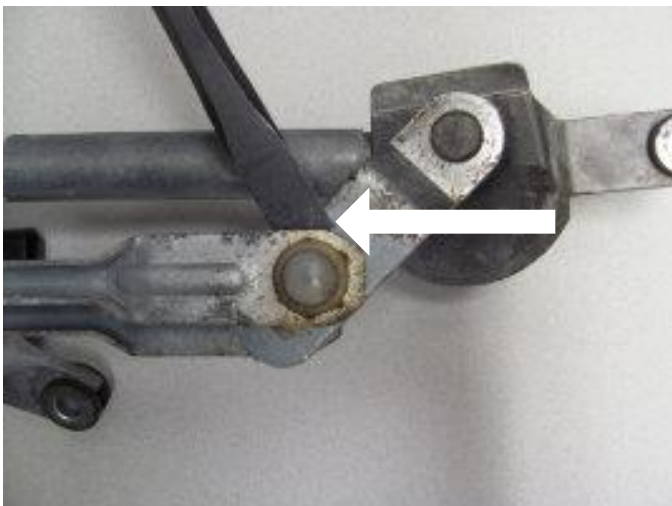
6116961

GM OE parts will have a part number tag

2. Place the assembly on the work bench or carefully secure it in a bench vise with non-marring inserts.

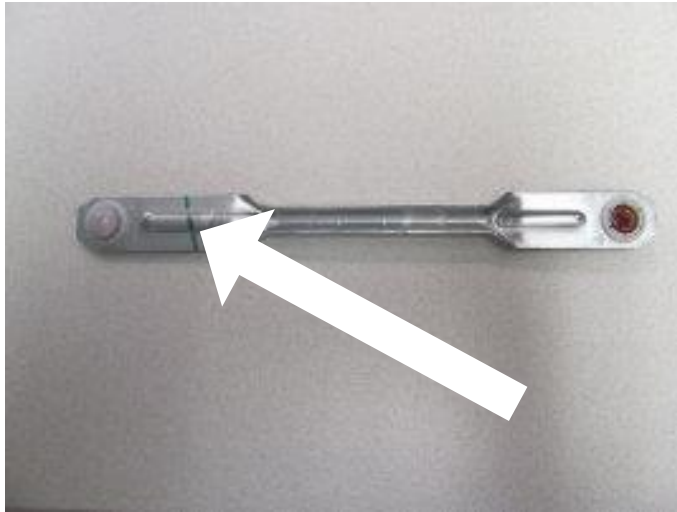
6116962

IMPORTANT: The short link rod has a long side and a short side. The long side is marked by a paint stripe. Ensure the long side is installed onto the motor pivot ball. Improper installation of this link will cause interference with the rotating assembly.
