TECHNICAL SERVICE BULLETIN

| Classification: EL22-011A | Reference: NTB22-051A | Date: February 22, 2023 |

HORN INOPERATIVE

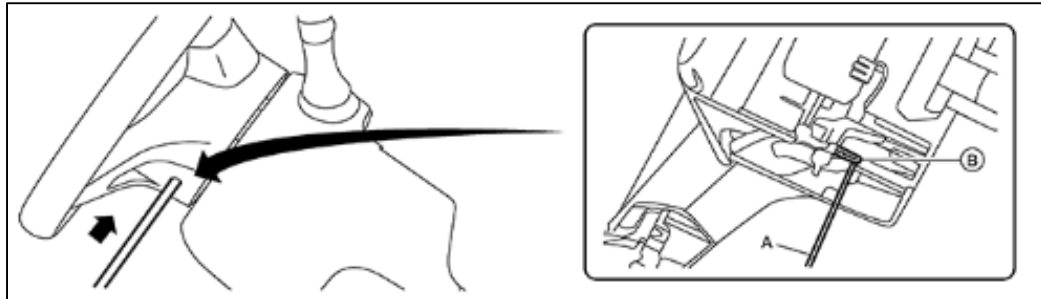
Figure 6

7. Turn the steering wheel in the opposite direction, and then repeat steps 4 - 6 to release spring B (Figure 2 on page 3).
8. Using the Airbag Release Tool (A), gently push the bottom pawl (B) and gently tilt the bottom of the driver airbag module outward so that the pawl will not re-engage, and then pull out the driver airbag module.
