PIT5921A Rear View Camera Coaxial Related Issues-B395A - B395B - B395C - B101E - B101D

Product Investigation Review Required

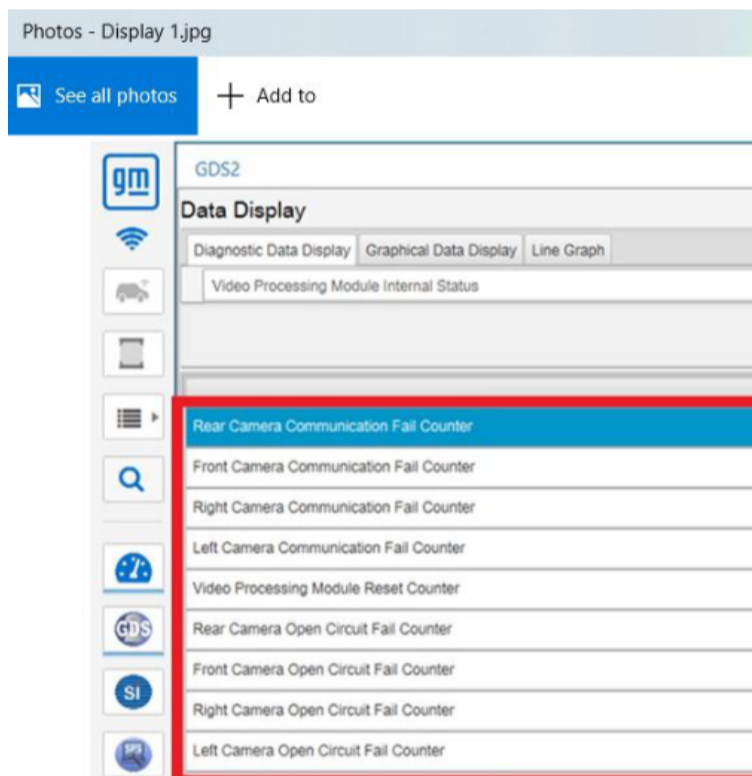
Module Diagnostics / K157 Video Processing Module / Video Processing Module Internal Status.

3. The three most critical parameters to look at are:

- a. Camera Communication Fail Counter
- b. Video Processing Module Reset Counter
- c. Camera Open Circuit Counter

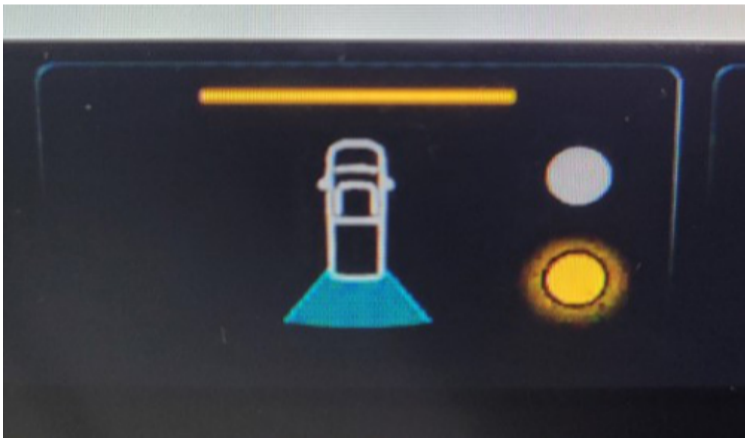
7. If it's difficult to determine the causal component, unplug all the cameras.
- Leave the rear camera input and video output at VPM.
 - Activate the Rearview Camera (RVC) using the "Cameras" touch button.

- If there is no image output, swap to the front, left, or right cameras into VPM rear camera input and repeat previous steps to check images again.
8. If concern(s) persist, refer to published diagnostics in SI.

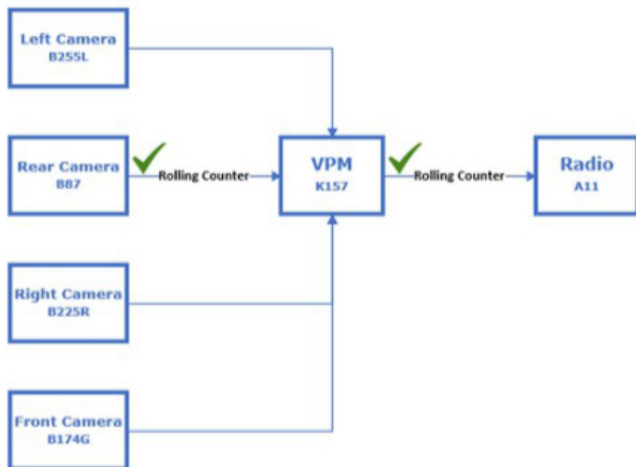
The Radio requires a rolling counter to ensure a video output on the radio screen. This counter prevents a frozen image to be displayed to the vehicle owner when shifting into reverse.

This rolling counter is monitored continuously to ensure we have video signal from the rear camera. It goes from the rear camera to the VPM and from the VPM to the Radio.
