Service Alert

Mazda North American Operations
Irvine, CA 92618-2922

Subject: CONNECTED VEHICLE SYMPTOM TROUBLESHOOTING	Service Alert No.: SA-009/23
	Last Issued : 03/01/2023

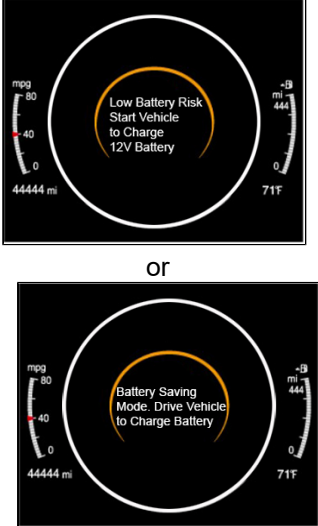
<p>Enrollment error</p>	<p>Go to SSPC1</p>
<p>8</p>	<p>2021 Mazda3, CX-30, CX-50, and MX-30 functions inoperative</p> <ul style="list-style-type: none"> • Vehicle Status Alert • Remote Engine Start / Stop • Remote Door Lock / Unlock • Remote Hazard Lights ON / OFF • Vehicle Finder (vehicle location mapping function is available) 	<p>Vehicle's electrical control area network (CAN) is in "Sleep Mode"</p>

<p>or</p> <p>No dealer visit is required. Sleep Mode can be reset by starting the engine and idling or driving for 5 minutes or longer.</p> <p>Go to 09-010/22.</p>
<p>9</p>	<p>First remote control attempt fails, second attempt works fine.</p> <ul style="list-style-type: none"> • Engine Start / Stop 	<p>Improper telematics communication unit (TCU) software.</p>	<p>Go to TSB 16-002/20.</p>
