Service Bulletin

Bulletin No.: 00-06-01-012M

Subject: Use of Surface Conditioning Disks When Cleaning Gasket Sealing Surfaces and/or Reused Parts

Models: 2023 and Prior GM Passenger Cars and Trucks including Silverado 4500HD, 5500HD and 6500HD (Excluding Chevrolet Medium Duty Low Cab Forward Equipped with Diesel Engine).
2017-2024 Chevrolet Silverado 2500/3500
2017-2024 GMC Sierra 2500/3500

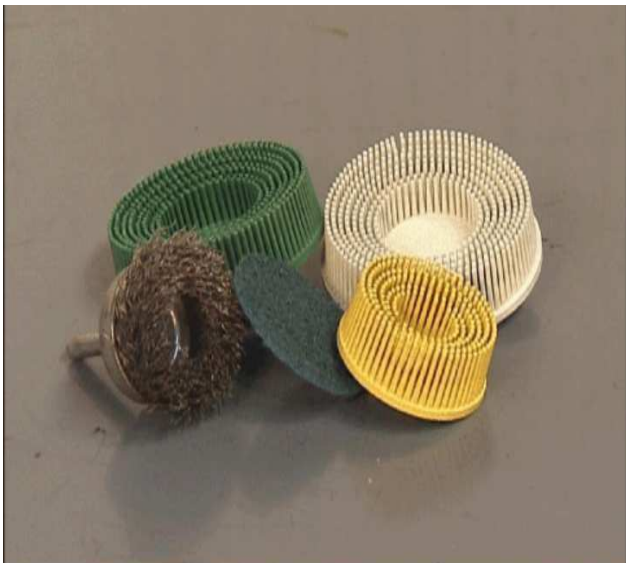
Notice: Do not use abrasive pad/bristle devices to clean the gasket surfaces of any engine, transmission, transfer case and axles as well as any other component that contains lubricant. Abrasive pads should not be used for some of the following reasons:

- Abrasive pads will produce fine grit that the oil filter will not be able to remove from the oil. THIS GRIT IS ABRASIVE AND HAS BEEN KNOWN TO CAUSE INTERNAL ENGINE DAMAGE. Abrasive pads can easily remove enough material to round cylinder head surfaces. This has been known to affect the gasket's ability to seal, especially in the narrow seal areas between the combustion chambers and coolant jackets.

- Abrasive pads, wire and abrasive rubber finger wheels can also remove enough metal to affect cylinder head, block, oil pan rail, and intake manifold runner flatness, which can cause coolant and oil leaks and air leaks. It takes about 15 seconds to remove 0.203mm (0.008in) of metal with an abrasive pad.
