GLOBAL SAFETY FIELD INVESTIGATIONS  
DCS6530  
URGENT - DISTRIBUTE IMMEDIATELY

Subject: N222375791-02 - Customer Satisfaction Program  
Park Assist Retrofit  
Population Update

# Customer Satisfaction Program

## N222375791 Park Assist Retrofit

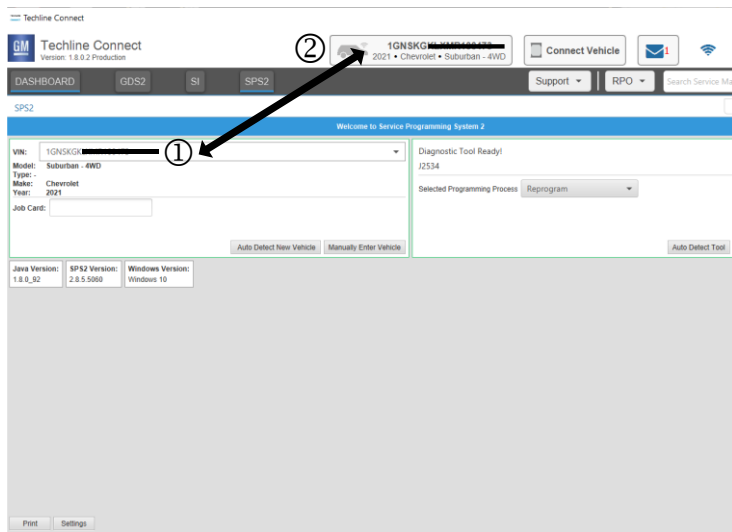
**Caution:** Be sure the VIN selected in the drop down menu (1) is the same as the vehicle connected (2) before beginning programming.

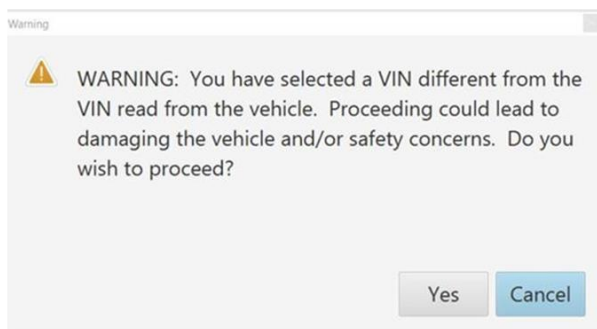
**Important:** If the vehicle VIN DOES NOT match, the message below will be shown.

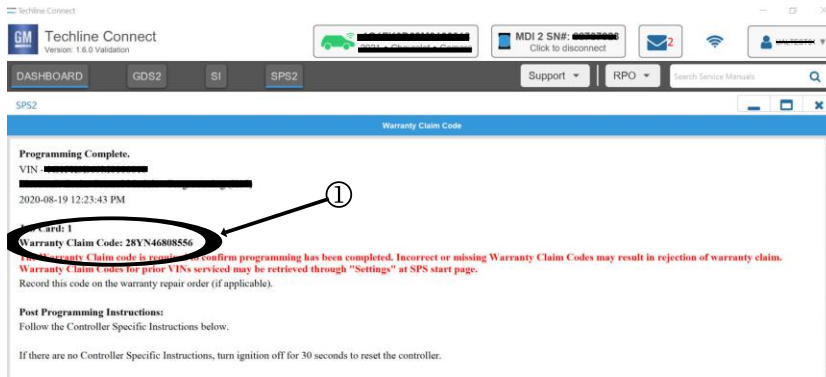
5644478

**Note:** The screenshot above is an example of module programming and may not be indicative of the specific module that is being programmed. Module selection and VIN information have been blacked out.

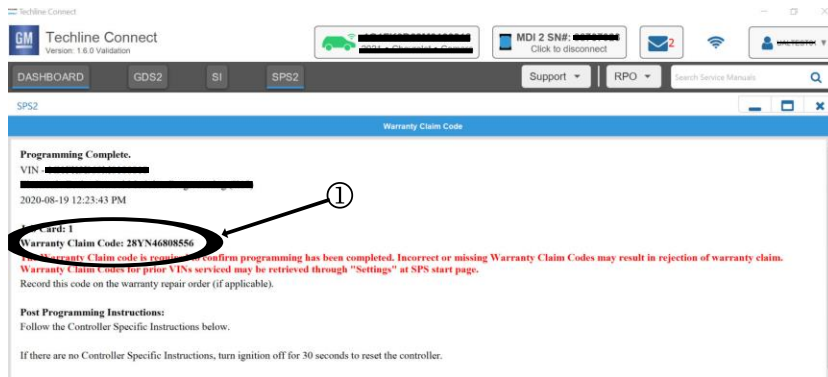
5644478

**Note:** The screenshot above is an example of module programming and may not be indicative of the specific module that is being programmed. Module selection and VIN information have been blacked out.

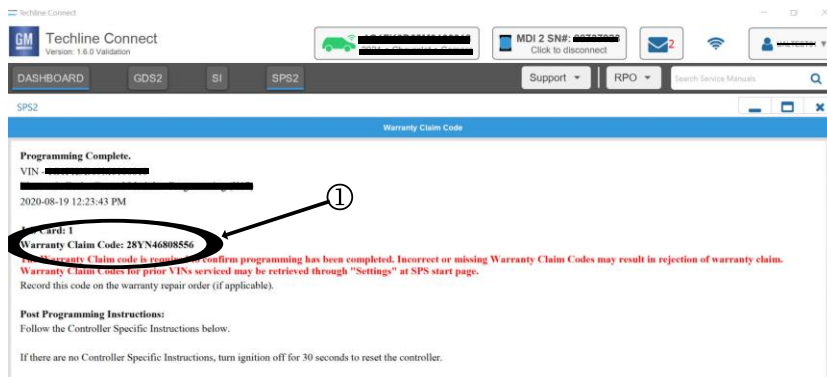
5644478

**Note:** The screenshot above is an example of module programming and may not be indicative of the specific module that is being programmed. Module selection and VIN information have been blacked out.

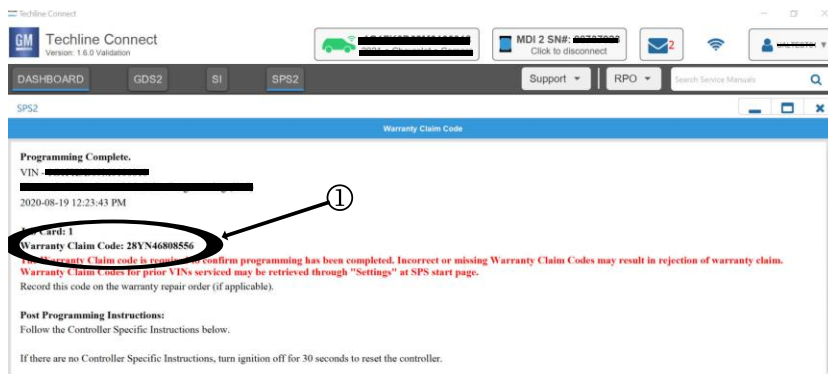
5644478

**Note:** The screenshot above is an example of module programming and may not be indicative of the specific module that is being programmed. Module selection and VIN information have been blacked out.

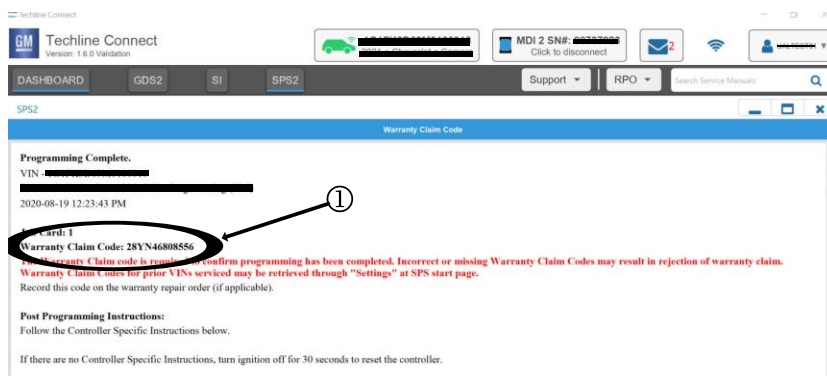
5644478

**Note:** The screenshot above is an example of module programming and may not be indicative of the specific module that is being programmed. Module selection and VIN information have been blacked out.
