Technical Service Bulletin

GROUP CAMPAIGN	NUMBER 23-01-021G
DATE APRIL 2023	MODEL(S) GV80 (JX1)

SUBJECT: 3.5L T-GDI ENGINE TURBOCHARGER OIL PORT RESURFACING
(SERVICE CAMPAIGN T25G)

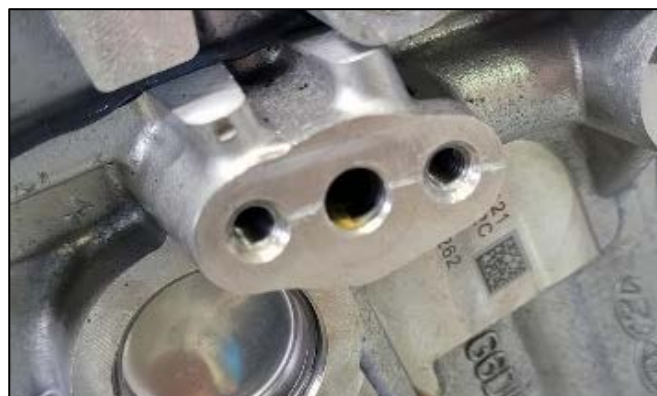
- Inspect the turbo oil feed mating surface on the LH side cylinder head for scratches.
 - If a scratch is found, continue to the next step.
 - If no scratch is found, reinstall the removed parts from Step 2 above in reverse order of removal and continue to **TURBOCHARGER OIL FEED REWORK (RH SIDE)** in the following pages.

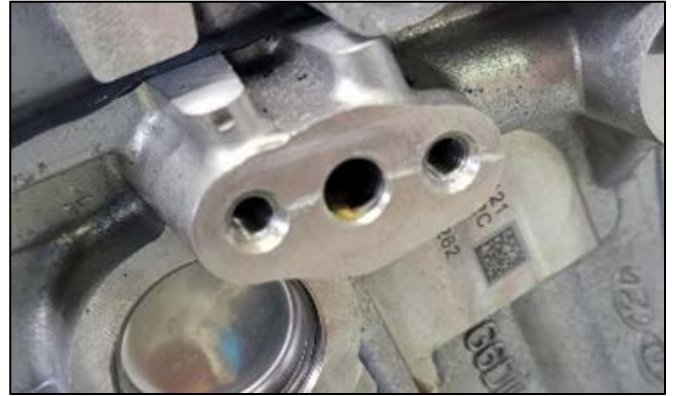
- Inspect the turbo oil feed mating surface on the RH side cylinder head for scratches. If a scratch is found, continue to the next step. If no scratch is found, skip Step 7 below and proceed directly to Step 8.

- Perform the polishing procedure on the RH side according to steps 5 - 15 of the TURBOCHARGER OIL FEED REWORK (LH SIDE) procedure.
