**HYUNDAI**
Technical Service Bulletin

GROUP CAMPAIGN	NUMBER 23-01-042H
DATE APRIL 2023	MODEL(S) PALISADE (LX2) SANTA FE PLUG-IN HYBRID (TM PHEV)

SUBJECT: ENGINE MOUNTING SUPPORT BRACKET RETIGHTENING
(CAMPAIGN TAG)

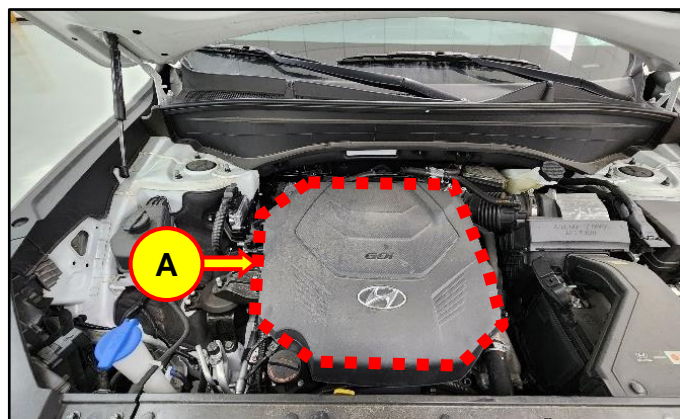
To avoid damaging the engine cover, do not disengage both front and rear clips at the same time.

- Retighten the engine mounting support bracket bolts (B) and nut (C) to the specified torque.

lb-ft	80
N.m	108
